Profile/Photo Observation Report

Street:	PARKER ST	Flow Control:	Not Controlled
City:	Hobart, IN	Year Renewed:	
Location:	Light Highway	Tape/Media #:	
Purpose:	Routine Assessment	Dia/Height:	8"
Use:	Sanitary	Material:	VCP
Drain Area:	NA	Lining:	
Category:	NA		
Comment:

Location Details:		Direction of Survey:	Downstream
US MH:	M-203-020	DS MH:	M-203-019
		Total Length Surveyed (ft):	3.1

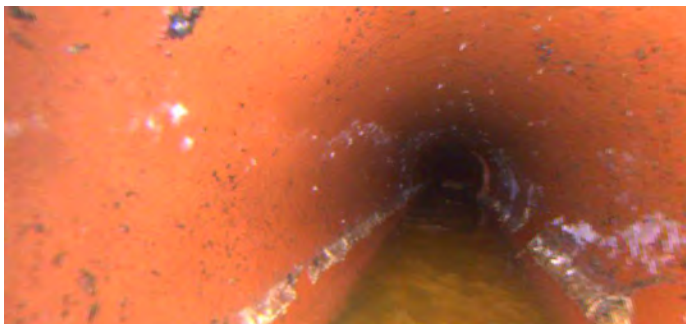
Code: **AMH**
Description: **Manhole**

Distance (ft): **.0**
Structural Grade: **0**
O&M Grade: **0**
Clock Start/From:
Clock To:
1st Value:
2nd Value:
Value Percent:
Continuous Index:
Within 8" of Joint: **NO**
Remarks: **M-203-020**

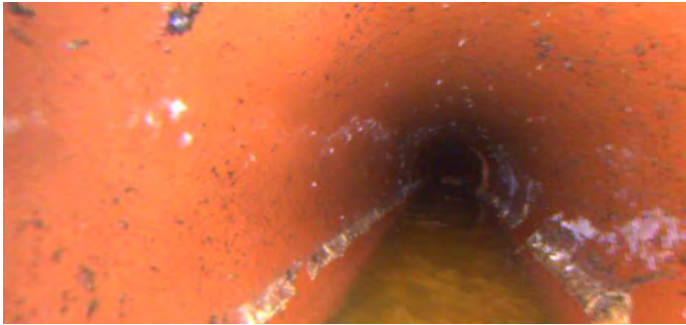
Code:	MWL
Description:	Water Level

Distance (ft):	.0
Structural Grade:	0
O&M Grade:	0
Clock Start/From:	
Clock To:	
1st Value:	
2nd Value:	
Value Percent:	5.000
Continuous Index:	
Within 8" of Joint:	NO
Remarks:

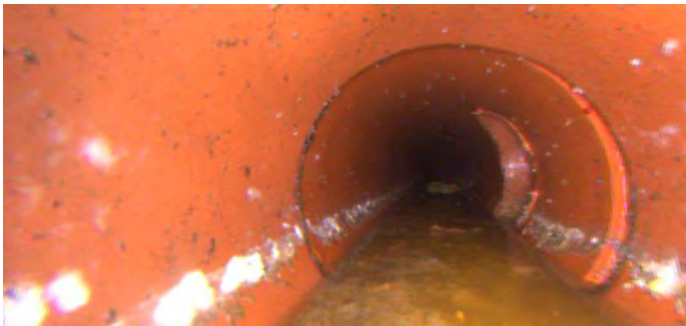
Code:	TF
Description:	Tap Factory

Distance (ft):	3.1
Structural Grade:	0
O&M Grade:	0
Clock Start/From:	3
Clock To:	
1st Value:	4.000
2nd Value:	
Value Percent:	
Continuous Index:	
Within 8" of Joint:	
Remarks:

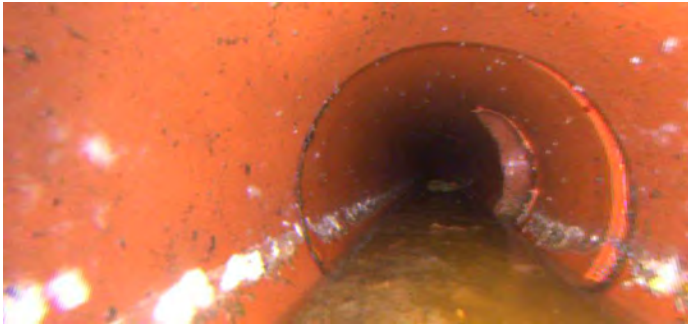
Code:	MSA
Description:	Abandoned Survey
Distance (ft):	3.1
Structural Grade:	0
O&M Grade:	0
Clock Start/From:	
Clock To:	
1st Value:	
2nd Value:	
Value Percent:	
Continuous Index:	
Within 8" of Joint:	NO
Remarks:	camera stopped
