Profile/Photo Observation Report

Date:	09/24/2018	Weather:		Coding:	PACP 6.0
Pipe Length (ft):	100.5	Owner:	NA	Pre Clean:	Not Known
P.O.#:		Surveyor:	Selasie Honu	PSR:	P-203-020-019
Customer:		Clean Date:	01/01/1900	Shape:	C

Street:	Parker St.	Flow Control:	Not Controlled
City:	Hobart, IN	Year Renewed:	
Location:	Light Highway	Tape/Media #:	
Purpose:	Routine Assessment	Dia/Height:	8"
Use:	Sanitary	Material:	VCP
Drain Area:	NA	Lining:	
Category:	NA		
Comment:

Location Details:		Direction of Survey:	Downstream
US MH:	M-203-020	DS MH:	M-203-019
		Total Length Surveyed (ft):	3.1

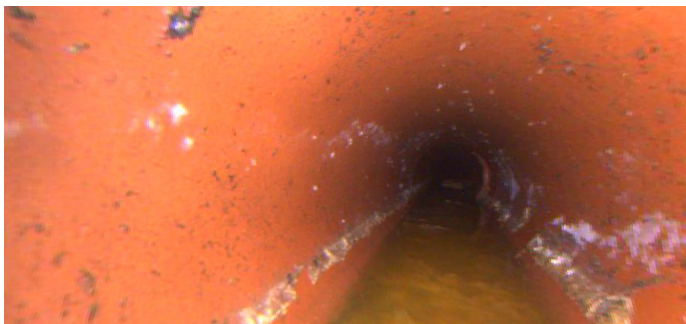
Code: **AMH**
Description: **Manhole**

Distance (ft): **.0**
Structural Grade: **0**
O&M Grade: **0**
Clock Start/From:
Clock To:
1st Value:
2nd Value:
Value Percent:
Continuous Index:
Within 8" of Joint: **NO**
Remarks: **M-203-020**

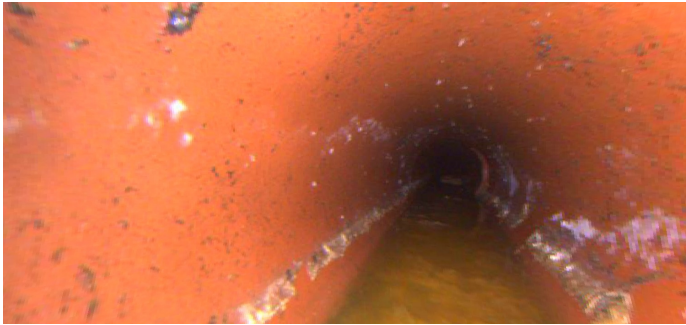
Code:	MWL
Description:	Water Level

Distance (ft):	.0
Structural Grade:	0
O&M Grade:	0
Clock Start/From:	
Clock To:	
1st Value:	
2nd Value:	
Value Percent:	5.000
Continuous Index:	
Within 8" of Joint:	NO
Remarks:

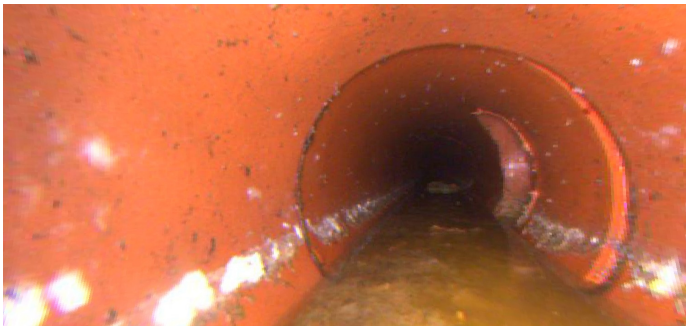
Code:	TF
Description:	Tap Factory

Distance (ft):	3.1
Structural Grade:	0
O&M Grade:	0
Clock Start/From:	3
Clock To:	
1st Value:	4.000
2nd Value:	
Value Percent:	
Continuous Index:	
Within 8" of Joint:	
Remarks:

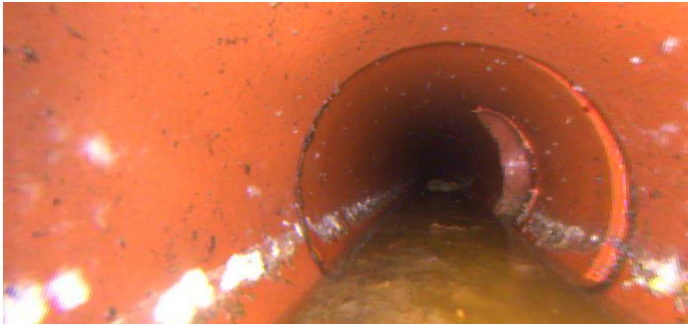
Code:	MSA
Description:	Abandoned Survey
Distance (ft):	3.1
Structural Grade:	0
O&M Grade:	0
Clock Start/From:	
Clock To:	
1st Value:	
2nd Value:	
Value Percent:	
Continuous Index:	
Within 8" of Joint:	NO
Remarks:	camera stopped
