## Profile/Photo Observation Report

Date:	<b>03/27/2018</b>	Weather:		Coding:	<b>PACP 6.0</b>
Pipe Length (ft):	<b>240.5</b>	Owner:	<b>NA</b>	Pre Clean:	<b>Not Known</b>
P.O.#:		Surveyor:	<b>Jen Costello</b>	PSR:	<b>P-203-021-022</b>
Customer:		Clean Date:	<b>01/01/1900</b>	Shape:	<b>C</b>

Street:	<b>ALLEY BETWEEN BARNES ST &amp; PARK</b>	Flow Control:	<b>Not Controlled</b>
City:	<b>Hobart, IN</b>	Year Renewed:	
Location:	<b>Other</b>	Tape/Media #:	
Purpose:	<b>Not Known</b>	Dia/Height:	<b>10"</b>
Use:	<b>Sanitary</b>	Material:	<b>VCP</b>
Drain Area:	<b>NA</b>	Lining:	
Category:	<b>NA</b>		
Comment:	<b>cnl</b>

Location Details:		Direction of Survey:	<b>Upstream</b>
US MH:	<b>M-203-022</b>	DS MH:	<b>M-203-021</b>
		Total Length Surveyed (ft):	<b>198.7</b>

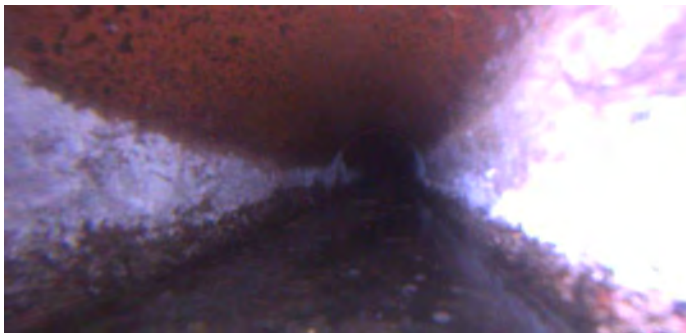
Code: **AMH**  
Description: **Manhole**

Distance (ft): **.0**  
Structural Grade: **0**  
O&M Grade: **0**  
Clock Start/From:  
Clock To:  
1st Value:  
2nd Value:  
Value Percent:  
Continuous Index:  
Within 8" of Joint: **NO**  
Remarks: **M-203-021**

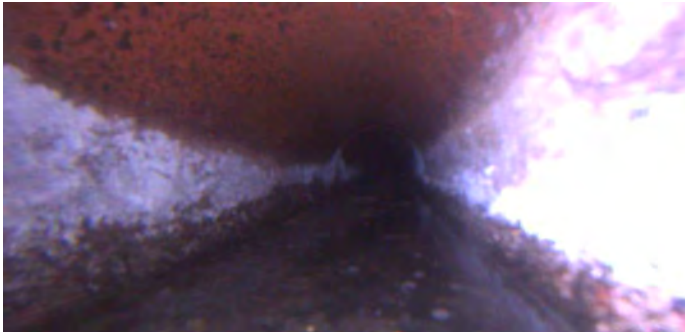
Code:	<b>MWL</b>
Description:	<b>Water Level</b>

Distance (ft):	<b>.0</b>
Structural Grade:	<b>0</b>
O&M Grade:	<b>0</b>
Clock Start/From:	
Clock To:	
1st Value:	
2nd Value:	
Value Percent:	<b>20.000</b>
Continuous Index:	
Within 8" of Joint:	<b>NO</b>
Remarks:

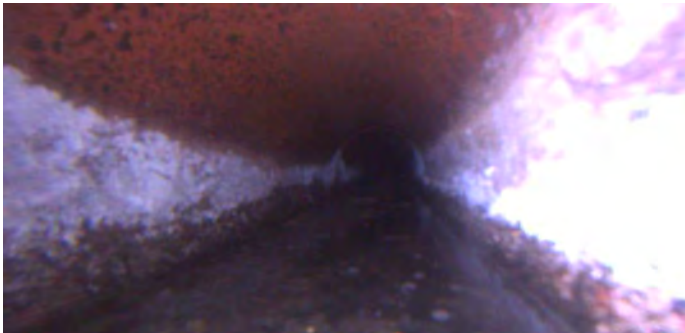
Code:	<b>DAGS</b>
Description:	<b>Deposits Attached Grease</b>

Distance (ft):	<b>.0</b>
Structural Grade:	<b>0</b>
O&M Grade:	<b>2</b>
Clock Start/From:	<b>8</b>
Clock To:	<b>4</b>
1st Value:	
2nd Value:	
Value Percent:	<b>5.000</b>
Continuous Index:	<b>S01</b>
Within 8" of Joint:	<b>NO</b>
Remarks:

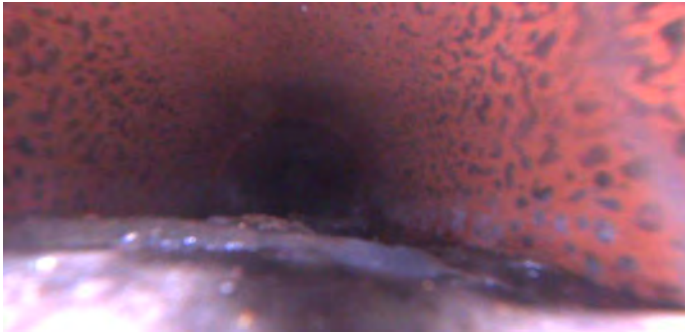
Code: **MWL**  
Description: **Water Level**

Distance (ft): **7.0**  
Structural Grade: **0**  
O&M Grade: **0**  
Clock Start/From:  
Clock To:  
1st Value:  
2nd Value:  
Value Percent: **30.000**  
Continuous Index:  
Within 8" of Joint: **NO**  
Remarks:

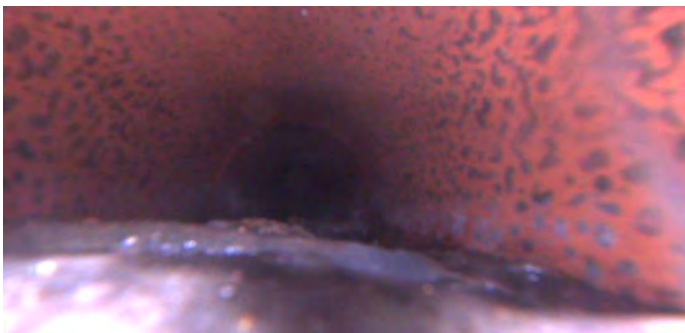
Code: **DAGS**  
Description: **Deposits Attached Grease**

Distance (ft): **7.0**  
Structural Grade: **0**  
O&M Grade: **2**  
Clock Start/From: **8**  
Clock To: **4**  
1st Value:  
2nd Value:  
Value Percent: **5.000**  
Continuous Index: **F01**  
Within 8" of Joint: **NO**  
Remarks:

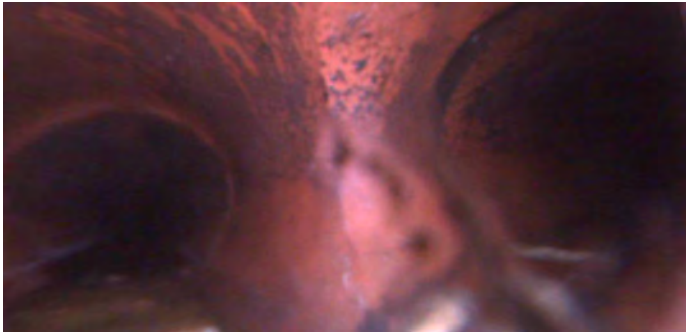
Code: **TFA**  
Description: **Tap Factory Active**

Distance (ft): **23.4**  
Structural Grade: **0**  
O&M Grade: **0**  
Clock Start/From: **3**  
Clock To:  
1st Value: **4.000**  
2nd Value:  
Value Percent:  
Continuous Index:  
Within 8" of Joint:  
Remarks:

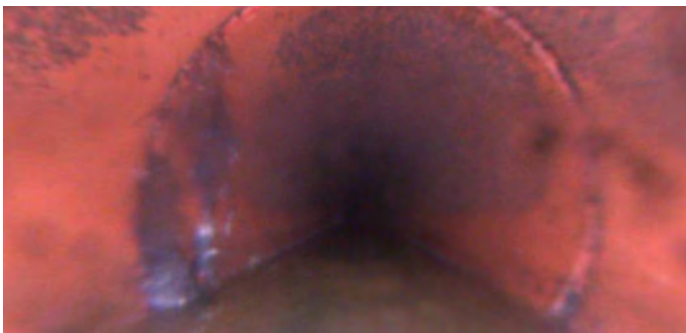
Code: **RMJ**  
Description: **Roots Medium Joint**

Distance (ft): **43.8**  
Structural Grade: **0**  
O&M Grade: **3**  
Clock Start/From: **8**  
Clock To: **11**  
1st Value:  
2nd Value:  
Value Percent: **5.000**  
Continuous Index:  
Within 8" of Joint: **YES**  
Remarks:

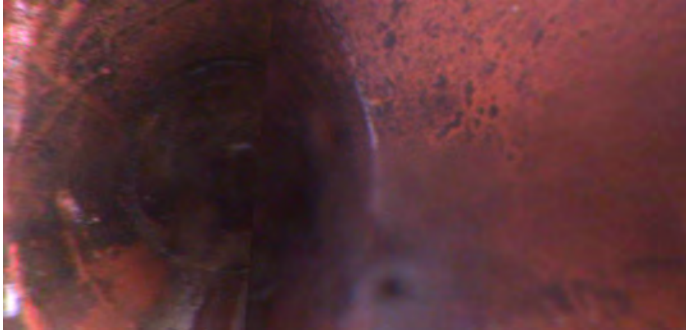
Code: **TF**  
Description: **Tap Factory**

Distance (ft): **49.8**  
Structural Grade: **0**  
O&M Grade: **0**  
Clock Start/From: **9**  
Clock To:  
1st Value: **4.000**  
2nd Value:  
Value Percent:  
Continuous Index:  
Within 8" of Joint:  
Remarks:

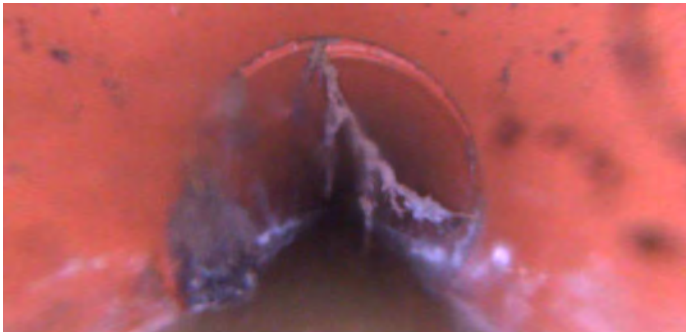
Code: **RMJ**  
Description: **Roots Medium Joint**

Distance (ft): **59.9**  
Structural Grade: **0**  
O&M Grade: **3**  
Clock Start/From: **8**  
Clock To: **4**  
1st Value:  
2nd Value:  
Value Percent: **10.000**  
Continuous Index:  
Within 8" of Joint: **YES**  
Remarks:

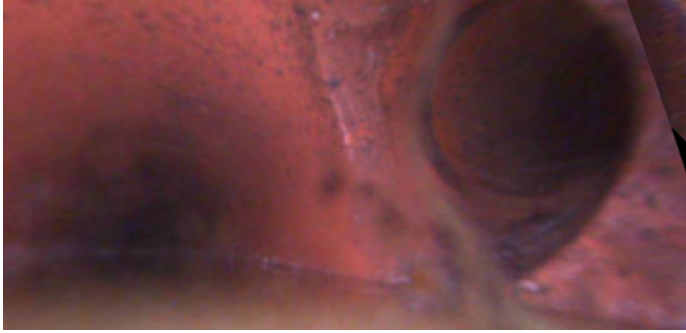
Code: **TF**  
Description: **Tap Factory**

Distance (ft): **85.3**  
Structural Grade: **0**  
O&M Grade: **0**  
Clock Start/From: **3**  
Clock To:  
1st Value: **4.000**  
2nd Value:  
Value Percent:  
Continuous Index:  
Within 8" of Joint:  
Remarks:

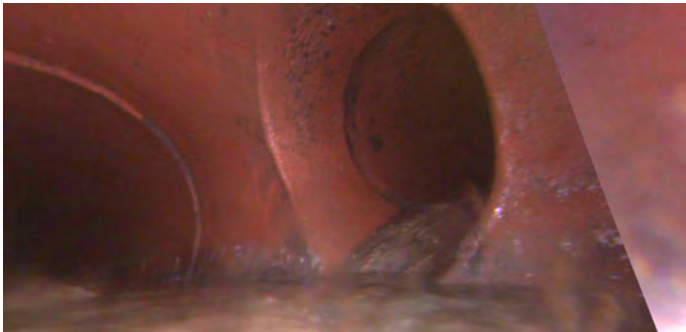
Code: **TF**  
Description: **Tap Factory**

Distance (ft): **138.1**  
Structural Grade: **0**  
O&M Grade: **0**  
Clock Start/From: **9**  
Clock To:  
1st Value: **4.000**  
2nd Value:  
Value Percent:  
Continuous Index:  
Within 8" of Joint:  
Remarks:

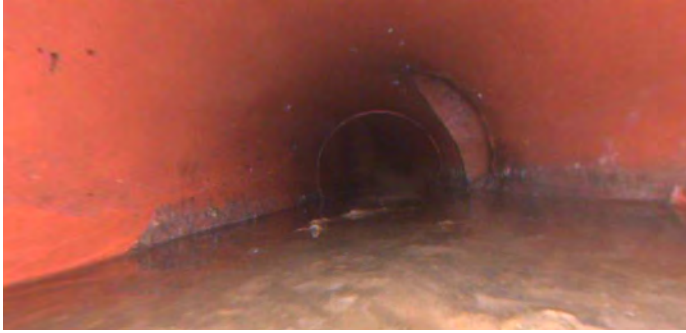
Code: **MGO**  
Description: **General Observation**

Distance (ft): **139.1**  
Structural Grade: **0**  
O&M Grade: **0**  
Clock Start/From:  
Clock To:  
1st Value:  
2nd Value:  
Value Percent:  
Continuous Index:  
Within 8" of Joint: **NO**  
Remarks: **REAR CAMERA**

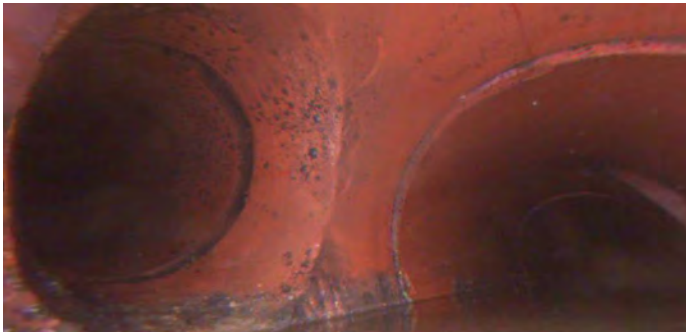
Code: **TF**  
Description: **Tap Factory**

Distance (ft): **139.8**  
Structural Grade: **0**  
O&M Grade: **0**  
Clock Start/From: **3**  
Clock To:  
1st Value: **4.000**  
2nd Value:  
Value Percent:  
Continuous Index:  
Within 8" of Joint:  
Remarks:

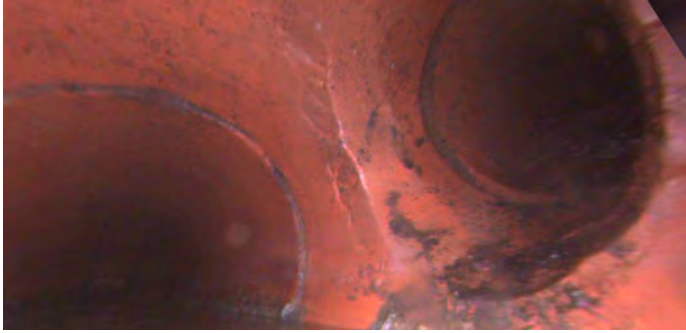
Code: **TF**  
Description: **Tap Factory**

Distance (ft): **170.5**  
Structural Grade: **0**  
O&M Grade: **0**  
Clock Start/From: **9**  
Clock To:  
1st Value: **4.000**  
2nd Value:  
Value Percent:  
Continuous Index:  
Within 8" of Joint:  
Remarks:
