Profile/Photo Observation Report

Date:	03/27/2018	Weather:		Coding:	PACP 6.0
Pipe Length (ft):	240.5	Owner:	NA	Pre Clean:	Not Known
P.O.#:		Surveyor:	Jen Costello	PSR:	P-203-021-022
Customer:		Clean Date:	01/01/1900	Shape:	C

Street:	ALLEY WAY	Flow Control:	Not Controlled
City:	Hobart, IN	Year Renewed:	
Location:	Other	Tape/Media #:	
Purpose:	Not Known	Dia/Height:	10"
Use:	Sanitary	Material:	VCP
Drain Area:	NA	Lining:	
Category:	NA		
Comment:	cnl

Location Details:		Direction of Survey:	Upstream
US MH:	M-203-022	DS MH:	M-203-021
		Total Length Surveyed (ft):	198.7

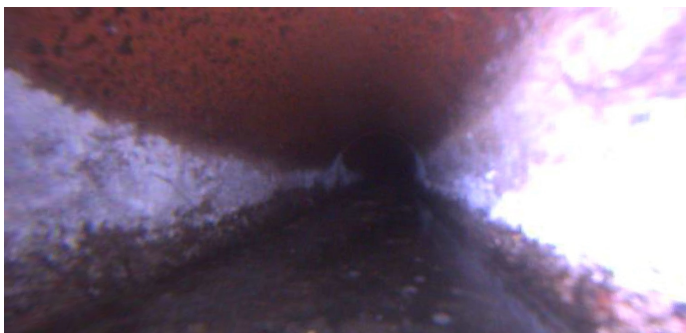
Code: **AMH**
Description: **Manhole**

Distance (ft): **.0**
Structural Grade: **0**
O&M Grade: **0**
Clock Start/From:
Clock To:
1st Value:
2nd Value:
Value Percent:
Continuous Index:
Within 8" of Joint: **NO**
Remarks: **M-203-021**

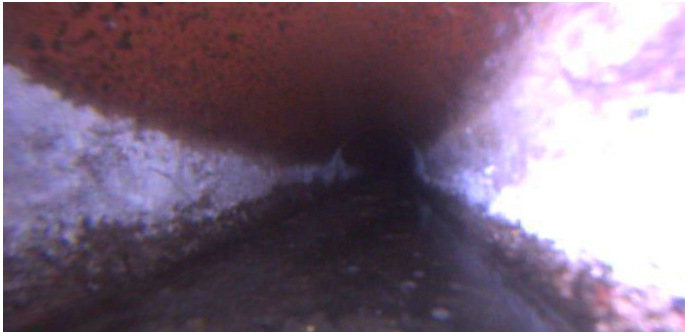
Code:	MWL
Description:	Water Level

Distance (ft):	.0
Structural Grade:	0
O&M Grade:	0
Clock Start/From:	
Clock To:	
1st Value:	
2nd Value:	
Value Percent:	20.000
Continuous Index:	
Within 8" of Joint:	NO
Remarks:

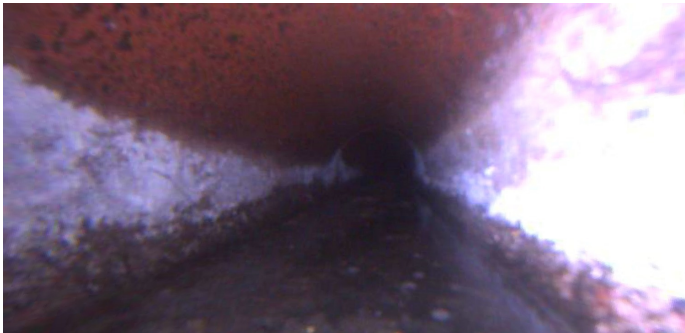
Code:	DAGS
Description:	Deposits Attached Grease

Distance (ft):	.0
Structural Grade:	0
O&M Grade:	2
Clock Start/From:	8
Clock To:	4
1st Value:	
2nd Value:	
Value Percent:	5.000
Continuous Index:	S01
Within 8" of Joint:	NO
Remarks:

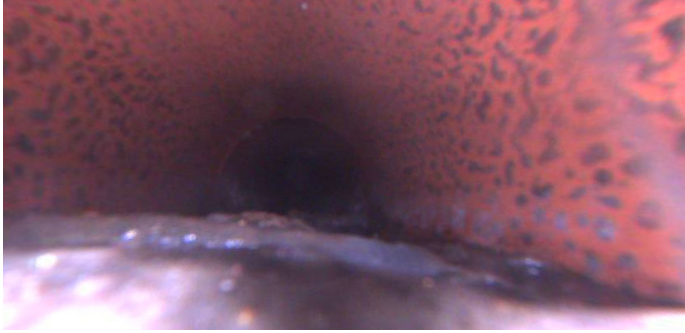
Code: **MWL**
Description: **Water Level**

Distance (ft): **7.0**
Structural Grade: **0**
O&M Grade: **0**
Clock Start/From:
Clock To:
1st Value:
2nd Value:
Value Percent: **30.000**
Continuous Index:
Within 8" of Joint: **NO**
Remarks:

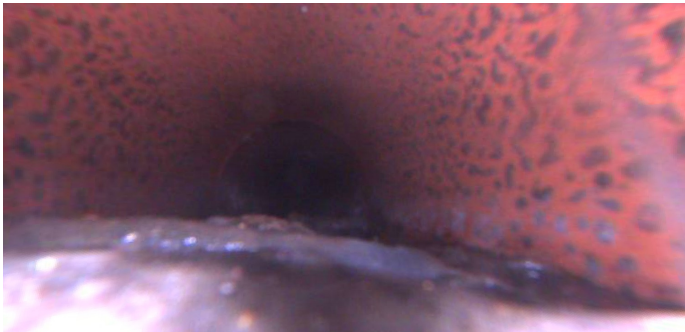
Code: **DAGS**
Description: **Deposits Attached Grease**

Distance (ft): **7.0**
Structural Grade: **0**
O&M Grade: **2**
Clock Start/From: **8**
Clock To: **4**
1st Value:
2nd Value:
Value Percent: **5.000**
Continuous Index: **F01**
Within 8" of Joint: **NO**
Remarks:

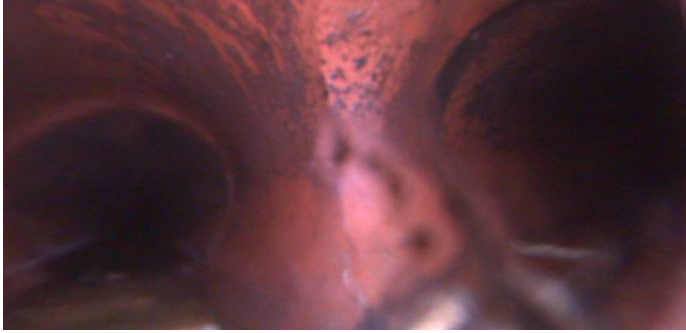
Code: **TFA**
Description: **Tap Factory Active**

Distance (ft): **23.4**
Structural Grade: **0**
O&M Grade: **0**
Clock Start/From: **3**
Clock To:
1st Value: **4.000**
2nd Value:
Value Percent:
Continuous Index:
Within 8" of Joint:
Remarks:

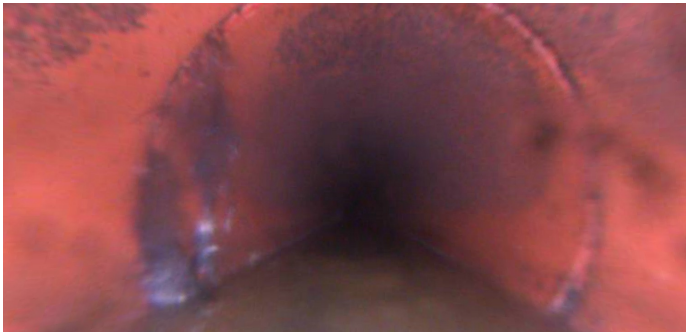
Code: **RMJ**
Description: **Roots Medium Joint**

Distance (ft): **43.8**
Structural Grade: **0**
O&M Grade: **3**
Clock Start/From: **8**
Clock To: **11**
1st Value:
2nd Value:
Value Percent: **5.000**
Continuous Index:
Within 8" of Joint: **YES**
Remarks:

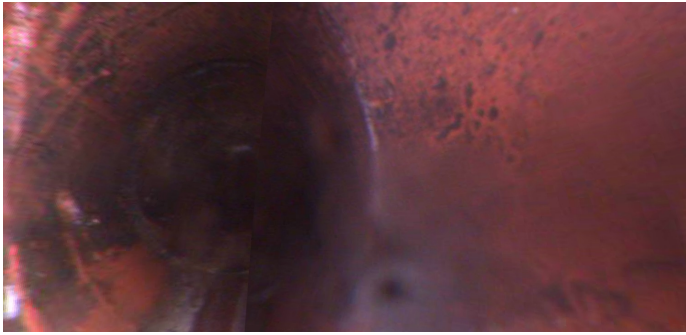
Code: **TF**
Description: **Tap Factory**

Distance (ft): **49.8**
Structural Grade: **0**
O&M Grade: **0**
Clock Start/From: **9**
Clock To:
1st Value: **4.000**
2nd Value:
Value Percent:
Continuous Index:
Within 8" of Joint:
Remarks:

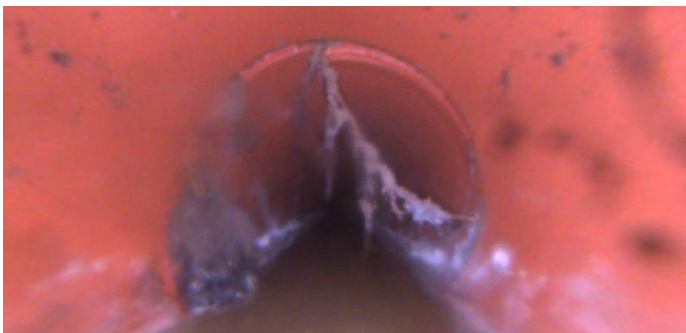
Code: **RMJ**
Description: **Roots Medium Joint**

Distance (ft): **59.9**
Structural Grade: **0**
O&M Grade: **3**
Clock Start/From: **8**
Clock To: **4**
1st Value:
2nd Value:
Value Percent: **10.000**
Continuous Index:
Within 8" of Joint: **YES**
Remarks:

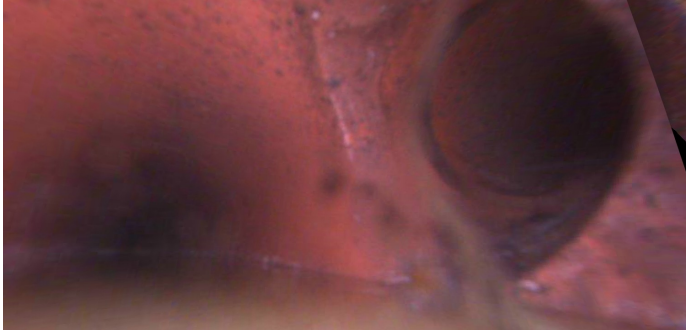
Code: **TF**
Description: **Tap Factory**

Distance (ft): **85.3**
Structural Grade: **0**
O&M Grade: **0**
Clock Start/From: **3**
Clock To:
1st Value: **4.000**
2nd Value:
Value Percent:
Continuous Index:
Within 8" of Joint:
Remarks:

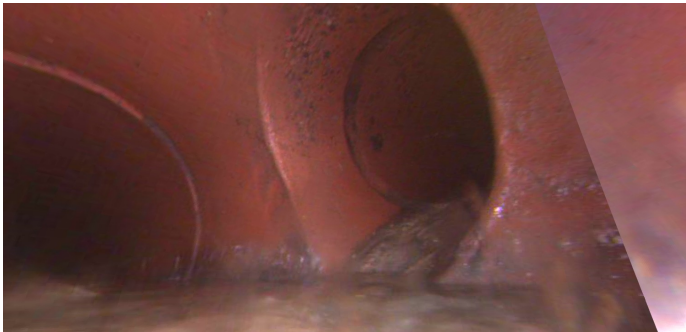
Code: **TF**
Description: **Tap Factory**

Distance (ft): **138.1**
Structural Grade: **0**
O&M Grade: **0**
Clock Start/From: **9**
Clock To:
1st Value: **4.000**
2nd Value:
Value Percent:
Continuous Index:
Within 8" of Joint:
Remarks:

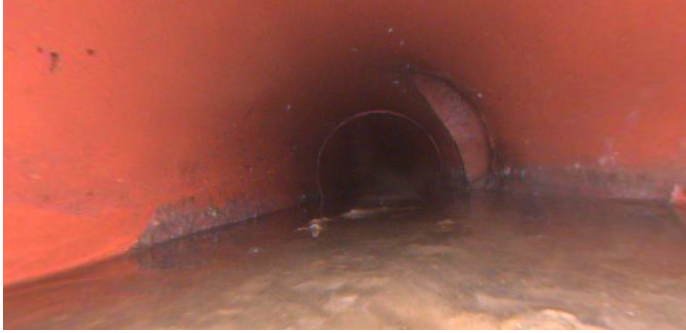
Code: **MGO**
Description: **General Observation**

Distance (ft): **139.1**
Structural Grade: **0**
O&M Grade: **0**
Clock Start/From:
Clock To:
1st Value:
2nd Value:
Value Percent:
Continuous Index:
Within 8" of Joint: **NO**
Remarks: **REAR CAMERA**

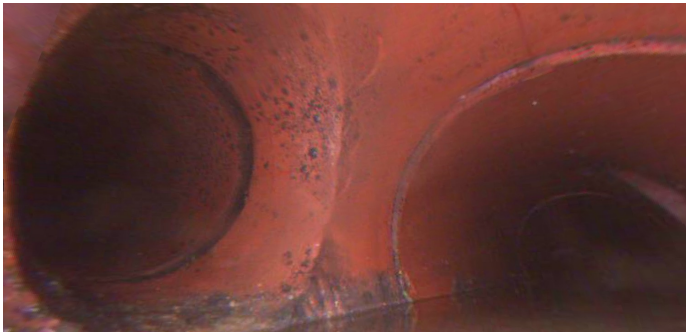
Code: **TF**
Description: **Tap Factory**

Distance (ft): **139.8**
Structural Grade: **0**
O&M Grade: **0**
Clock Start/From: **3**
Clock To:
1st Value: **4.000**
2nd Value:
Value Percent:
Continuous Index:
Within 8" of Joint:
Remarks:

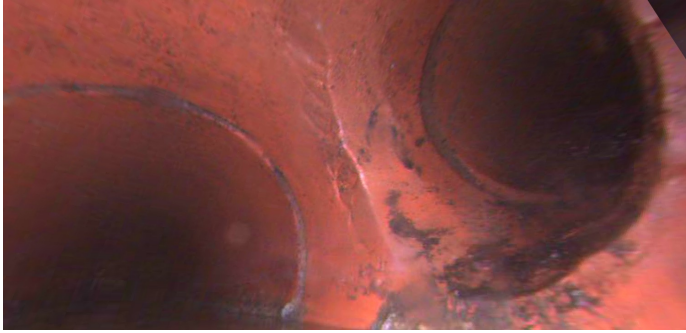
Code: **TF**
Description: **Tap Factory**

Distance (ft): **170.5**
Structural Grade: **0**
O&M Grade: **0**
Clock Start/From: **9**
Clock To:
1st Value: **4.000**
2nd Value:
Value Percent:
Continuous Index:
Within 8" of Joint:
Remarks:
