Profile/Photo Observation Report

Date:	03/26/2018	Weather:		Coding:	PACP 6.0
Pipe Length (ft):	248.3	Owner:	NA	Pre Clean:	Not Known
P.O.#:		Surveyor:	Byrd Fitzgerald	PSR:	P-203-022-023
Customer:		Clean Date:	01/01/1900	Shape:	C

Street:	W 38TH AVE	Flow Control:	Not Controlled
City:	Hobart, IN	Year Renewed:	
Location:	Other	Tape/Media #:	
Purpose:	Not Known	Dia/Height:	10"
Use:	Sanitary	Material:	VCP
Drain Area:	NA	Lining:	
Category:	NA		
Comment:

Location Details:		Direction of Survey:	Downstream
US MH:	M-203-023	DS MH:	M-203-022
		Total Length Surveyed (ft):	72.8

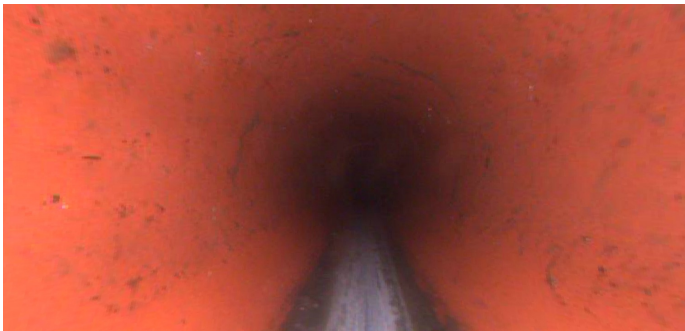
Code: **AMH**
Description: **Manhole**

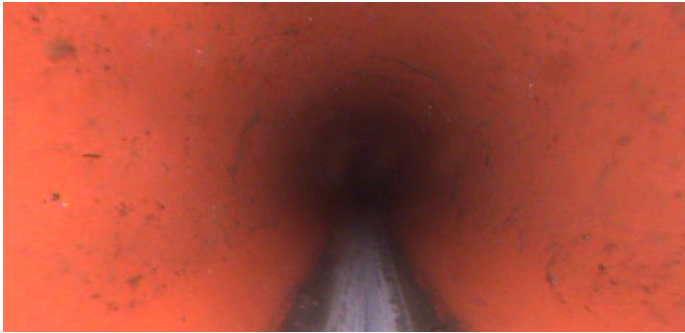
Code:	MWL
Description:	Water Level

Distance (ft):	.0
Structural Grade:	0
O&M Grade:	0
Clock Start/From:	
Clock To:	
1st Value:	
2nd Value:	
Value Percent:	5.000
Continuous Index:	
Within 8" of Joint:	NO
Remarks:

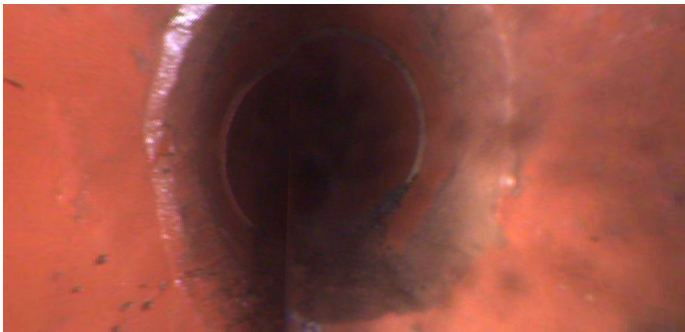
Code:	TF
Description:	Tap Factory

Distance (ft):	41.6
Structural Grade:	0
O&M Grade:	0
Clock Start/From:	3
Clock To:	
1st Value:	4.000
2nd Value:	
Value Percent:	
Continuous Index:	
Within 8" of Joint:	YES
Remarks:

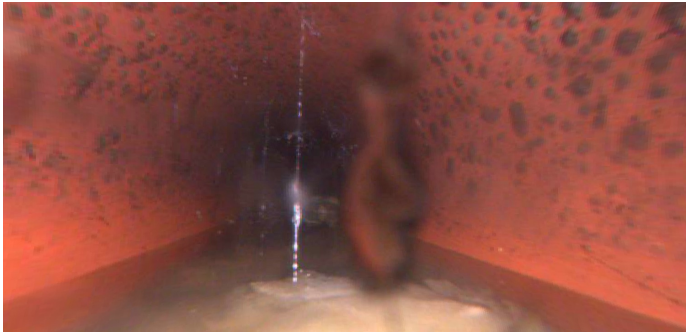
Code: **DSZ**
Description: **Deposits Settled Other**

Distance (ft): **69.0**
Structural Grade: **0**
O&M Grade: **2**
Clock Start/From: **6**
Clock To:
1st Value:
2nd Value:
Value Percent: **5.000**
Continuous Index: **S01**
Within 8" of Joint: **NO**
Remarks: **tissue**

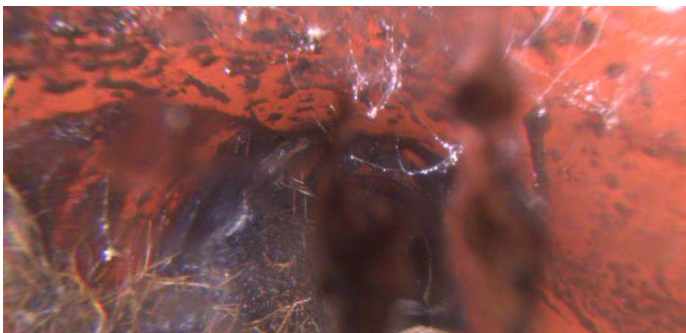
Code: **FM**
Description: **Fracture Multiple**

Distance (ft): **71.0**
Structural Grade: **4**
O&M Grade: **0**
Clock Start/From: **8**
Clock To: **4**
1st Value:
2nd Value:
Value Percent:
Continuous Index:
Within 8" of Joint:
Remarks:

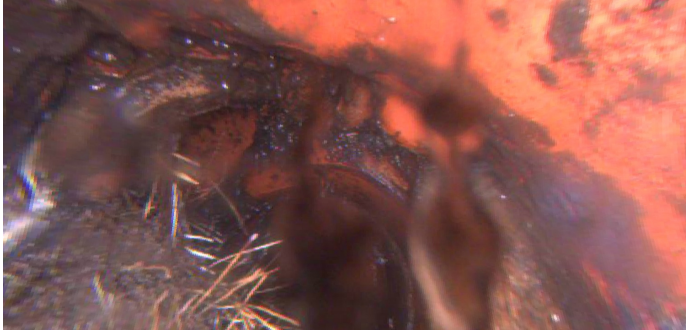
Code: **TB**
Description: **Tap Break-in**

Distance (ft): **71.5**
Structural Grade: **0**
O&M Grade: **0**
Clock Start/From: **11**
Clock To:
1st Value: **4.000**
2nd Value:
Value Percent:
Continuous Index:
Within 8" of Joint: **YES**
Remarks:

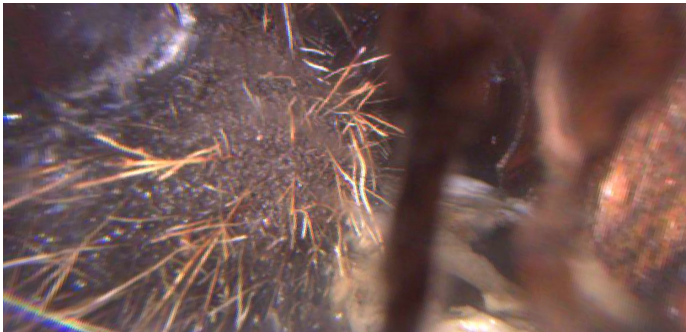
Code: **RBB**
Description: **Roots Ball Barrel**

Distance (ft): **71.5**
Structural Grade: **0**
O&M Grade: **5**
Clock Start/From: **6**
Clock To: **9**
1st Value:
2nd Value:
Value Percent: **55.000**
Continuous Index:
Within 8" of Joint: **NO**
Remarks: **from tap**

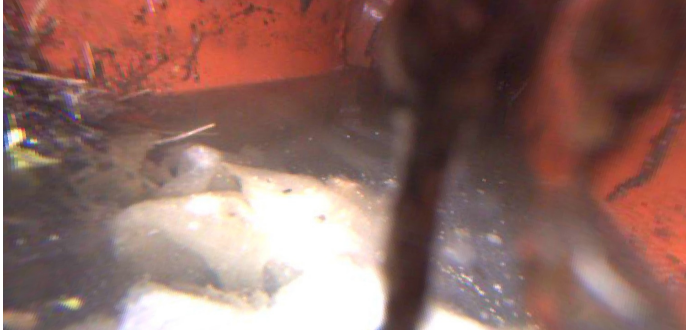
Code: **MSA**
Description: **Abandoned Survey**

Distance (ft): **72.8**
Structural Grade: **0**
O&M Grade: **0**
Clock Start/From:
Clock To:
1st Value:
2nd Value:
Value Percent:
Continuous Index:
Within 8" of Joint: **NO**
Remarks: **rbb**

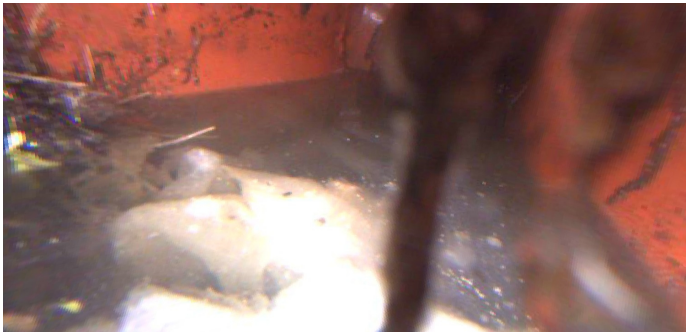
Code: **DSZ**
Description: **Deposits Settled Other**

Distance (ft): **72.8**
Structural Grade: **0**
O&M Grade: **2**
Clock Start/From: **6**
Clock To:
1st Value:
2nd Value:
Value Percent: **5.000**
Continuous Index: **F01**
Within 8" of Joint: **NO**
Remarks: **tissue**
