Profile/Photo Observation Report

Date:	03/26/2018	Weather:		Coding:	PACP 6.0
Pipe Length (ft):	248.3	Owner:	NA	Pre Clean:	Not Known
P.O.#:		Surveyor:	Byrd Fitzgerald	PSR:	P-203-022-023
Customer:		Clean Date:	01/01/1900	Shape:	C

Street:	E 38th Ave	Flow Control:	Not Controlled
City:	Hobart, IN	Year Renewed:	
Location:	Other	Tape/Media #:	
Purpose:	Not Known	Dia/Height:	10"
Use:	Sanitary	Material:	VCP
Drain Area:	NA	Lining:	
Category:	NA		
Comment:

Location Details:		Direction of Survey:	Downstream
US MH:	M-203-023	DS MH:	M-203-022
		Total Length Surveyed (ft):	72.8

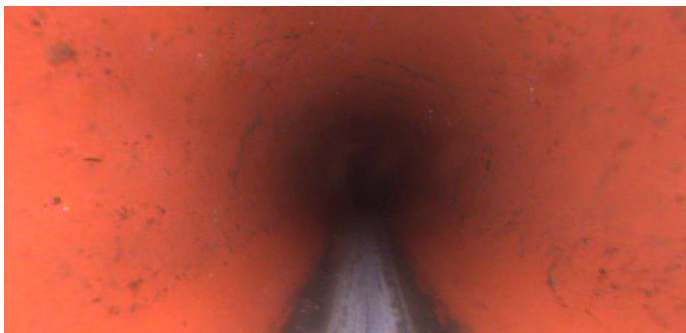
Code: **AMH**
Description: **Manhole**

Distance (ft): **.0**
Structural Grade: **0**
O&M Grade: **0**
Clock Start/From:
Clock To:
1st Value:
2nd Value:
Value Percent:
Continuous Index:
Within 8" of Joint: **NO**
Remarks: **M-203-023**

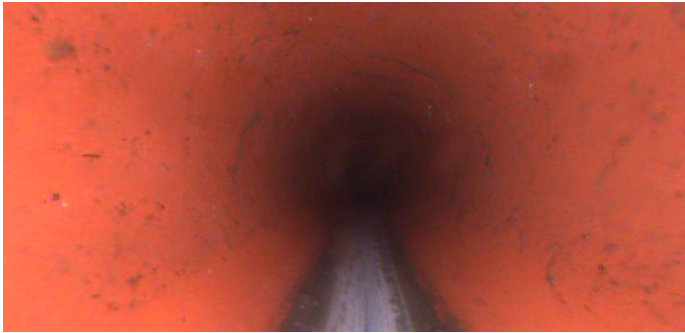
Code:	MWL
Description:	Water Level

Distance (ft):	.0
Structural Grade:	0
O&M Grade:	0
Clock Start/From:	
Clock To:	
1st Value:	
2nd Value:	
Value Percent:	5.000
Continuous Index:	
Within 8" of Joint:	NO
Remarks:

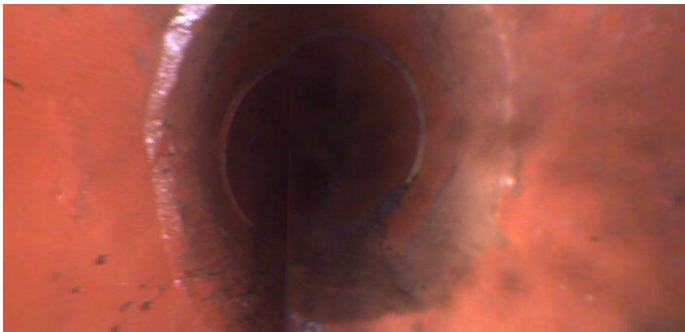
Code:	TF
Description:	Tap Factory

Distance (ft):	41.6
Structural Grade:	0
O&M Grade:	0
Clock Start/From:	3
Clock To:	
1st Value:	4.000
2nd Value:	
Value Percent:	
Continuous Index:	
Within 8" of Joint:	YES
Remarks:

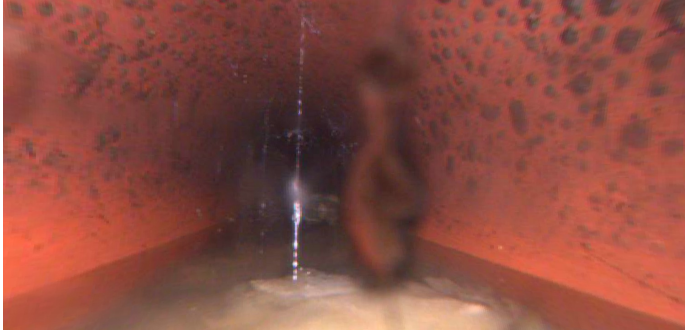
Code: **DSZ**
Description: **Deposits Settled Other**

Distance (ft): **69.0**
Structural Grade: **0**
O&M Grade: **2**
Clock Start/From: **6**
Clock To:
1st Value:
2nd Value:
Value Percent: **5.000**
Continuous Index: **S01**
Within 8" of Joint: **NO**
Remarks: **tissue**

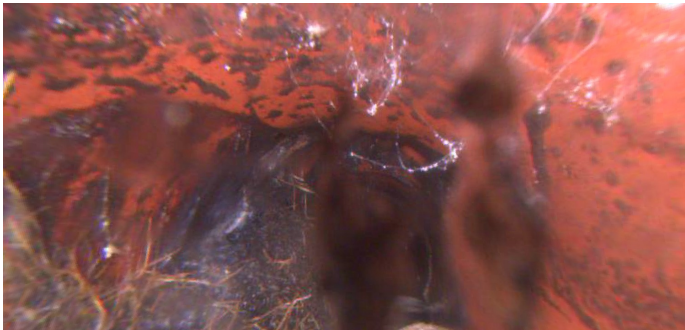
Code: **FM**
Description: **Fracture Multiple**

Distance (ft): **71.0**
Structural Grade: **4**
O&M Grade: **0**
Clock Start/From: **8**
Clock To: **4**
1st Value:
2nd Value:
Value Percent:
Continuous Index:
Within 8" of Joint:
Remarks:

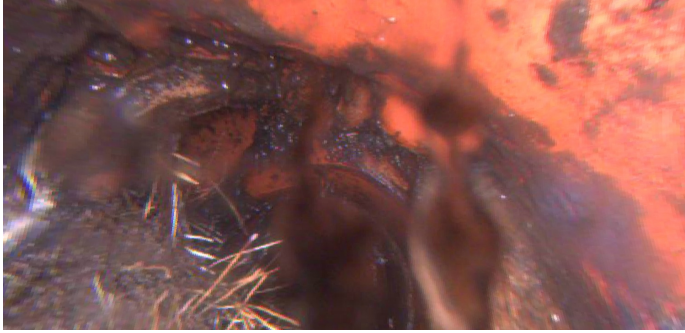
Code: **TB**
Description: **Tap Break-in**

Distance (ft): **71.5**
Structural Grade: **0**
O&M Grade: **0**
Clock Start/From: **11**
Clock To:
1st Value: **4.000**
2nd Value:
Value Percent:
Continuous Index:
Within 8" of Joint: **YES**
Remarks:

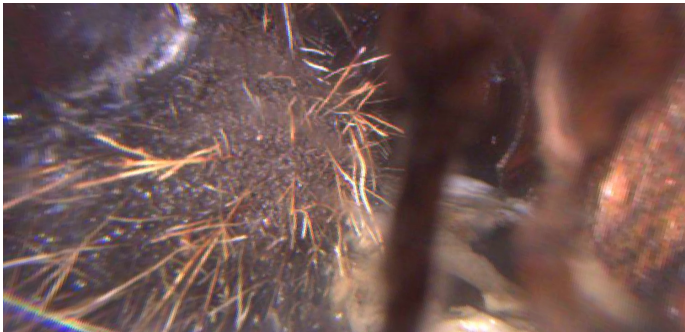
Code: **RBB**
Description: **Roots Ball Barrel**

Distance (ft): **71.5**
Structural Grade: **0**
O&M Grade: **5**
Clock Start/From: **6**
Clock To: **9**
1st Value:
2nd Value:
Value Percent: **55.000**
Continuous Index:
Within 8" of Joint: **NO**
Remarks: **from tap**

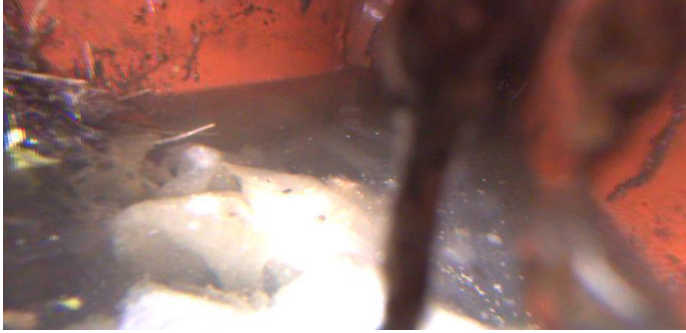
Code: **MSA**
Description: **Abandoned Survey**

Distance (ft): **72.8**
Structural Grade: **0**
O&M Grade: **0**
Clock Start/From:
Clock To:
1st Value:
2nd Value:
Value Percent:
Continuous Index:
Within 8" of Joint: **NO**
Remarks: **rbb**

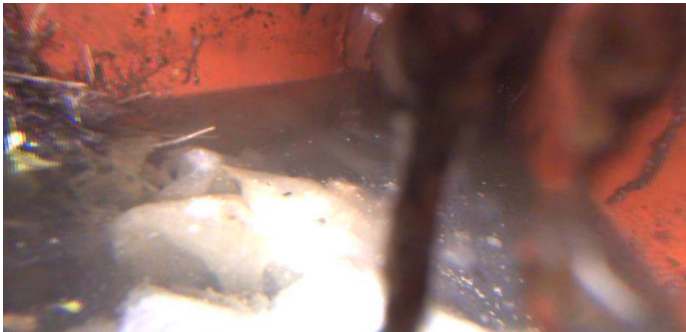
Code: **DSZ**
Description: **Deposits Settled Other**

Distance (ft): **72.8**
Structural Grade: **0**
O&M Grade: **2**
Clock Start/From: **6**
Clock To:
1st Value:
2nd Value:
Value Percent: **5.000**
Continuous Index: **F01**
Within 8" of Joint: **NO**
Remarks: **tissue**
