## Profile/Photo Observation Report

Street:	<b>W 38TH AVE</b>	Flow Control:	<b>Not Controlled</b>
City:	<b>Hobart, IN</b>	Year Renewed:	
Location:	<b>Light Highway</b>	Tape/Media #:	
Purpose:	<b>Routine Assessment</b>	Dia/Height:	<b>10"</b>
Use:	<b>Sanitary</b>	Material:	<b>VCP</b>
Drain Area:	<b>NA</b>	Lining:	
Category:	<b>NA</b>		
Comment:

Location Details:		Direction of Survey:	<b>Downstream</b>
US MH:	<b>M-203-023</b>	DS MH:	<b>M-203-022</b>
		Total Length Surveyed (ft):	<b>72.3</b>

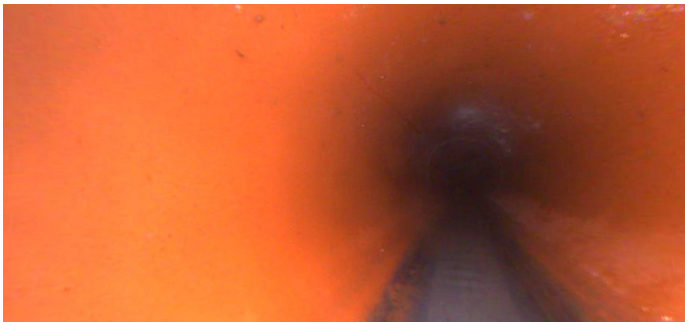
Code: **AMH**  
Description: **Manhole**

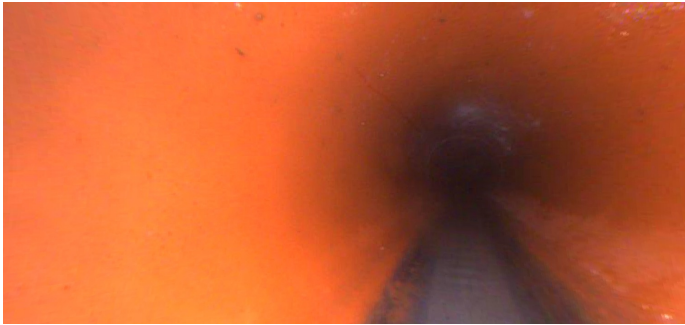
Code:	<b>MWL</b>
Description:	<b>Water Level</b>

Distance (ft):	<b>.0</b>
Structural Grade:	<b>0</b>
O&M Grade:	<b>0</b>
Clock Start/From:	
Clock To:	
1st Value:	
2nd Value:	
Value Percent:	<b>5.000</b>
Continuous Index:	
Within 8" of Joint:	<b>NO</b>
Remarks:

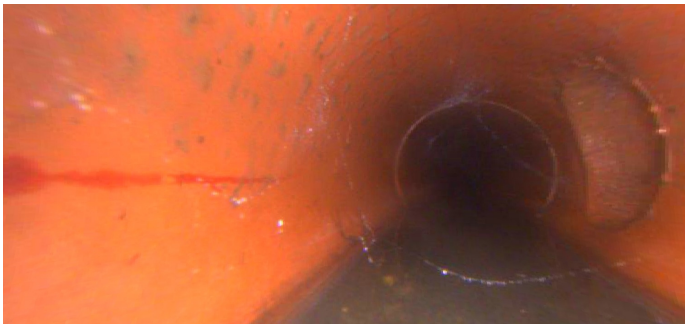
Code:	<b>TF</b>
Description:	<b>Tap Factory</b>

Distance (ft):	<b>40.3</b>
Structural Grade:	<b>0</b>
O&M Grade:	<b>0</b>
Clock Start/From:	<b>3</b>
Clock To:	
1st Value:	<b>4.000</b>
2nd Value:	
Value Percent:	
Continuous Index:	
Within 8" of Joint:	
Remarks:

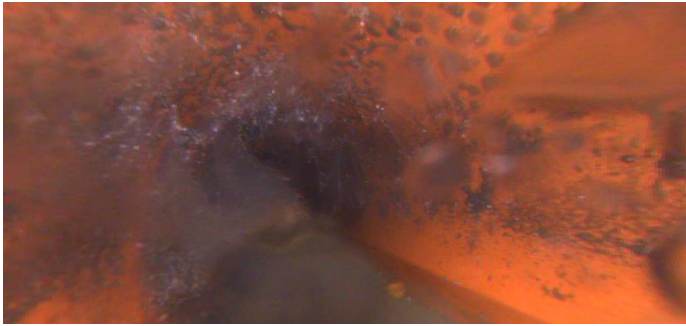
Code: **RBB**  
Description: **Roots Ball Barrel**

Distance (ft): **69.9**  
Structural Grade: **0**  
O&M Grade: **5**  
Clock Start/From: **6**  
Clock To: **5**  
1st Value:  
2nd Value:  
Value Percent: **55.000**  
Continuous Index:  
Within 8" of Joint: **NO**  
Remarks:

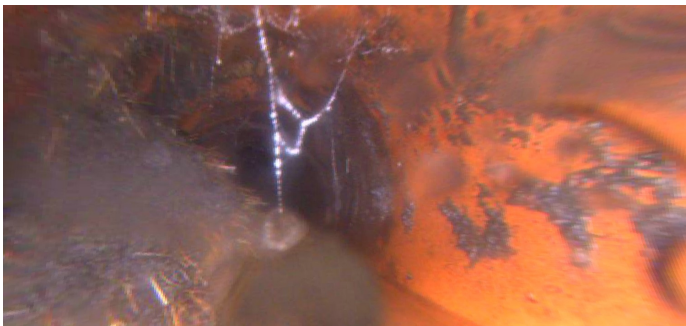
Code: **FM**  
Description: **Fracture Multiple**

Distance (ft): **70.6**  
Structural Grade: **4**  
O&M Grade: **0**  
Clock Start/From: **7**  
Clock To: **5**  
1st Value:  
2nd Value:  
Value Percent:  
Continuous Index:  
Within 8" of Joint: **YES**  
Remarks:

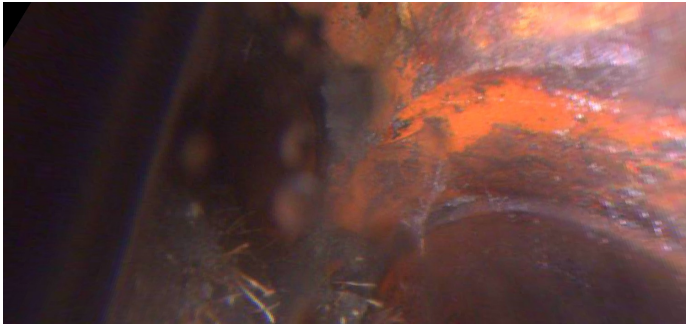
Code: **TFD**  
Description: **Tap Factory Defective**

Distance (ft): **72.0**  
Structural Grade: **0**  
O&M Grade: **2**  
Clock Start/From: **9**  
Clock To:  
1st Value: **4.000**  
2nd Value:  
Value Percent:  
Continuous Index:  
Within 8" of Joint:  
Remarks: **root infiltration**

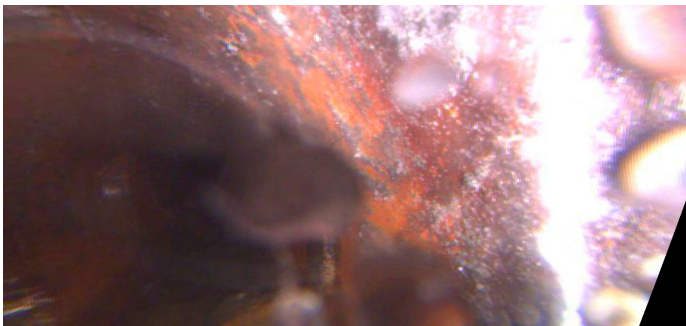
Code: **MSA**  
Description: **Abandoned Survey**

Distance (ft): **72.3**  
Structural Grade: **0**  
O&M Grade: **0**  
Clock Start/From:  
Clock To:  
1st Value:  
2nd Value:  
Value Percent:  
Continuous Index:  
Within 8" of Joint: **NO**  
Remarks: **root infiltration**
