## Profile/Photo Observation Report

Street:	<b>38th. Ave.</b>	Flow Control:	<b>Not Controlled</b>
City:	<b>Hobart, IN</b>	Year Renewed:	
Location:	<b>Light Highway</b>	Tape/Media #:	
Purpose:	<b>Routine Assessment</b>	Dia/Height:	<b>10"</b>
Use:	<b>Sanitary</b>	Material:	<b>VCP</b>
Drain Area:	<b>NA</b>	Lining:	
Category:	<b>NA</b>		
Comment:

Location Details:		Direction of Survey:	<b>Downstream</b>
US MH:	<b>M-203-023</b>	DS MH:	<b>M-203-022</b>
		Total Length Surveyed (ft):	<b>72.3</b>

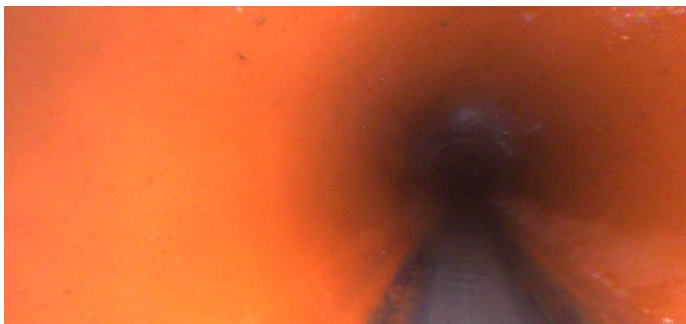
Code: **AMH**  
Description: **Manhole**

Distance (ft): **.0**  
Structural Grade: **0**  
O&M Grade: **0**  
Clock Start/From:  
Clock To:  
1st Value:  
2nd Value:  
Value Percent:  
Continuous Index:  
Within 8" of Joint: **NO**  
Remarks: **M-203-023**

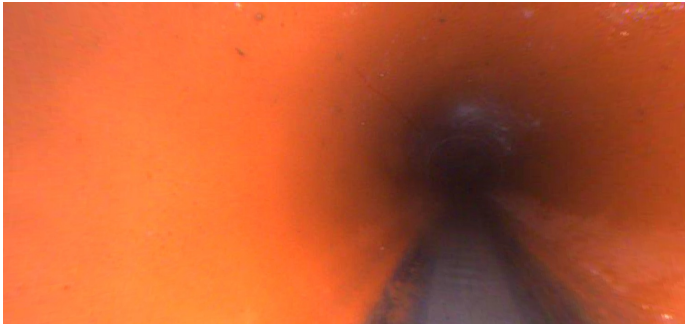
Code:	<b>MWL</b>
Description:	<b>Water Level</b>

Distance (ft):	<b>.0</b>
Structural Grade:	<b>0</b>
O&M Grade:	<b>0</b>
Clock Start/From:	
Clock To:	
1st Value:	
2nd Value:	
Value Percent:	<b>5.000</b>
Continuous Index:	
Within 8" of Joint:	<b>NO</b>
Remarks:

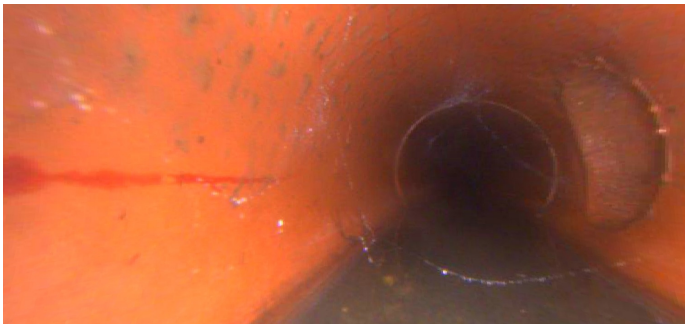
Code:	<b>TF</b>
Description:	<b>Tap Factory</b>

Distance (ft):	<b>40.3</b>
Structural Grade:	<b>0</b>
O&M Grade:	<b>0</b>
Clock Start/From:	<b>3</b>
Clock To:	
1st Value:	<b>4.000</b>
2nd Value:	
Value Percent:	
Continuous Index:	
Within 8" of Joint:	
Remarks:

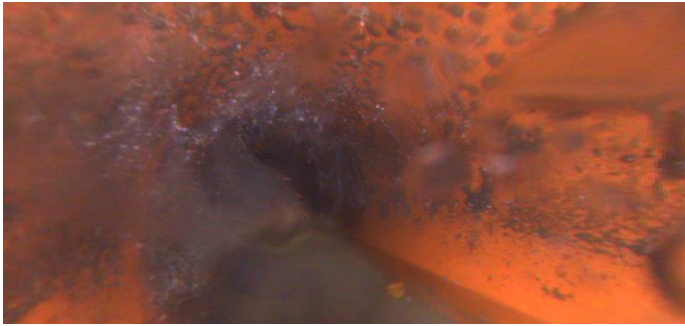
Code: **RBB**  
Description: **Roots Ball Barrel**

Distance (ft): **69.9**  
Structural Grade: **0**  
O&M Grade: **5**  
Clock Start/From: **6**  
Clock To: **5**  
1st Value:  
2nd Value:  
Value Percent: **55.000**  
Continuous Index:  
Within 8" of Joint: **NO**  
Remarks:

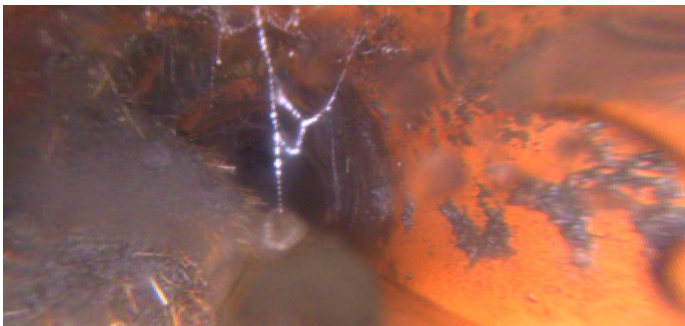
Code: **FM**  
Description: **Fracture Multiple**

Distance (ft): **70.6**  
Structural Grade: **4**  
O&M Grade: **0**  
Clock Start/From: **7**  
Clock To: **5**  
1st Value:  
2nd Value:  
Value Percent:  
Continuous Index:  
Within 8" of Joint: **YES**  
Remarks:

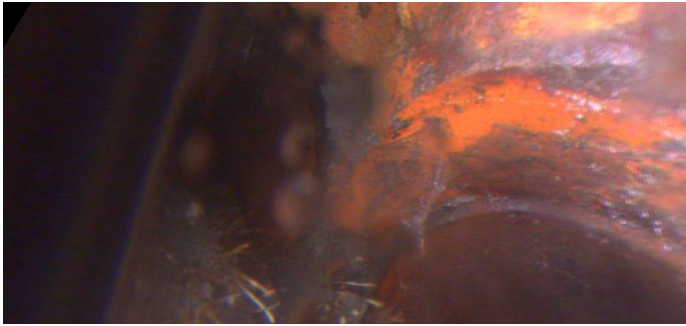
Code: **TFD**  
Description: **Tap Factory Defective**

Distance (ft): **72.0**  
Structural Grade: **0**  
O&M Grade: **2**  
Clock Start/From: **9**  
Clock To:  
1st Value: **4.000**  
2nd Value:  
Value Percent:  
Continuous Index:  
Within 8" of Joint:  
Remarks: **root infiltration**

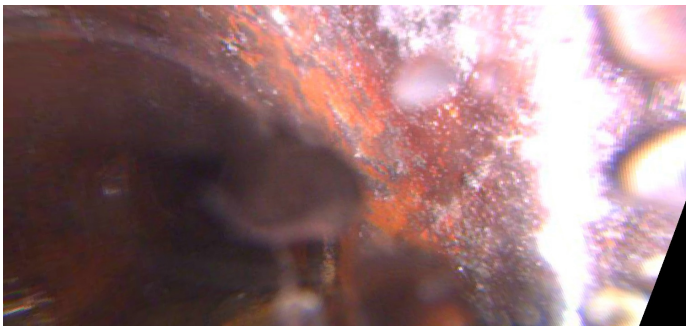
Code: **MSA**  
Description: **Abandoned Survey**

Distance (ft): **72.3**  
Structural Grade: **0**  
O&M Grade: **0**  
Clock Start/From:  
Clock To:  
1st Value:  
2nd Value:  
Value Percent:  
Continuous Index:  
Within 8" of Joint: **NO**  
Remarks: **root infiltration**
