Profile/Photo Observation Report

Date:	03/26/2018	Weather:		Coding:	PACP 6.0
Pipe Length (ft):	157.1	Owner:	NA	Pre Clean:	Not Known
P.O.#:		Surveyor:	Byrd Fitzgerald	PSR:	P-203-024-023
Customer:		Clean Date:	01/01/1900	Shape:	C

Street:	W 38TH AVE	Flow Control:	Not Controlled
City:	Hobart, IN	Year Renewed:	
Location:	Other	Tape/Media #:	
Purpose:	Not Known	Dia/Height:	10"
Use:	Sanitary	Material:	VCP
Drain Area:	NA	Lining:	
Category:	NA		
Comment:

Location Details:		Direction of Survey:	Downstream
US MH:	M-203-023	DS MH:	M-203-024
		Total Length Surveyed (ft):	71.7

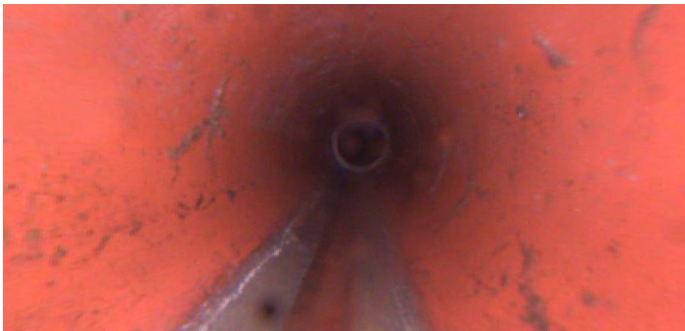
Code: **AMH**
Description: **Manhole**

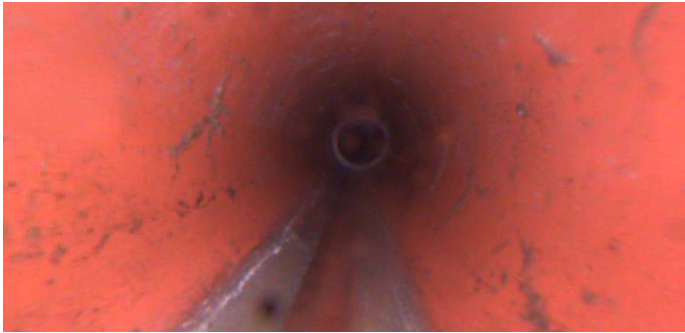
Code:	MWL
Description:	Water Level

Distance (ft):	.0
Structural Grade:	0
O&M Grade:	0
Clock Start/From:	
Clock To:	
1st Value:	
2nd Value:	
Value Percent:	5.000
Continuous Index:	
Within 8" of Joint:	NO
Remarks:

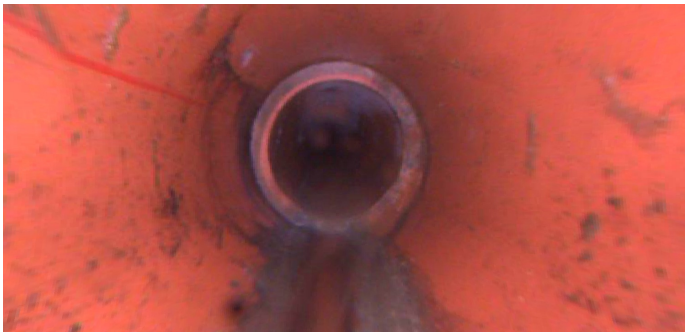
Code:	FL
Description:	Fracture Longitudinal

Distance (ft):	3.4
Structural Grade:	3
O&M Grade:	0
Clock Start/From:	11
Clock To:	
1st Value:	
2nd Value:	
Value Percent:	
Continuous Index:	
Within 8" of Joint:	YES
Remarks:

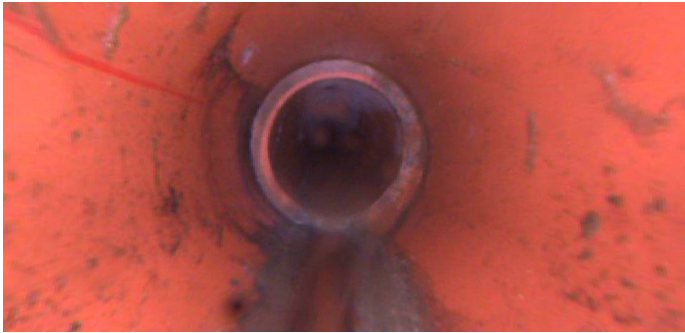
Code: **MSC**
Description: **Shape or Size Change**

Distance (ft): **3.4**
Structural Grade: **0**
O&M Grade: **0**
Clock Start/From:
Clock To:
1st Value: **6.000**
2nd Value:
Value Percent:
Continuous Index:
Within 8" of Joint: **NO**
Remarks:

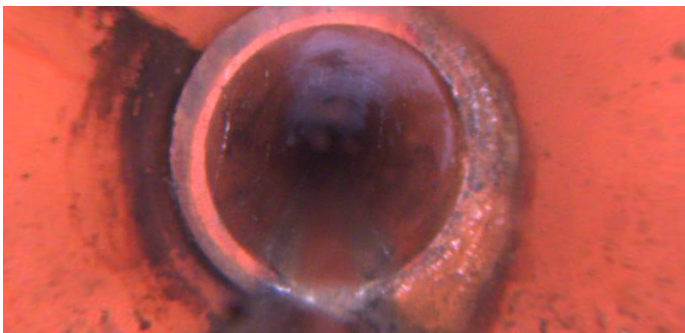
Code: **IW**
Description: **Infil Weeper**

Distance (ft): **4.0**
Structural Grade: **0**
O&M Grade: **2**
Clock Start/From: **8**
Clock To: **4**
1st Value:
2nd Value:
Value Percent:
Continuous Index:
Within 8" of Joint: **YES**
Remarks:

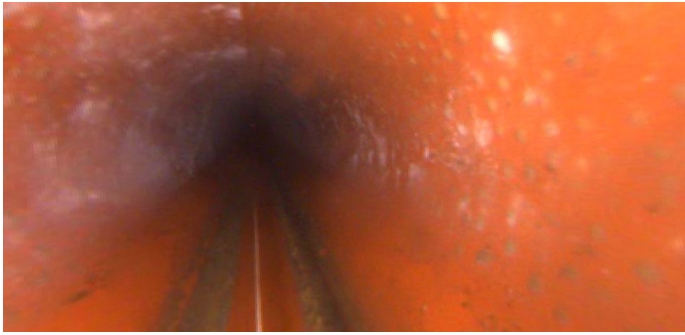
Code: **MGO**
Description: **General Observation**

Distance (ft): **42.4**
Structural Grade: **0**
O&M Grade: **0**
Clock Start/From:
Clock To:
1st Value:
2nd Value:
Value Percent:
Continuous Index:
Within 8" of Joint: **NO**
Remarks: **rear camera/cob webs**

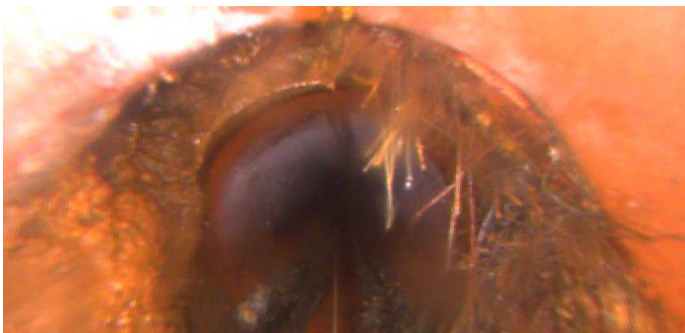
Code: **RMJ**
Description: **Roots Medium Joint**

Distance (ft): **49.5**
Structural Grade: **0**
O&M Grade: **3**
Clock Start/From: **7**
Clock To: **12**
1st Value:
2nd Value:
Value Percent: **10.000**
Continuous Index:
Within 8" of Joint: **YES**
Remarks:

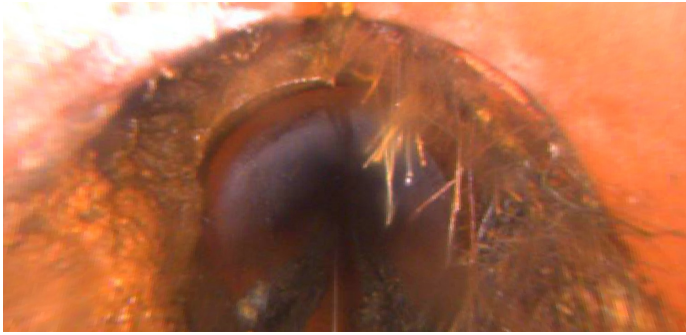
Code: **DAE**
Description: **Deposits Attached Encrustation**

Distance (ft): **49.5**
Structural Grade: **0**
O&M Grade: **2**
Clock Start/From: **2**
Clock To: **5**
1st Value:
2nd Value:
Value Percent: **5.000**
Continuous Index:
Within 8" of Joint: **YES**
Remarks:

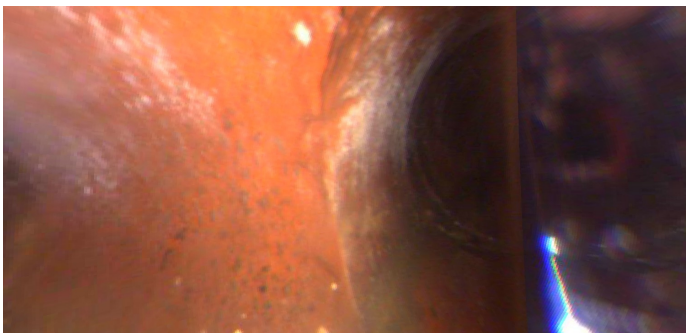
Code: **TF**
Description: **Tap Factory**

Distance (ft): **50.4**
Structural Grade: **0**
O&M Grade: **0**
Clock Start/From: **9**
Clock To:
1st Value: **4.000**
2nd Value:
Value Percent:
Continuous Index:
Within 8" of Joint: **YES**
Remarks:

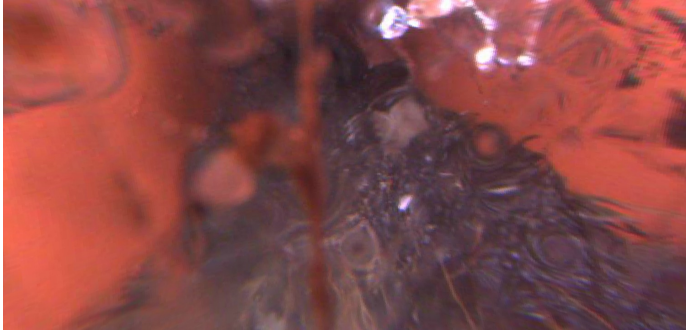
Code: **RML**
Description: **Roots Medium Lateral**

Distance (ft): **71.1**
Structural Grade: **0**
O&M Grade: **3**
Clock Start/From: **3**
Clock To: **7**
1st Value:
2nd Value:
Value Percent: **25.000**
Continuous Index:
Within 8" of Joint: **NO**
Remarks:

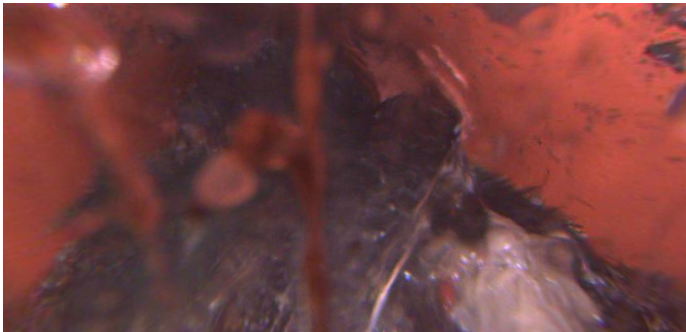
Code: **TFD**
Description: **Tap Factory Defective**

Distance (ft): **71.7**
Structural Grade: **0**
O&M Grade: **2**
Clock Start/From: **3**
Clock To:
1st Value: **4.000**
2nd Value:
Value Percent:
Continuous Index:
Within 8" of Joint:
Remarks: **roots**

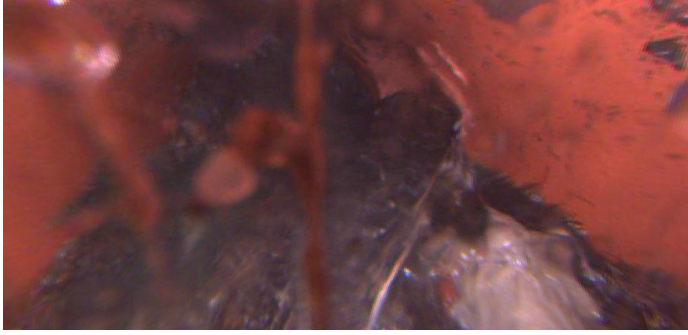
Code:	MSA
Description:	Abandoned Survey
Distance (ft):	71.7
Structural Grade:	0
O&M Grade:	0
Clock Start/From:	
Clock To:	
1st Value:	
2nd Value:	
Value Percent:	
Continuous Index:	
Within 8" of Joint:	NO
Remarks:	rmb
