Profile/Photo Observation Report

Street:	E 38th Ave	Flow Control:	Not Controlled
City:	Hobart, IN	Year Renewed:	
Location:	Other	Tape/Media #:	
Purpose:	Not Known	Dia/Height:	10"
Use:	Sanitary	Material:	VCP
Drain Area:	NA	Lining:	
Category:	NA		
Comment:

Location Details:		Direction of Survey:	Downstream
US MH:	M-203-023	DS MH:	M-203-024
		Total Length Surveyed (ft):	71.7

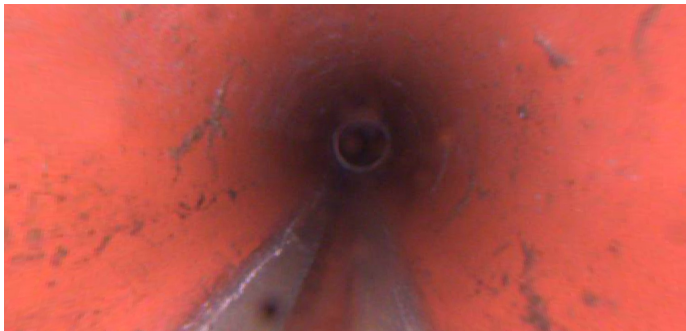
Code: **AMH**
Description: **Manhole**

Distance (ft): **.0**
Structural Grade: **0**
O&M Grade: **0**
Clock Start/From:
Clock To:
1st Value:
2nd Value:
Value Percent:
Continuous Index:
Within 8" of Joint: **NO**
Remarks: **M-203-023**

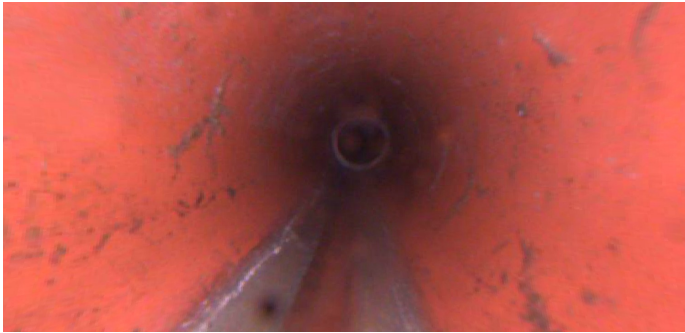
Code:	MWL
Description:	Water Level

Distance (ft):	.0
Structural Grade:	0
O&M Grade:	0
Clock Start/From:	
Clock To:	
1st Value:	
2nd Value:	
Value Percent:	5.000
Continuous Index:	
Within 8" of Joint:	NO
Remarks:

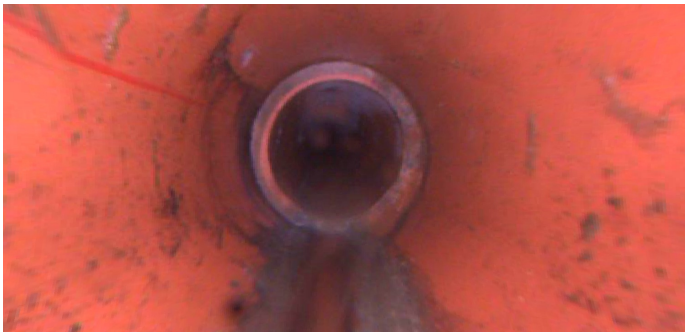
Code:	FL
Description:	Fracture Longitudinal

Distance (ft):	3.4
Structural Grade:	3
O&M Grade:	0
Clock Start/From:	11
Clock To:	
1st Value:	
2nd Value:	
Value Percent:	
Continuous Index:	
Within 8" of Joint:	YES
Remarks:

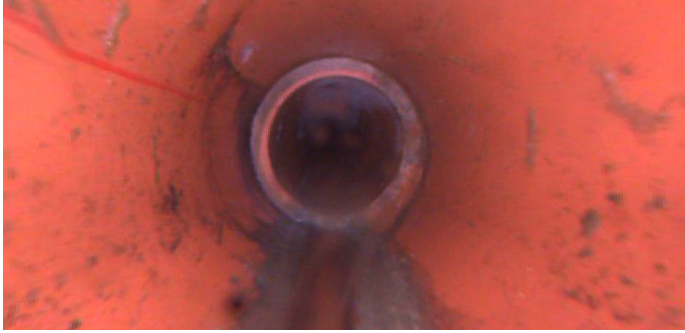
Code: **MSC**
Description: **Shape or Size Change**

Distance (ft): **3.4**
Structural Grade: **0**
O&M Grade: **0**
Clock Start/From:
Clock To:
1st Value: **6.000**
2nd Value:
Value Percent:
Continuous Index:
Within 8" of Joint: **NO**
Remarks:

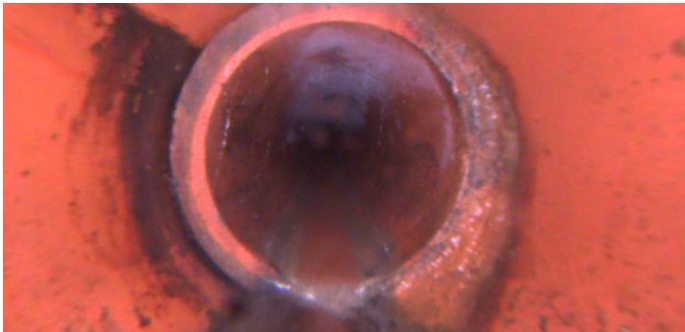
Code: **IW**
Description: **Infil Weeper**

Distance (ft): **4.0**
Structural Grade: **0**
O&M Grade: **2**
Clock Start/From: **8**
Clock To: **4**
1st Value:
2nd Value:
Value Percent:
Continuous Index:
Within 8" of Joint: **YES**
Remarks:

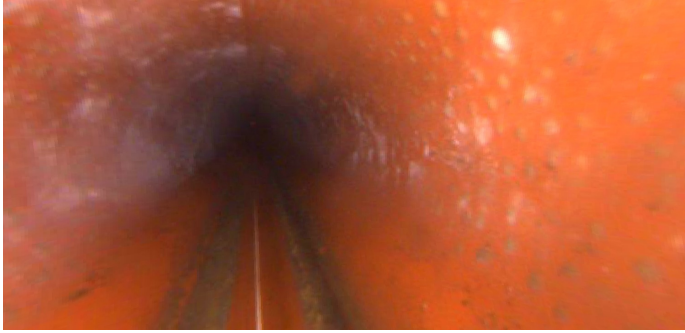
Code: **MGO**
Description: **General Observation**

Distance (ft): **42.4**
Structural Grade: **0**
O&M Grade: **0**
Clock Start/From:
Clock To:
1st Value:
2nd Value:
Value Percent:
Continuous Index:
Within 8" of Joint: **NO**
Remarks: **rear camera/cob webs**

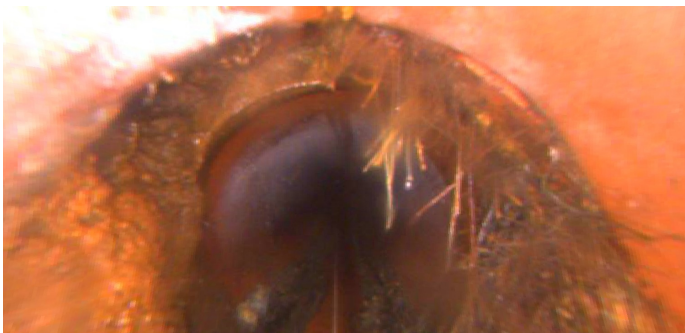
Code: **RMJ**
Description: **Roots Medium Joint**

Distance (ft): **49.5**
Structural Grade: **0**
O&M Grade: **3**
Clock Start/From: **7**
Clock To: **12**
1st Value:
2nd Value:
Value Percent: **10.000**
Continuous Index:
Within 8" of Joint: **YES**
Remarks:

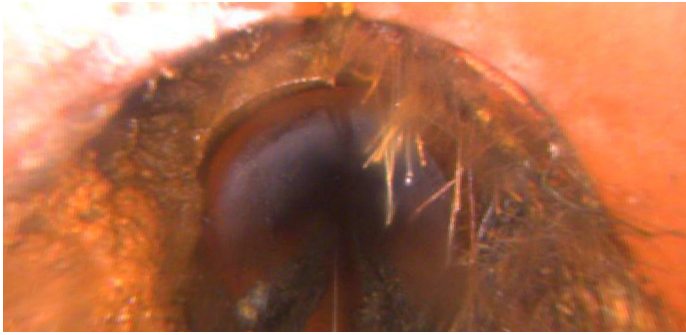
Code: **DAE**
Description: **Deposits Attached Encrustation**

Distance (ft): **49.5**
Structural Grade: **0**
O&M Grade: **2**
Clock Start/From: **2**
Clock To: **5**
1st Value:
2nd Value:
Value Percent: **5.000**
Continuous Index:
Within 8" of Joint: **YES**
Remarks:

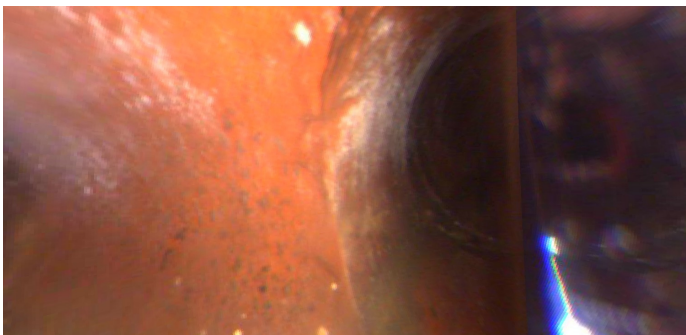
Code: **TF**
Description: **Tap Factory**

Distance (ft): **50.4**
Structural Grade: **0**
O&M Grade: **0**
Clock Start/From: **9**
Clock To:
1st Value: **4.000**
2nd Value:
Value Percent:
Continuous Index:
Within 8" of Joint: **YES**
Remarks:

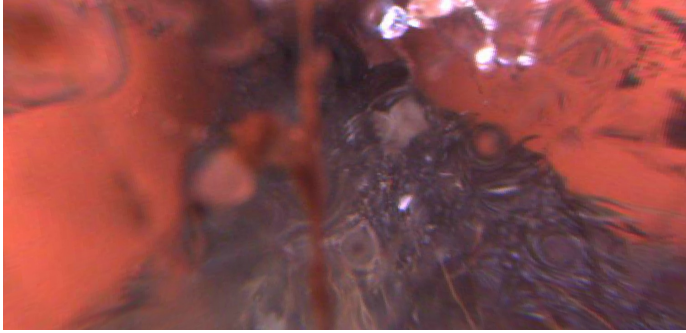
Code: **RML**
Description: **Roots Medium Lateral**

Distance (ft): **71.1**
Structural Grade: **0**
O&M Grade: **3**
Clock Start/From: **3**
Clock To: **7**
1st Value:
2nd Value:
Value Percent: **25.000**
Continuous Index:
Within 8" of Joint: **NO**
Remarks:

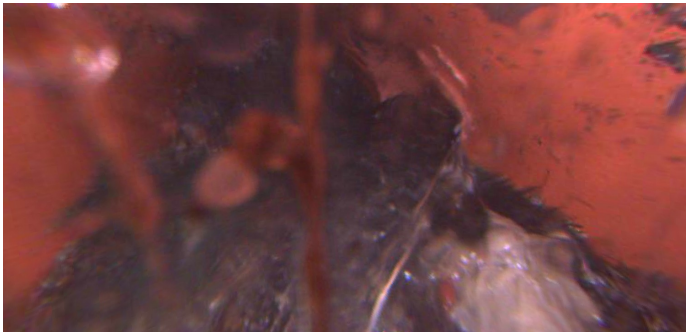
Code: **TFD**
Description: **Tap Factory Defective**

Distance (ft): **71.7**
Structural Grade: **0**
O&M Grade: **2**
Clock Start/From: **3**
Clock To:
1st Value: **4.000**
2nd Value:
Value Percent:
Continuous Index:
Within 8" of Joint:
Remarks: **roots**

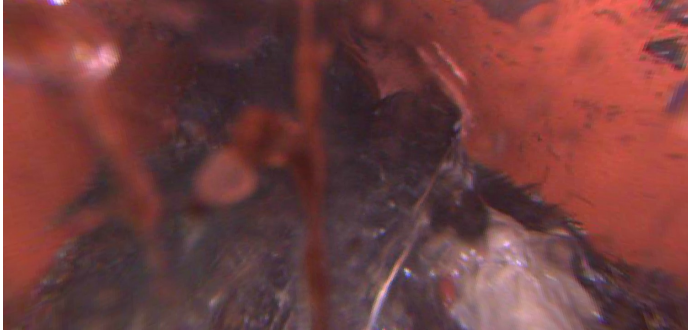
Code:	MSA
Description:	Abandoned Survey
Distance (ft):	71.7
Structural Grade:	0
O&M Grade:	0
Clock Start/From:	
Clock To:	
1st Value:	
2nd Value:	
Value Percent:	
Continuous Index:	
Within 8" of Joint:	NO
Remarks:	rmb
