Profile/Photo Observation Report

| Street: | W 38TH AVE | Flow Control: | Not Controlled |
| Purpose: | Routine Assessment | Dia/Height: | 12" |

| US MH: | M-203-023 | DS MH: | M-203-024 |

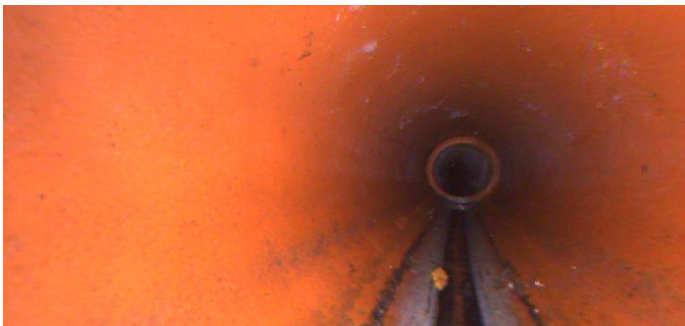
Code: **MWL**
Description: **Water Level**

Distance (ft): **.0**
Structural Grade: **0**
O&M Grade: **0**
Clock Start/From:
Clock To:
1st Value:
2nd Value:
Value Percent: **5.000**
Continuous Index:
Within 8" of Joint: **NO**
Remarks:

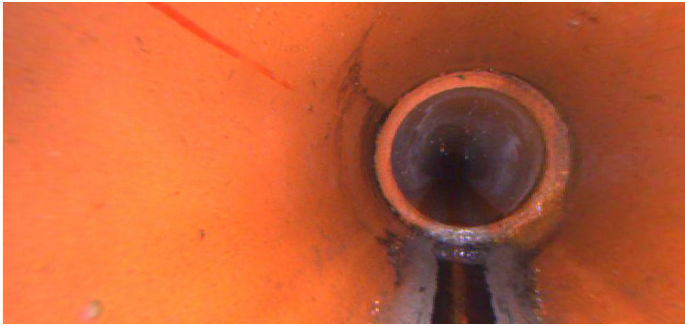
Code: **FL**
Description: **Fracture Longitudinal**

Distance (ft): **3.2**
Structural Grade: **3**
O&M Grade: **0**
Clock Start/From: **10**
Clock To:
1st Value:
2nd Value:
Value Percent:
Continuous Index:
Within 8" of Joint: **YES**
Remarks:

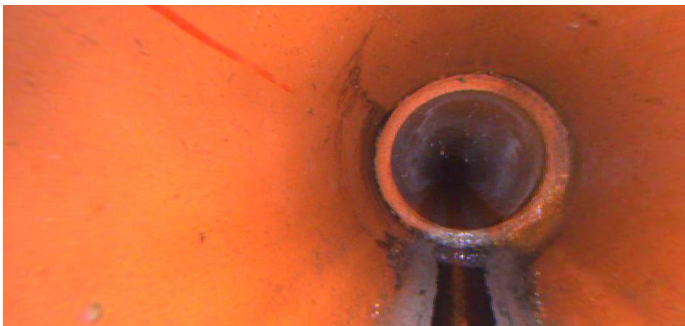
Code: **IS**
Description: **Infil Stain**

Distance (ft): **3.2**
Structural Grade: **0**
O&M Grade: **0**
Clock Start/From: **7**
Clock To: **11**
1st Value:
2nd Value:
Value Percent:
Continuous Index:
Within 8" of Joint: **YES**
Remarks:

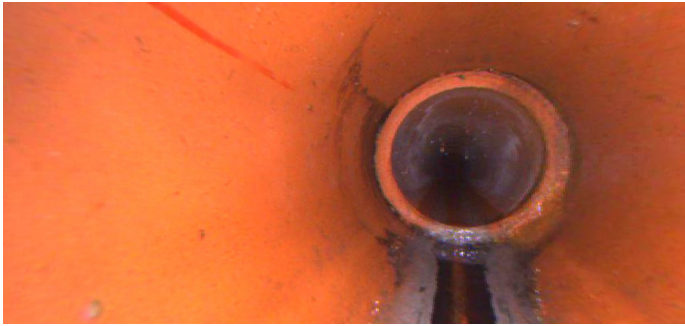
Code: **DAE**
Description: **Deposits Attached Encrustation**

Distance (ft): **3.2**
Structural Grade: **0**
O&M Grade: **2**
Clock Start/From: **7**
Clock To: **5**
1st Value:
2nd Value:
Value Percent: **10.000**
Continuous Index:
Within 8" of Joint: **YES**
Remarks:

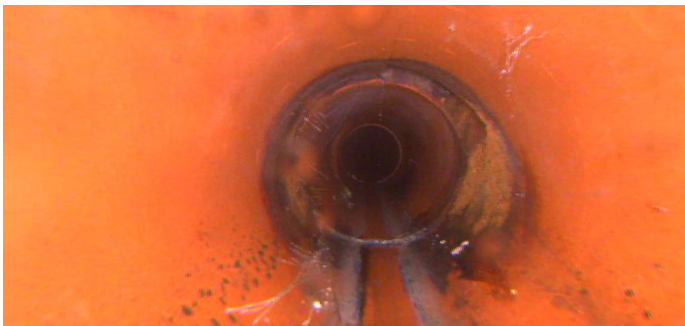
Code: **IS**
Description: **Infil Stain**

Distance (ft): **47.8**
Structural Grade: **0**
O&M Grade: **0**
Clock Start/From: **7**
Clock To: **5**
1st Value:
2nd Value:
Value Percent:
Continuous Index:
Within 8" of Joint: **YES**
Remarks:

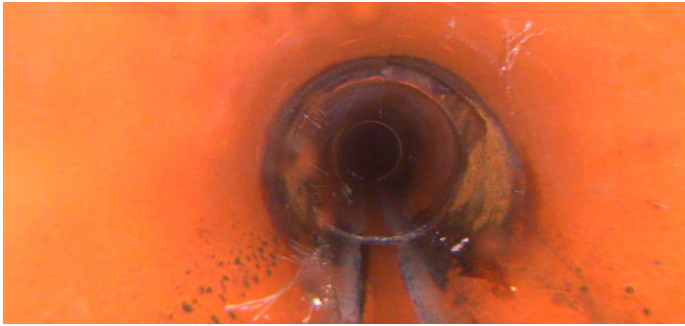
Code: **RFJ**
Description: **Roots Fine Joint**

Distance (ft): **47.8**
Structural Grade: **0**
O&M Grade: **1**
Clock Start/From: **7**
Clock To: **5**
1st Value:
2nd Value:
Value Percent:
Continuous Index:
Within 8" of Joint: **YES**
Remarks:

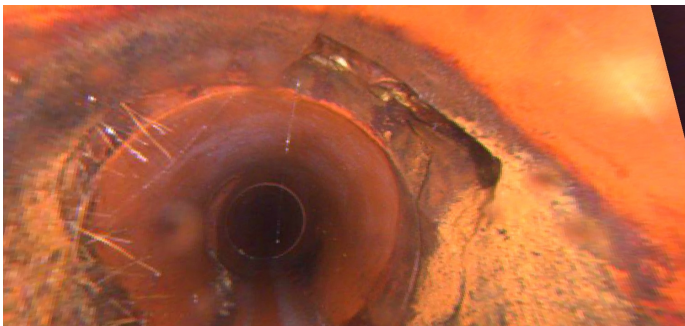
Code: **HVV**
Description: **Hole Void Visible**

Distance (ft): **48.3**
Structural Grade: **5**
O&M Grade: **0**
Clock Start/From: **12**
Clock To: **2**
1st Value:
2nd Value:
Value Percent:
Continuous Index:
Within 8" of Joint: **YES**
Remarks:

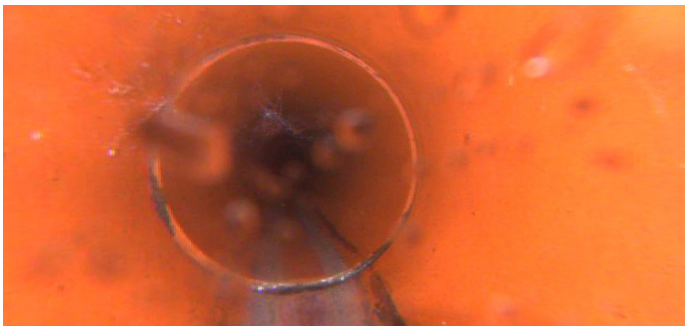
Code: **RFJ**
Description: **Roots Fine Joint**

Distance (ft): **60.0**
Structural Grade: **0**
O&M Grade: **1**
Clock Start/From: **8**
Clock To: **5**
1st Value:
2nd Value:
Value Percent:
Continuous Index:
Within 8" of Joint: **YES**
Remarks:

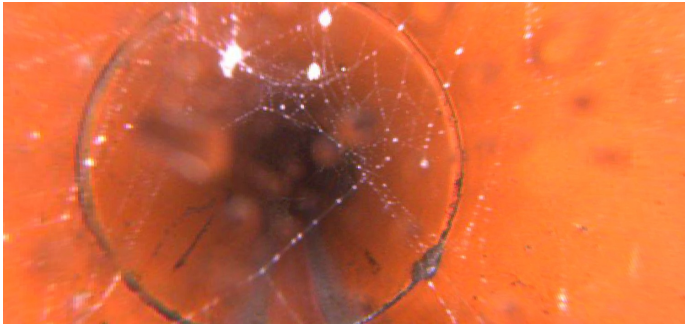
Code: **RFJ**
Description: **Roots Fine Joint**

Distance (ft): **70.1**
Structural Grade: **0**
O&M Grade: **1**
Clock Start/From: **3**
Clock To: **5**
1st Value:
2nd Value:
Value Percent:
Continuous Index:
Within 8" of Joint: **YES**
Remarks:

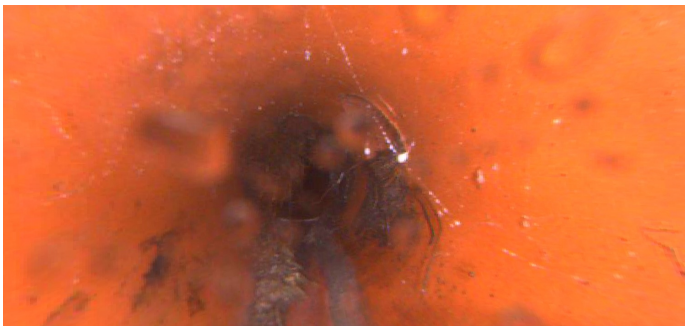
Code: **RFB**
Description: **Roots Fine Barrel**

Distance (ft): **70.8**
Structural Grade: **0**
O&M Grade: **2**
Clock Start/From: **6**
Clock To: **7**
1st Value:
2nd Value:
Value Percent:
Continuous Index:
Within 8" of Joint: **NO**
Remarks:

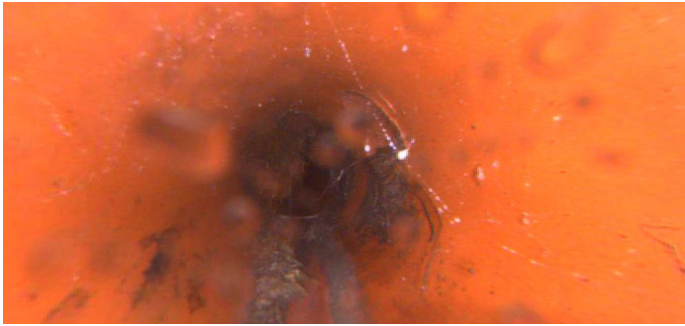
Code: **RMJ**
Description: **Roots Medium Joint**

Distance (ft): **70.8**
Structural Grade: **0**
O&M Grade: **3**
Clock Start/From: **7**
Clock To: **5**
1st Value:
2nd Value:
Value Percent: **30.000**
Continuous Index:
Within 8" of Joint: **YES**
Remarks:

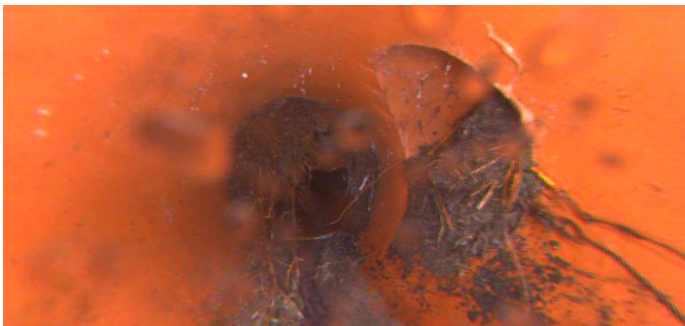
Code: **TFD**
Description: **Tap Factory Defective**

Distance (ft): **71.2**
Structural Grade: **0**
O&M Grade: **2**
Clock Start/From: **2**
Clock To:
1st Value: **4.000**
2nd Value:
Value Percent:
Continuous Index:
Within 8" of Joint: **NO**
Remarks: **root infiltration**

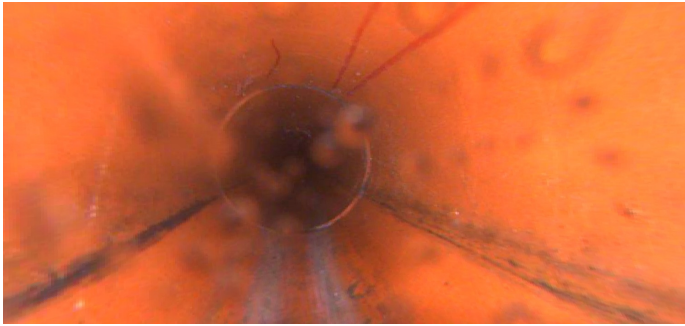
Code: **RFJ**
Description: **Roots Fine Joint**

Distance (ft): **76.3**
Structural Grade: **0**
O&M Grade: **1**
Clock Start/From: **11**
Clock To: **5**
1st Value:
2nd Value:
Value Percent:
Continuous Index:
Within 8" of Joint: **YES**
Remarks:

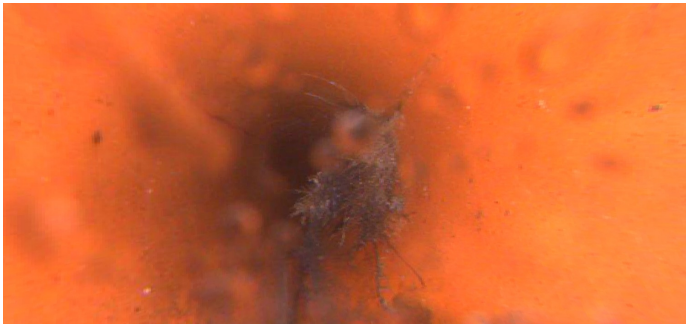
Code: **FL**
Description: **Fracture Longitudinal**

Distance (ft): **132.4**
Structural Grade: **3**
O&M Grade: **0**
Clock Start/From: **1**
Clock To:
1st Value:
2nd Value:
Value Percent:
Continuous Index:
Within 8" of Joint: **NO**
Remarks:

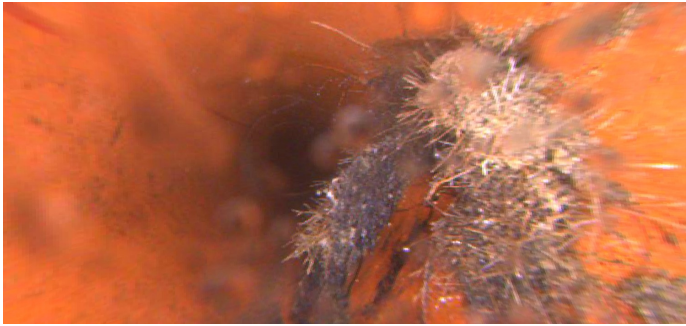
Code: **RMJ**
Description: **Roots Medium Joint**

Distance (ft): **133.1**
Structural Grade: **0**
O&M Grade: **3**
Clock Start/From: **1**
Clock To: **6**
1st Value:
2nd Value:
Value Percent: **30.000**
Continuous Index:
Within 8" of Joint: **YES**
Remarks:

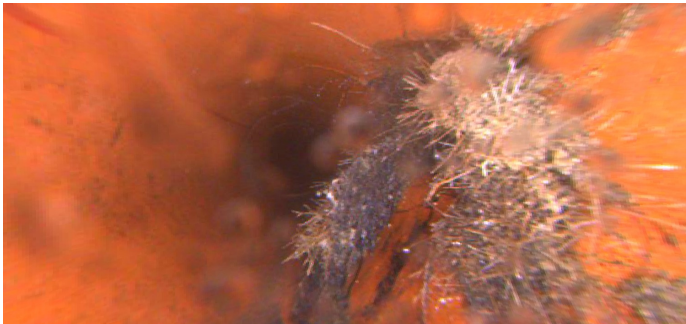
Code: **TFD**
Description: **Tap Factory Defective**

Distance (ft): **133.1**
Structural Grade: **0**
O&M Grade: **2**
Clock Start/From: **2**
Clock To:
1st Value: **4.000**
2nd Value:
Value Percent:
Continuous Index:
Within 8" of Joint:
Remarks: **root infiltration**

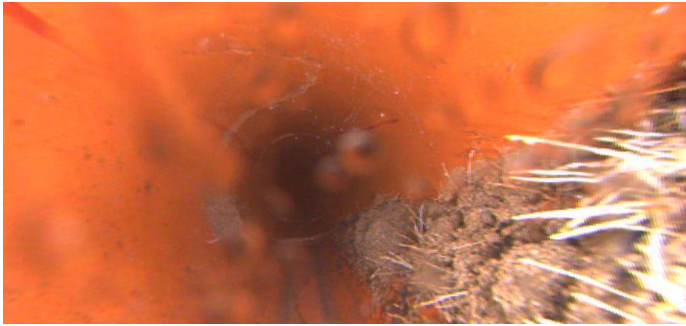
Code: **RMB**
Description: **Roots Medium Barrel**

Distance (ft): **133.8**
Structural Grade: **0**
O&M Grade: **4**
Clock Start/From: **2**
Clock To: **5**
1st Value:
2nd Value:
Value Percent: **20.000**
Continuous Index:
Within 8" of Joint: **NO**
Remarks:

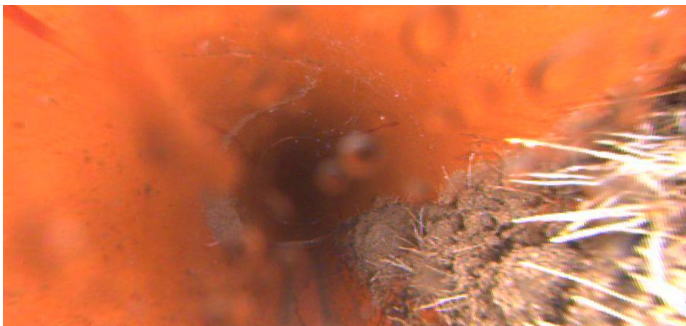
Code: **RFB**
Description: **Roots Fine Barrel**

Distance (ft): **133.9**
Structural Grade: **0**
O&M Grade: **2**
Clock Start/From: **8**
Clock To: **5**
1st Value:
2nd Value:
Value Percent:
Continuous Index:
Within 8" of Joint: **NO**
Remarks:

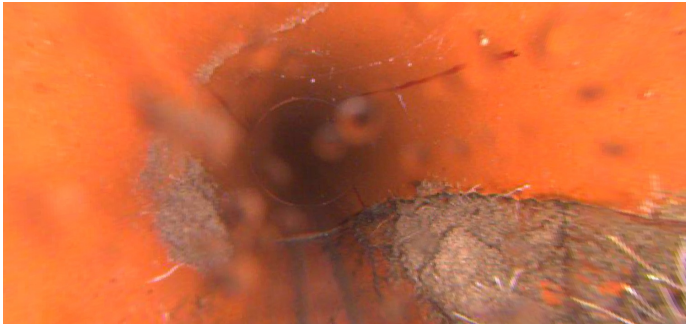
Code: **FM**
Description: **Fracture Multiple**

Distance (ft): **134.3**
Structural Grade: **4**
O&M Grade: **0**
Clock Start/From: **6**
Clock To: **6**
1st Value:
2nd Value:
Value Percent:
Continuous Index:
Within 8" of Joint:
Remarks:

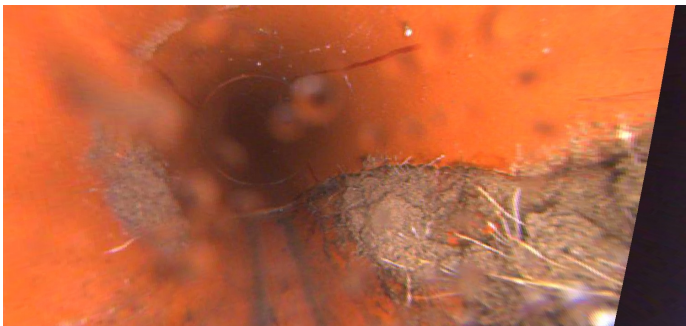
Code: **FL**
Description: **Fracture Longitudinal**

Distance (ft): **134.3**
Structural Grade: **3**
O&M Grade: **0**
Clock Start/From: **3**
Clock To:
1st Value:
2nd Value:
Value Percent:
Continuous Index:
Within 8" of Joint:
Remarks:
