Profile/Photo Observation Report

Date:	09/25/2018	Weather:		Coding:	PACP 6.0
Pipe Length (ft):	157.1	Owner:	NA	Pre Clean:	Not Known
P.O.#:		Surveyor:	Selasie Honu	PSR:	P-203-024-023
Customer:		Clean Date:	01/01/1900	Shape:	C

Street:	38th. Ave.	Flow Control:	Not Controlled
City:	Hobart, IN	Year Renewed:	
Location:	Light Highway	Tape/Media #:	
Purpose:	Routine Assessment	Dia/Height:	12"
Use:	Sanitary	Material:	VCP
Drain Area:	NA	Lining:	
Category:	NA		
Comment:

Location Details:		Direction of Survey:	Downstream
US MH:	M-203-023	DS MH:	M-203-024
		Total Length Surveyed (ft):	147.8

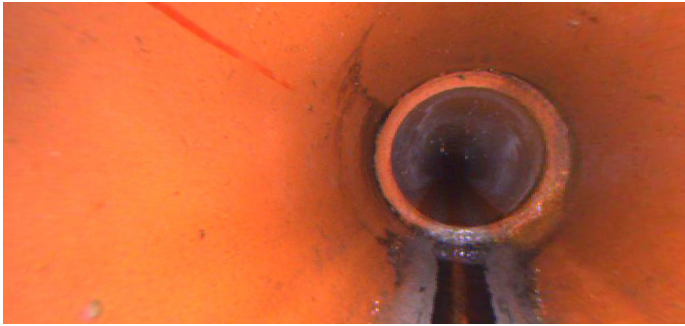
Code: **FL**
Description: **Fracture Longitudinal**

Distance (ft): **3.2**
Structural Grade: **3**
O&M Grade: **0**
Clock Start/From: **10**
Clock To:
1st Value:
2nd Value:
Value Percent:
Continuous Index:
Within 8" of Joint: **YES**
Remarks:

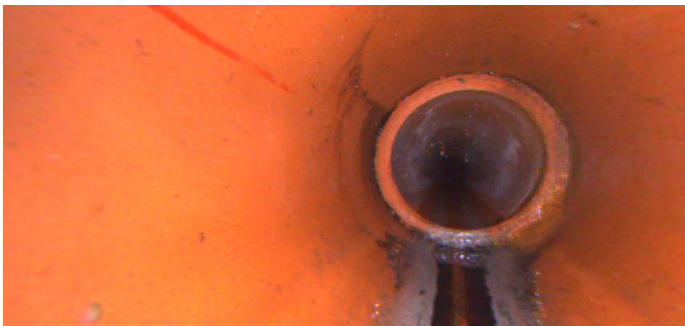
Code: **IS**
Description: **Infil Stain**

Distance (ft): **3.2**
Structural Grade: **0**
O&M Grade: **0**
Clock Start/From: **7**
Clock To: **11**
1st Value:
2nd Value:
Value Percent:
Continuous Index:
Within 8" of Joint: **YES**
Remarks:

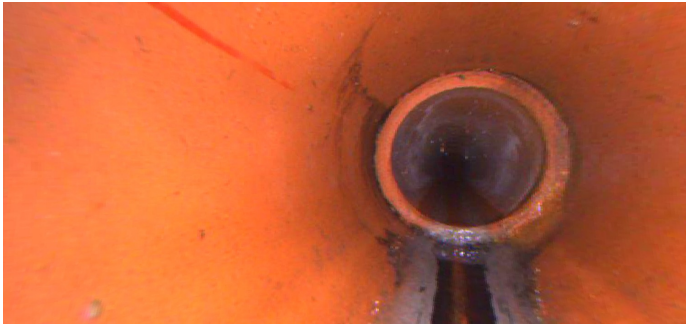
Code: **DAE**
Description: **Deposits Attached Encrustation**

Distance (ft): **3.2**
Structural Grade: **0**
O&M Grade: **2**
Clock Start/From: **7**
Clock To: **5**
1st Value:
2nd Value:
Value Percent: **10.000**
Continuous Index:
Within 8" of Joint: **YES**
Remarks:

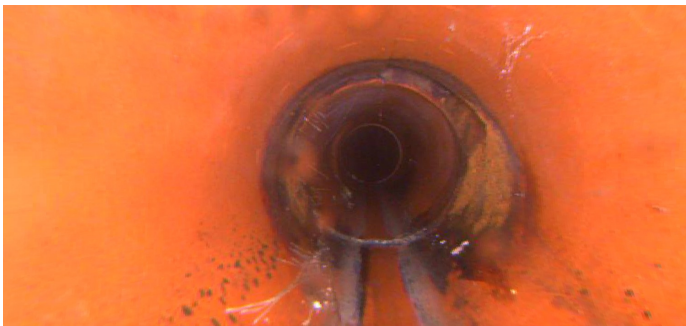
Code: **IS**
Description: **Infil Stain**

Distance (ft): **47.8**
Structural Grade: **0**
O&M Grade: **0**
Clock Start/From: **7**
Clock To: **5**
1st Value:
2nd Value:
Value Percent:
Continuous Index:
Within 8" of Joint: **YES**
Remarks:

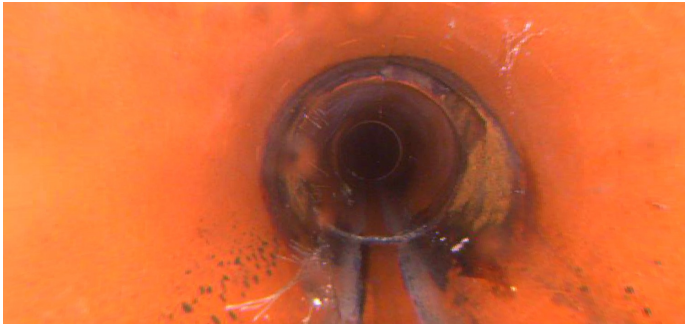
Code: **RFJ**
Description: **Roots Fine Joint**

Distance (ft): **47.8**
Structural Grade: **0**
O&M Grade: **1**
Clock Start/From: **7**
Clock To: **5**
1st Value:
2nd Value:
Value Percent:
Continuous Index:
Within 8" of Joint: **YES**
Remarks:

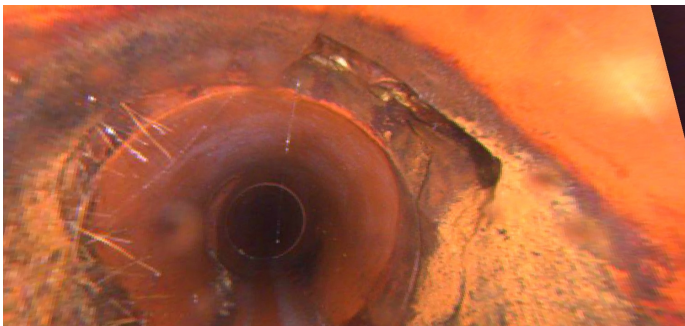
Code: **HVV**
Description: **Hole Void Visible**

Distance (ft): **48.3**
Structural Grade: **5**
O&M Grade: **0**
Clock Start/From: **12**
Clock To: **2**
1st Value:
2nd Value:
Value Percent:
Continuous Index:
Within 8" of Joint: **YES**
Remarks:

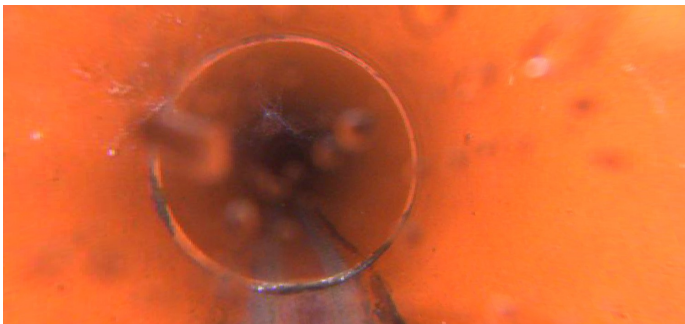
Code: **RFJ**
Description: **Roots Fine Joint**

Distance (ft): **60.0**
Structural Grade: **0**
O&M Grade: **1**
Clock Start/From: **8**
Clock To: **5**
1st Value:
2nd Value:
Value Percent:
Continuous Index:
Within 8" of Joint: **YES**
Remarks:

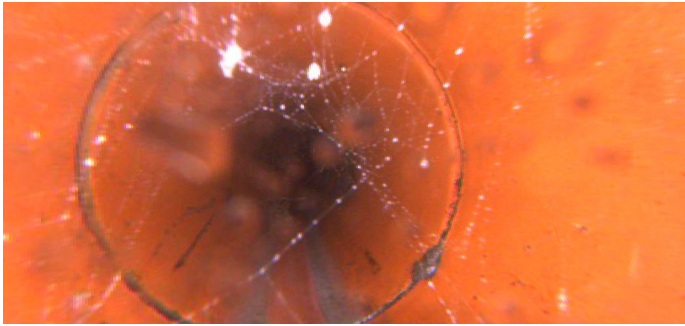
Code: **RFJ**
Description: **Roots Fine Joint**

Distance (ft): **70.1**
Structural Grade: **0**
O&M Grade: **1**
Clock Start/From: **3**
Clock To: **5**
1st Value:
2nd Value:
Value Percent:
Continuous Index:
Within 8" of Joint: **YES**
Remarks:

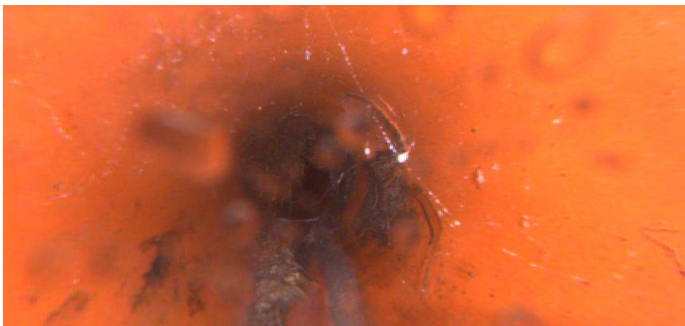
Code: **RFB**
Description: **Roots Fine Barrel**

Distance (ft): **70.8**
Structural Grade: **0**
O&M Grade: **2**
Clock Start/From: **6**
Clock To: **7**
1st Value:
2nd Value:
Value Percent:
Continuous Index:
Within 8" of Joint: **NO**
Remarks:

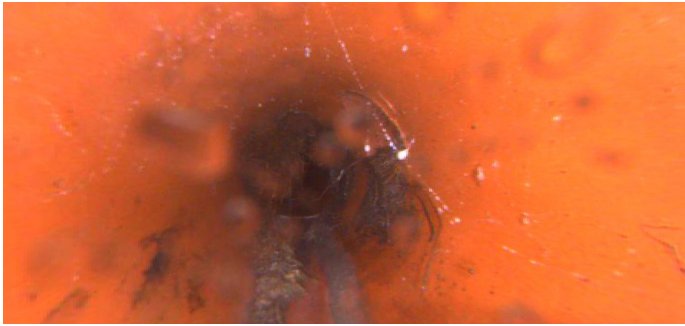
Code: **RMJ**
Description: **Roots Medium Joint**

Distance (ft): **70.8**
Structural Grade: **0**
O&M Grade: **3**
Clock Start/From: **7**
Clock To: **5**
1st Value:
2nd Value:
Value Percent: **30.000**
Continuous Index:
Within 8" of Joint: **YES**
Remarks:

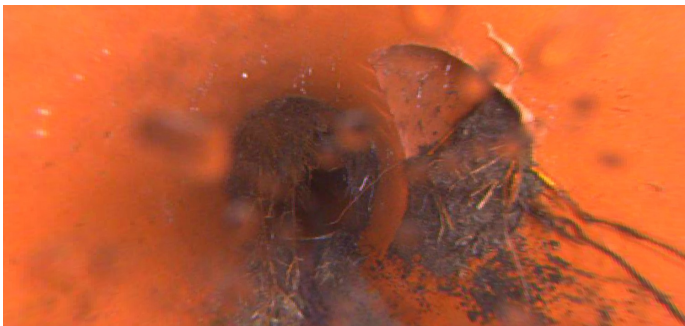
Code: **TFD**
Description: **Tap Factory Defective**

Distance (ft): **71.2**
Structural Grade: **0**
O&M Grade: **2**
Clock Start/From: **2**
Clock To:
1st Value: **4.000**
2nd Value:
Value Percent:
Continuous Index:
Within 8" of Joint: **NO**
Remarks: **root infiltration**

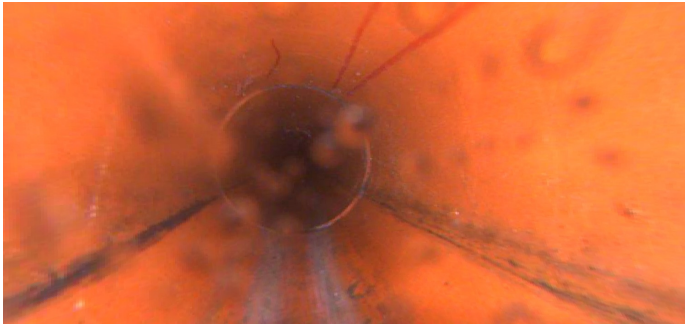
Code: **RFJ**
Description: **Roots Fine Joint**

Distance (ft): **76.3**
Structural Grade: **0**
O&M Grade: **1**
Clock Start/From: **11**
Clock To: **5**
1st Value:
2nd Value:
Value Percent:
Continuous Index:
Within 8" of Joint: **YES**
Remarks:

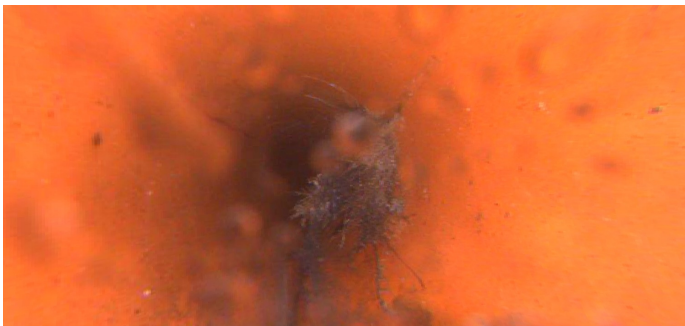
Code: **FL**
Description: **Fracture Longitudinal**

Distance (ft): **132.4**
Structural Grade: **3**
O&M Grade: **0**
Clock Start/From: **1**
Clock To:
1st Value:
2nd Value:
Value Percent:
Continuous Index:
Within 8" of Joint: **NO**
Remarks:

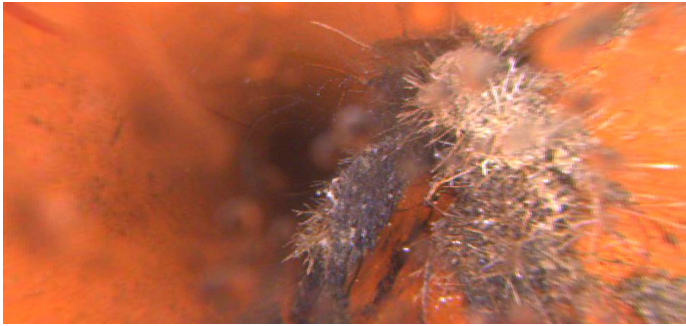
Code: **RMJ**
Description: **Roots Medium Joint**

Distance (ft): **133.1**
Structural Grade: **0**
O&M Grade: **3**
Clock Start/From: **1**
Clock To: **6**
1st Value:
2nd Value:
Value Percent: **30.000**
Continuous Index:
Within 8" of Joint: **YES**
Remarks:

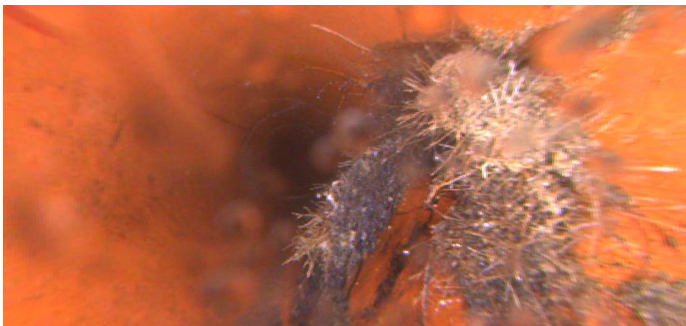
Code: **TFD**
Description: **Tap Factory Defective**

Distance (ft): **133.1**
Structural Grade: **0**
O&M Grade: **2**
Clock Start/From: **2**
Clock To:
1st Value: **4.000**
2nd Value:
Value Percent:
Continuous Index:
Within 8" of Joint:
Remarks: **root infiltration**

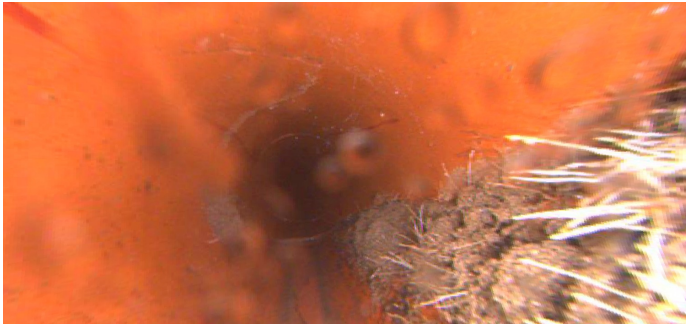
Code: **RMB**
Description: **Roots Medium Barrel**

Distance (ft): **133.8**
Structural Grade: **0**
O&M Grade: **4**
Clock Start/From: **2**
Clock To: **5**
1st Value:
2nd Value:
Value Percent: **20.000**
Continuous Index:
Within 8" of Joint: **NO**
Remarks:

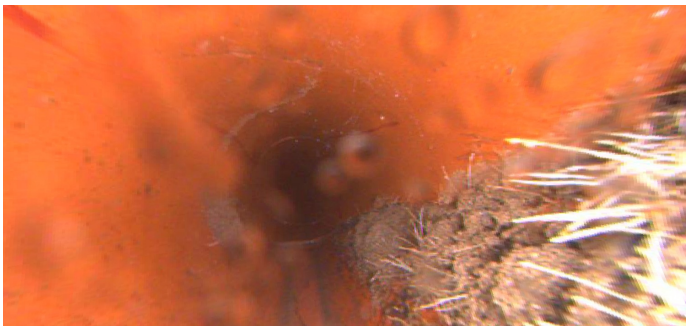
Code: **RFB**
Description: **Roots Fine Barrel**

Distance (ft): **133.9**
Structural Grade: **0**
O&M Grade: **2**
Clock Start/From: **8**
Clock To: **5**
1st Value:
2nd Value:
Value Percent:
Continuous Index:
Within 8" of Joint: **NO**
Remarks:

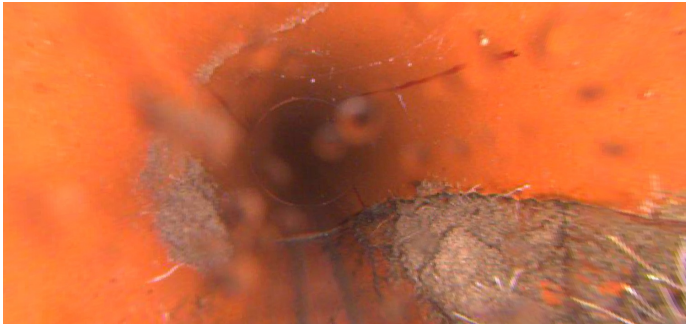
Code: **FM**
Description: **Fracture Multiple**

Distance (ft): **134.3**
Structural Grade: **4**
O&M Grade: **0**
Clock Start/From: **6**
Clock To: **6**
1st Value:
2nd Value:
Value Percent:
Continuous Index:
Within 8" of Joint:
Remarks:

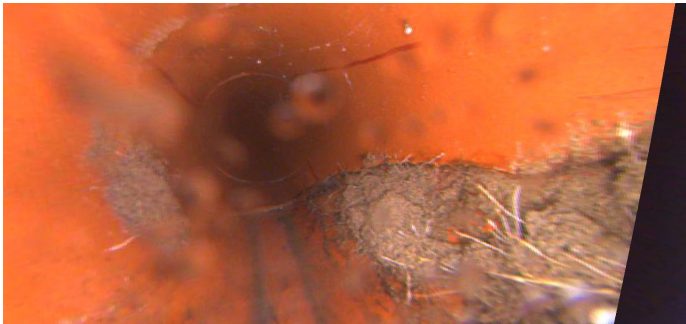
Code: **FL**
Description: **Fracture Longitudinal**

Distance (ft): **134.3**
Structural Grade: **3**
O&M Grade: **0**
Clock Start/From: **3**
Clock To:
1st Value:
2nd Value:
Value Percent:
Continuous Index:
Within 8" of Joint:
Remarks:
