## Profile/Photo Observation Report

Date:	<b>03/26/2018</b>	Weather:		Coding:	<b>PACP 6.0</b>
Pipe Length (ft):	<b>340.7</b>	Owner:	<b>NA</b>	Pre Clean:	<b>Not Known</b>
P.O.#:		Surveyor:	<b>Byrd Fitzgerald</b>	PSR:	<b>P-203-023-026</b>
Customer:		Clean Date:	<b>01/01/1900</b>	Shape:	<b>C</b>

Street:	<b>E 38th Ave</b>	Flow Control:	<b>Not Controlled</b>
City:	<b>Hobart, IN</b>	Year Renewed:	
Location:	<b>Other</b>	Tape/Media #:	
Purpose:	<b>Not Known</b>	Dia/Height:	<b>12"</b>
Use:	<b>Sanitary</b>	Material:	<b>VCP</b>
Drain Area:	<b>NA</b>	Lining:	
Category:	<b>NA</b>		
Comment:	<b>Debris, sediment. Solo will not deploy</b>		
Location Details:		Direction of Survey:	<b>Upstream</b>
US MH:	<b>M-203-026</b>	DS MH:	<b>M-203-023</b>
		Total Length Surveyed (ft):	<b>74.3</b>

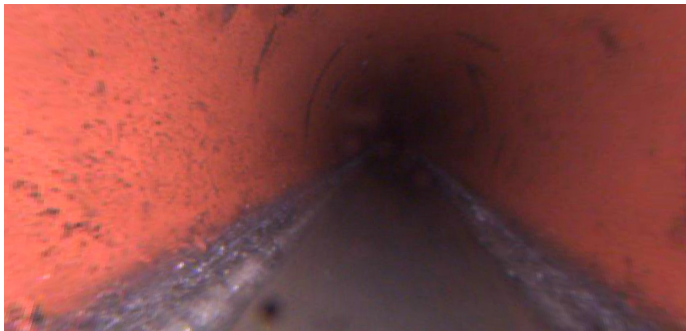
Code: **AMH**  
Description: **Manhole**

Distance (ft): **.0**  
Structural Grade: **0**  
O&M Grade: **0**  
Clock Start/From:  
Clock To:  
1st Value:  
2nd Value:  
Value Percent:  
Continuous Index:  
Within 8" of Joint: **NO**  
Remarks: **M-203-023**

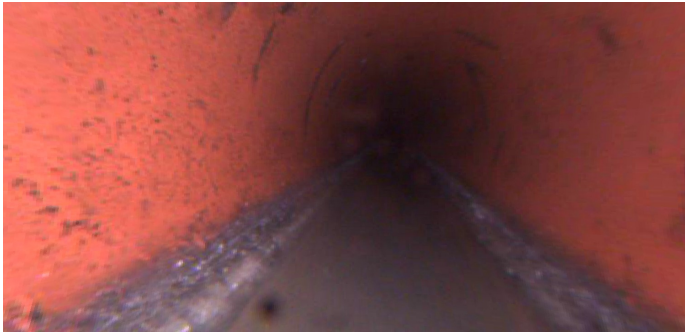
Code:	<b>MWL</b>
Description:	<b>Water Level</b>

Distance (ft):	<b>.0</b>
Structural Grade:	<b>0</b>
O&M Grade:	<b>0</b>
Clock Start/From:	
Clock To:	
1st Value:	
2nd Value:	
Value Percent:	<b>5.000</b>
Continuous Index:	
Within 8" of Joint:	<b>NO</b>
Remarks:

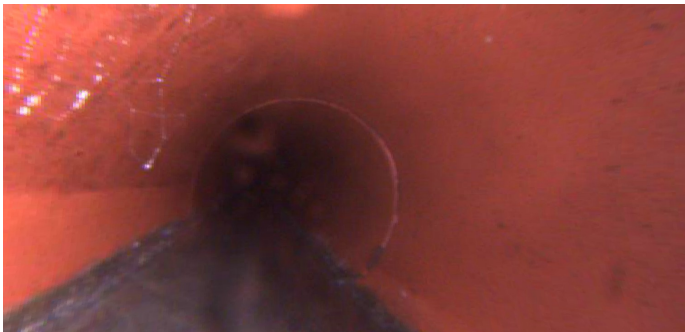
Code:	<b>MSA</b>
Description:	<b>Abandoned Survey</b>

Distance (ft):	<b>74.3</b>
Structural Grade:	<b>0</b>
O&M Grade:	<b>0</b>
Clock Start/From:	
Clock To:	
1st Value:	
2nd Value:	
Value Percent:	
Continuous Index:	
Within 8" of Joint:	<b>NO</b>
Remarks:	<b>stopped/no blockage</b>
