Profile/Photo Observation Report

Date:	09/25/2018	Weather:		Coding:	PACP 6.0
Pipe Length (ft):	340.7	Owner:	NA	Pre Clean:	Not Known
P.O.#:		Surveyor:	Justin Gonzales	PSR:	P-203-023-026
Customer:		Clean Date:	01/01/1900	Shape:	C

Street:	38th. Ave.	Flow Control:	Not Controlled
City:	Hobart, IN	Year Renewed:	
Location:	Light Highway	Tape/Media #:	
Purpose:	Routine Assessment	Dia/Height:	12"
Use:	Sanitary	Material:	VCP
Drain Area:	NA	Lining:	
Category:	NA		
Comment:

Location Details:		Direction of Survey:	Upstream
US MH:	M-203-026	DS MH:	M-203-023
		Total Length Surveyed (ft):	334.3

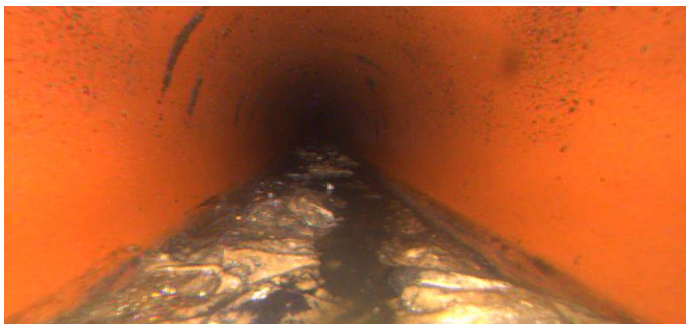
Code: **AMH**
Description: **Manhole**

Distance (ft): **.0**
Structural Grade: **0**
O&M Grade: **0**
Clock Start/From:
Clock To:
1st Value:
2nd Value:
Value Percent:
Continuous Index:
Within 8" of Joint: **NO**
Remarks: **M-203-023**

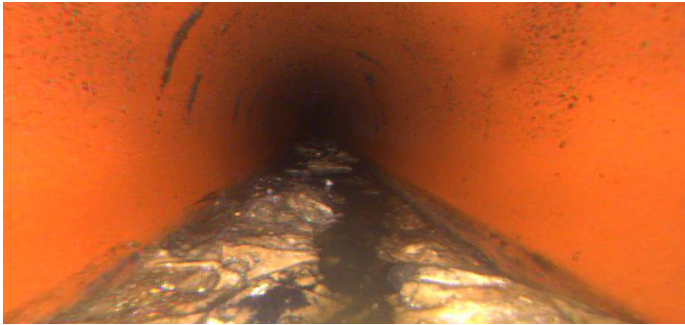
Code:	MWL
Description:	Water Level

Distance (ft):	.0
Structural Grade:	0
O&M Grade:	0
Clock Start/From:	
Clock To:	
1st Value:	
2nd Value:	
Value Percent:	10.000
Continuous Index:	
Within 8" of Joint:	NO
Remarks:

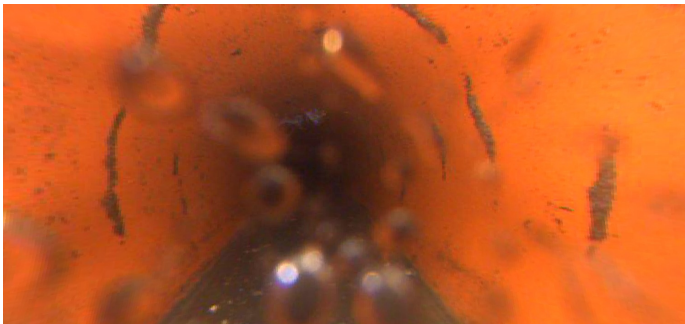
Code:	MGO
Description:	General Observation

Distance (ft):	31.7
Structural Grade:	0
O&M Grade:	0
Clock Start/From:	
Clock To:	
1st Value:	
2nd Value:	
Value Percent:	
Continuous Index:	
Within 8" of Joint:	NO
Remarks:	WATER DROPLETS FROM SPIDER WEBS

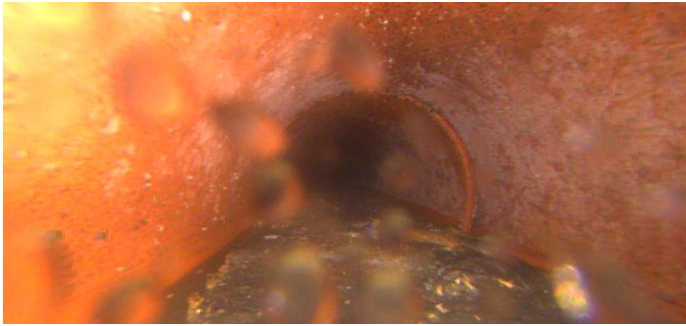
Code: **DAGS**
Description: **Deposits Attached Grease**

Distance (ft): **158.9**
Structural Grade: **0**
O&M Grade: **2**
Clock Start/From: **7**
Clock To: **5**
1st Value:
2nd Value:
Value Percent: **5.000**
Continuous Index: **S01**
Within 8" of Joint: **YES**
Remarks: **WANDER**

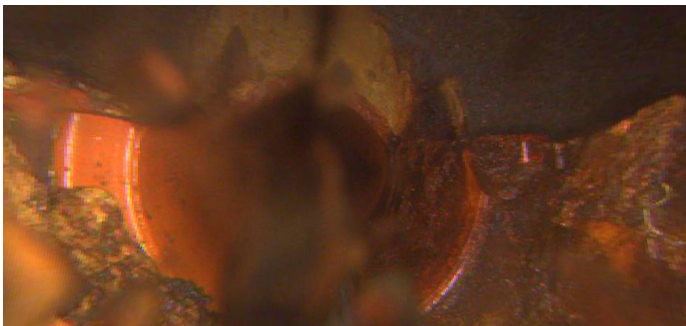
Code: **AMH**
Description: **Manhole**

Distance (ft): **334.3**
Structural Grade: **0**
O&M Grade: **0**
Clock Start/From:
Clock To:
1st Value:
2nd Value:
Value Percent:
Continuous Index:
Within 8" of Joint: **NO**
Remarks: **M-203-026**

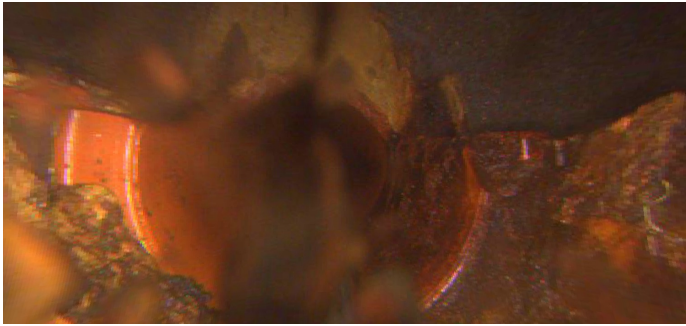
Code:	DAGS
Description:	Deposits Attached Grease
Distance (ft):	334.3
Structural Grade:	0
O&M Grade:	2
Clock Start/From:	7
Clock To:	5
1st Value:	
2nd Value:	
Value Percent:	5.000
Continuous Index:	F01
Within 8" of Joint:	YES
Remarks:	WANDER
