Profile/Photo Observation Report

Date:	10/18/2021	Weather:		Coding:	PACP 6.0
Pipe Length (ft):		Owner:	Hobart, IN	Pre Clean:	Not Known
P.O.#:	871_1	Surveyor:	M. Pielacha	PSR:	P-203-028-027
Customer:	Hobart, IN	Clean Date:		Shape:	C

Street:	38th Avenue	Flow Control:	
City:	Hobart, IN	Year Renewed:	
Location:	Alley	Tape/Media #:	871
Purpose:	Routine Assessment	Dia/Height:	10"
Use:	Sanitary	Material:	VCP
Drain Area:		Lining:	
Category:	NA		
Comment:

Location Details:		Direction of Survey:	Upstream
US MH:	M-203-27	DS MH:	M-203-28
		Total Length Surveyed (ft):	263.2

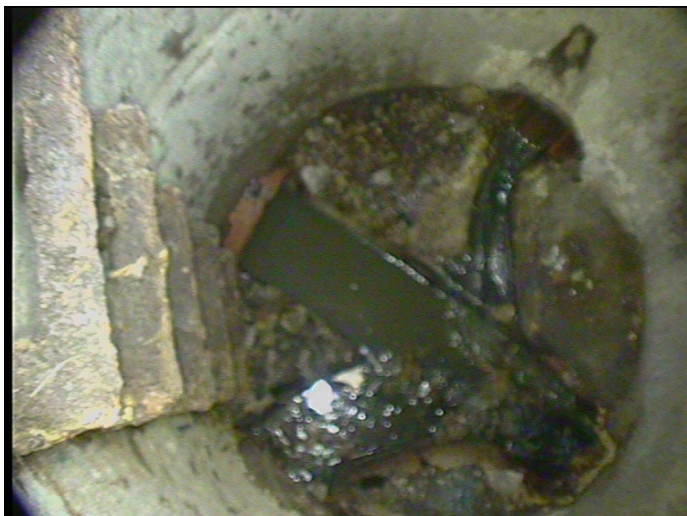
Code: **AMH**
 Description: **Manhole**

Distance (ft): **.0**
 Structural Grade: **0**
 O&M Grade: **0**
 Clock Start/From:
 Clock To:
 1st Value:
 2nd Value:
 Value Percent:
 Continuous Index:
 Within 8" of Joint: **NO**
 Remarks: **M-203-28**

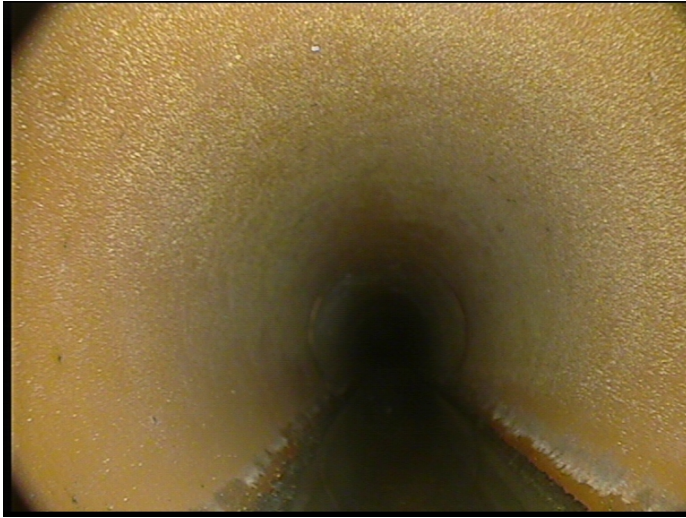
Code:	MWL
Description:	Water Level
Distance (ft):	.0
Structural Grade:	0
O&M Grade:	0
Clock Start/From:	
Clock To:	
1st Value:	
2nd Value:	
Value Percent:	5.000
Continuous Index:	
Within 8" of Joint:	NO
Remarks:

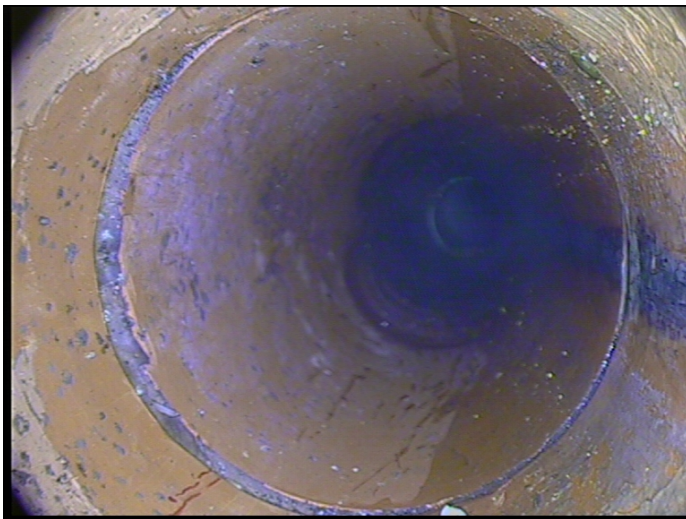
Code:	TF
Description:	Tap Factory
Distance (ft):	74.1
Structural Grade:	0
O&M Grade:	0
Clock Start/From:	2
Clock To:	
1st Value:	4.000
2nd Value:	
Value Percent:	
Continuous Index:	
Within 8" of Joint:	NO
Remarks:

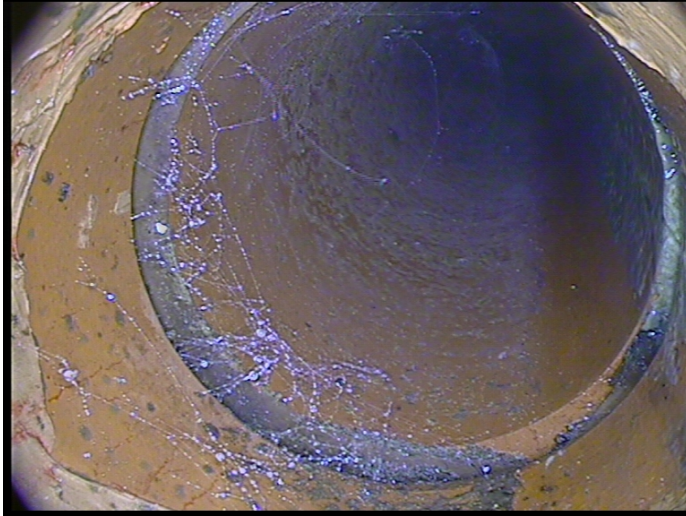
Code: **TF**
Description: **Tap Factory**

Distance (ft): **120.7**
Structural Grade: **0**
O&M Grade: **0**
Clock Start/From: **3**
Clock To:
1st Value: **4.000**
2nd Value:
Value Percent:
Continuous Index:
Within 8" of Joint: **NO**
Remarks:

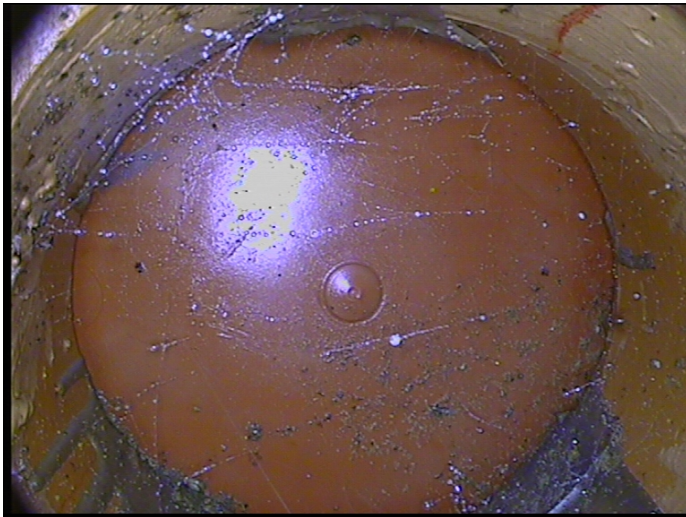
Code: **TFC**
Description: **Tap Factory Capped**

Distance (ft): **122.3**
Structural Grade: **0**
O&M Grade: **0**
Clock Start/From: **10**
Clock To:
1st Value: **4.000**
2nd Value:
Value Percent:
Continuous Index:
Within 8" of Joint: **NO**
Remarks:

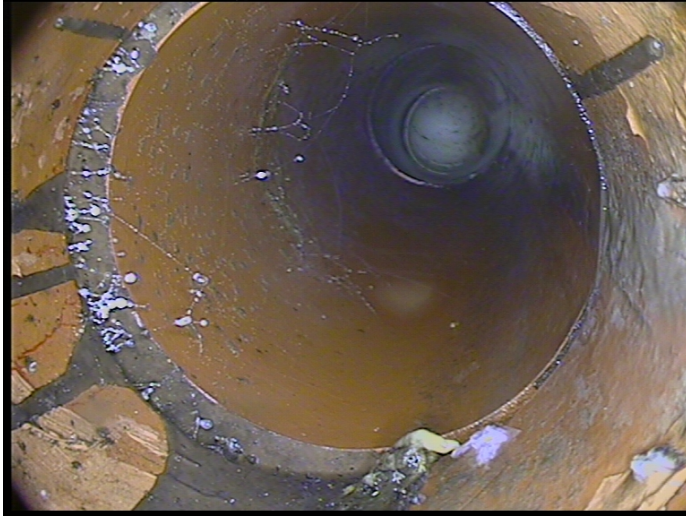
Code: **TF**
Description: **Tap Factory**

Distance (ft): **200.3**
Structural Grade: **0**
O&M Grade: **0**
Clock Start/From: **2**
Clock To:
1st Value: **4.000**
2nd Value:
Value Percent:
Continuous Index:
Within 8" of Joint: **NO**
Remarks:

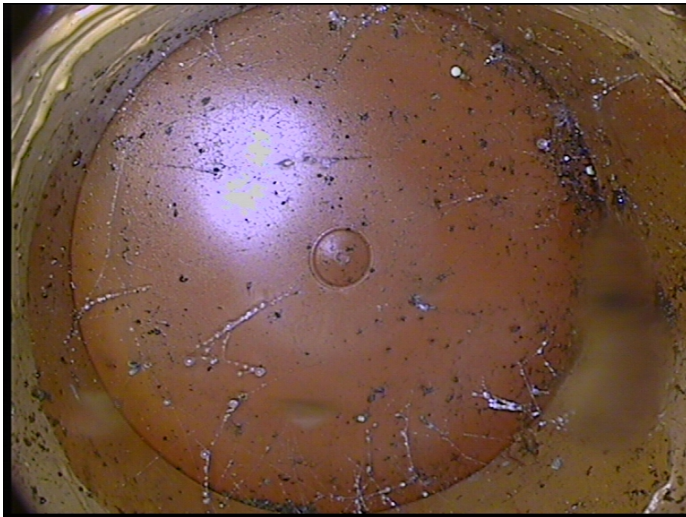
Code: **TFC**
Description: **Tap Factory Capped**

Distance (ft): **242.9**
Structural Grade: **0**
O&M Grade: **0**
Clock Start/From: **10**
Clock To:
1st Value: **4.000**
2nd Value:
Value Percent:
Continuous Index:
Within 8" of Joint: **NO**
Remarks:

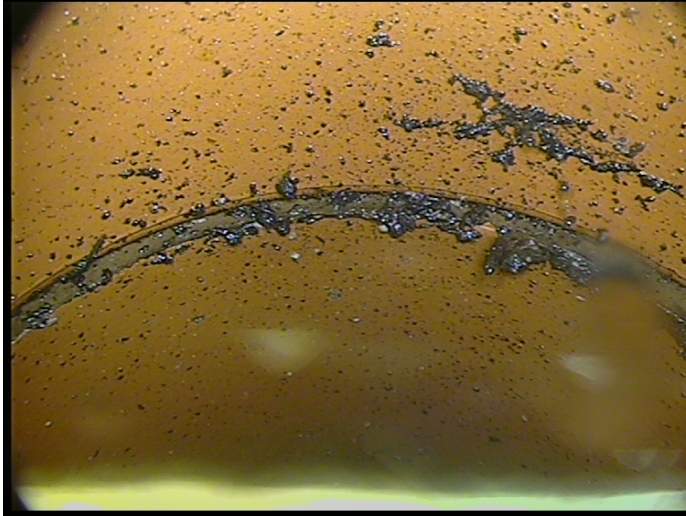
Code:	MWL
Description:	Water Level
Distance (ft):	248.6
Structural Grade:	0
O&M Grade:	0
Clock Start/From:	
Clock To:	
1st Value:	
2nd Value:	
Value Percent:	35.000
Continuous Index:	
Within 8" of Joint:	NO
Remarks:

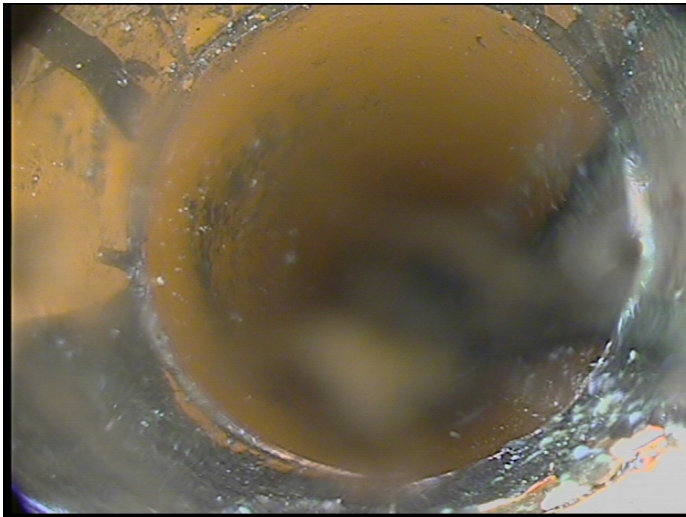
Code:	TF
Description:	Tap Factory
Distance (ft):	255.3
Structural Grade:	0
O&M Grade:	0
Clock Start/From:	3
Clock To:	
1st Value:	4.000
2nd Value:	
Value Percent:	
Continuous Index:	
Within 8" of Joint:	NO
Remarks:

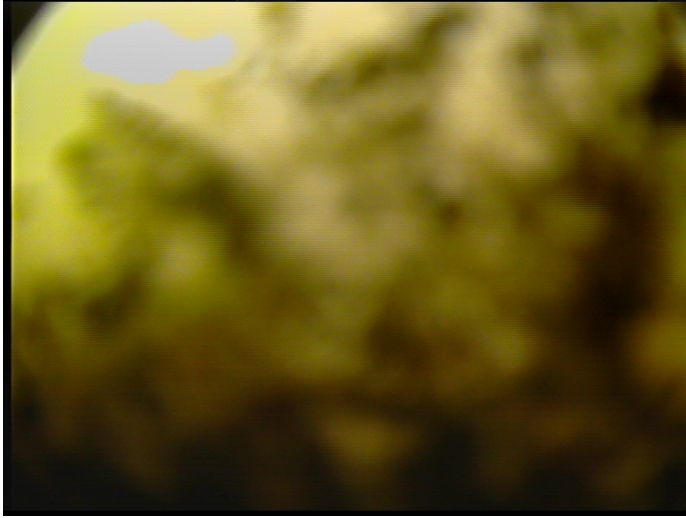
Code: **MCU**
Description: **Camera Underwater**

Distance (ft): **261.9**
Structural Grade: **0**
O&M Grade: **4**
Clock Start/From:
Clock To:
1st Value:
2nd Value:
Value Percent:
Continuous Index:
Within 8" of Joint: **NO**
Remarks:
