Profile/Photo Observation Report

Date:	09/27/2018	Weather:		Coding:	PACP 6.0
Pipe Length (ft):	193.4	Owner:	NA	Pre Clean:	Not Known
P.O.#:		Surveyor:	Selasie Honu	PSR:	P-203-029-028
Customer:		Clean Date:	01/01/1900	Shape:	C

Street:	ALLEY BETWEEN SHERMAN ST & MO	Flow Control:	Not Controlled
City:	Hobart, IN	Year Renewed:	
Location:	Light Highway	Tape/Media #:	
Purpose:	Routine Assessment	Dia/Height:	10"
Use:	Sanitary	Material:	VCP
Drain Area:	NA	Lining:	
Category:	NA		
Comment:

Location Details:		Direction of Survey:	Upstream
US MH:	M-203-028	DS MH:	M-203-029
		Total Length Surveyed (ft):	195.1

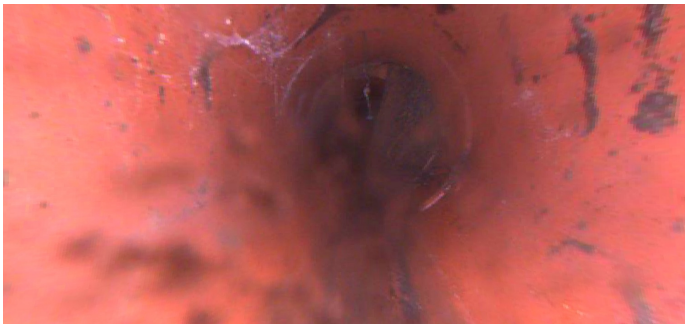
Code:	TFD
Description:	Tap Factory Defective

Distance (ft):	8.8
Structural Grade:	0
O&M Grade:	2
Clock Start/From:	12
Clock To:	
1st Value:	4.000
2nd Value:	
Value Percent:	
Continuous Index:	
Within 8" of Joint:	
Remarks:	root infiltration

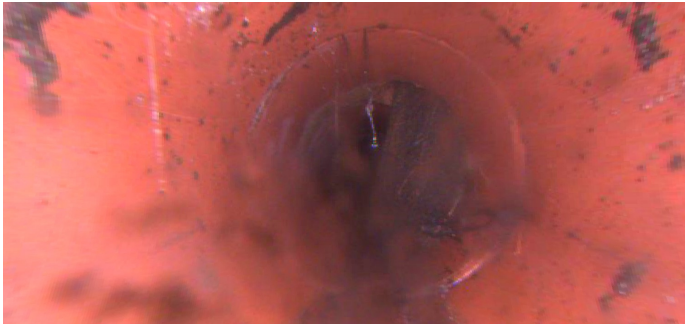
Code: **RFJ**
Description: **Roots Fine Joint**

Distance (ft): **9.2**
Structural Grade: **0**
O&M Grade: **1**
Clock Start/From: **7**
Clock To: **5**
1st Value:
2nd Value:
Value Percent:
Continuous Index:
Within 8" of Joint: **YES**
Remarks:

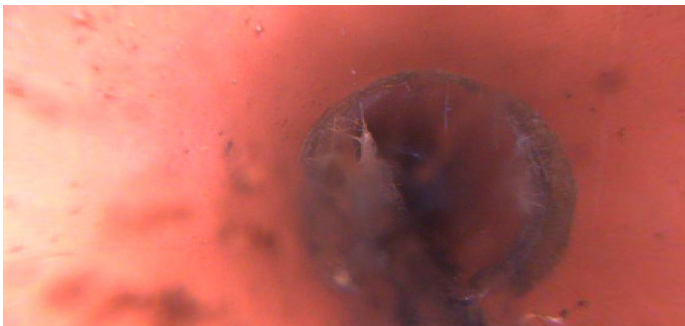
Code: **RMJ**
Description: **Roots Medium Joint**

Distance (ft): **11.2**
Structural Grade: **0**
O&M Grade: **3**
Clock Start/From: **7**
Clock To: **5**
1st Value:
2nd Value:
Value Percent: **20.000**
Continuous Index:
Within 8" of Joint: **YES**
Remarks:

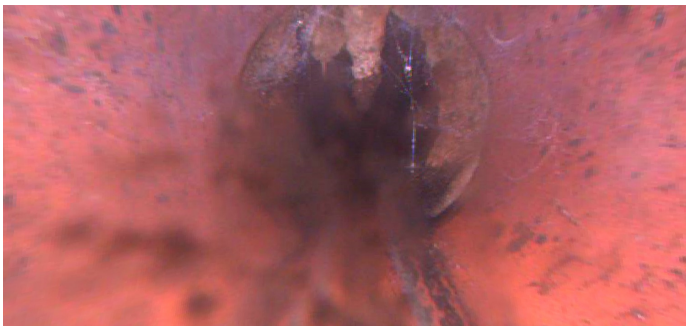
Code: **RMJ**
Description: **Roots Medium Joint**

Distance (ft): **39.0**
Structural Grade: **0**
O&M Grade: **3**
Clock Start/From: **7**
Clock To: **5**
1st Value:
2nd Value:
Value Percent: **40.000**
Continuous Index:
Within 8" of Joint: **YES**
Remarks:

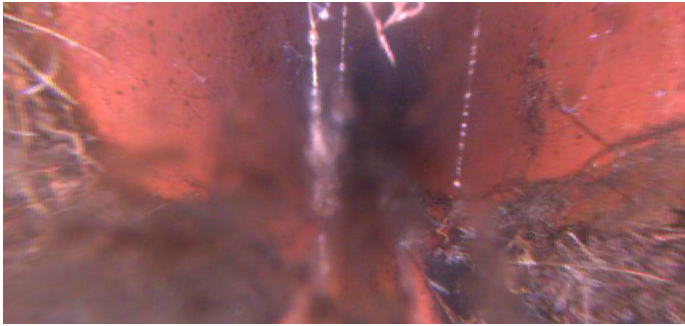
Code: **RMB**
Description: **Roots Medium Barrel**

Distance (ft): **40.0**
Structural Grade: **0**
O&M Grade: **4**
Clock Start/From: **5**
Clock To:
1st Value:
2nd Value:
Value Percent: **15.000**
Continuous Index:
Within 8" of Joint: **NO**
Remarks:

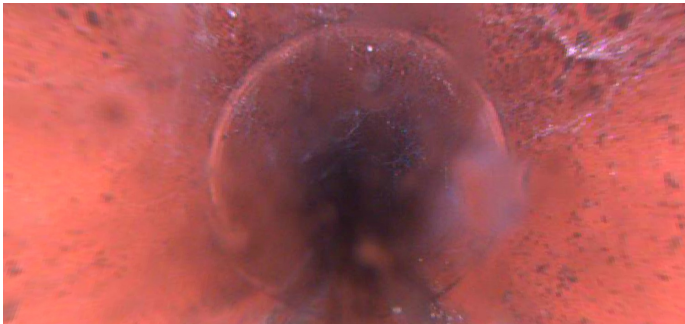
Code: **RFJ**
Description: **Roots Fine Joint**

Distance (ft): **54.9**
Structural Grade: **0**
O&M Grade: **1**
Clock Start/From: **7**
Clock To: **5**
1st Value:
2nd Value:
Value Percent:
Continuous Index:
Within 8" of Joint: **YES**
Remarks:

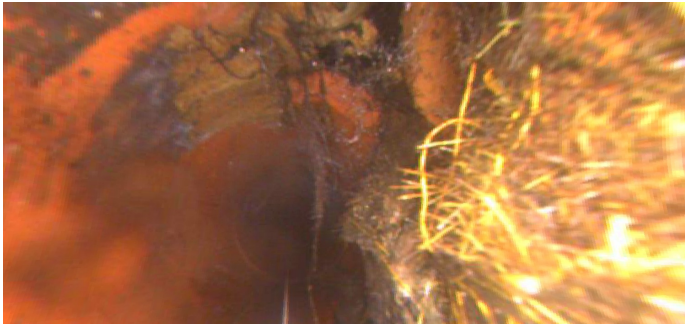
Code: **TFD**
Description: **Tap Factory Defective**

Distance (ft): **120.9**
Structural Grade: **0**
O&M Grade: **2**
Clock Start/From: **1**
Clock To:
1st Value: **4.000**
2nd Value:
Value Percent:
Continuous Index:
Within 8" of Joint:
Remarks: **root infiltration**

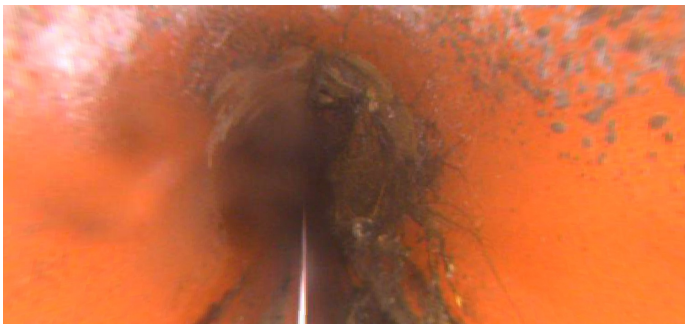
Code: **RMB**
Description: **Roots Medium Barrel**

Distance (ft): **122.5**
Structural Grade: **0**
O&M Grade: **4**
Clock Start/From: **12**
Clock To: **5**
1st Value:
2nd Value:
Value Percent: **40.000**
Continuous Index:
Within 8" of Joint: **NO**
Remarks:

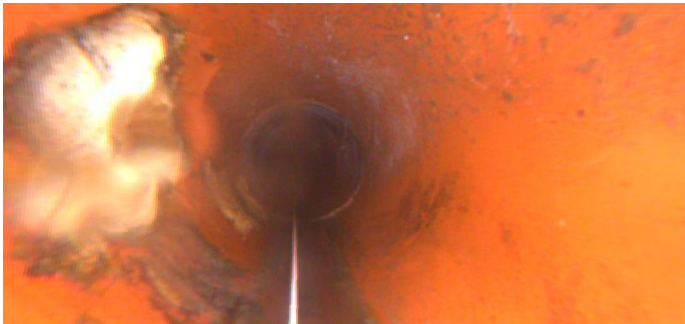
Code: **FL**
Description: **Fracture Longitudinal**

Distance (ft): **143.2**
Structural Grade: **3**
O&M Grade: **0**
Clock Start/From: **9**
Clock To:
1st Value:
2nd Value:
Value Percent:
Continuous Index:
Within 8" of Joint: **YES**
Remarks:

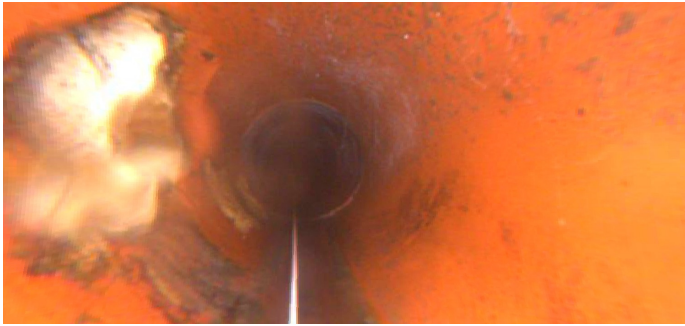
Code: **DAE**
Description: **Deposits Attached Encrustation**

Distance (ft): **143.2**
Structural Grade: **0**
O&M Grade: **3**
Clock Start/From: **6**
Clock To: **9**
1st Value:
2nd Value:
Value Percent: **20.000**
Continuous Index:
Within 8" of Joint:
Remarks:
