Profile/Photo Observation Report

Date:	09/27/2018	Weather:		Coding:	PACP 6.0
Pipe Length (ft):	193.4	Owner:	NA	Pre Clean:	Not Known
P.O.#:		Surveyor:	Selasie Honu	PSR:	P-203-029-028
Customer:		Clean Date:	01/01/1900	Shape:	C

Street:	39th. Ave.	Flow Control:	Not Controlled
City:	Hobart, IN	Year Renewed:	
Location:	Light Highway	Tape/Media #:	
Purpose:	Routine Assessment	Dia/Height:	10"
Use:	Sanitary	Material:	VCP
Drain Area:	NA	Lining:	
Category:	NA		
Comment:

Location Details:		Direction of Survey:	Upstream
US MH:	M-203-028	DS MH:	M-203-029
		Total Length Surveyed (ft):	195.1

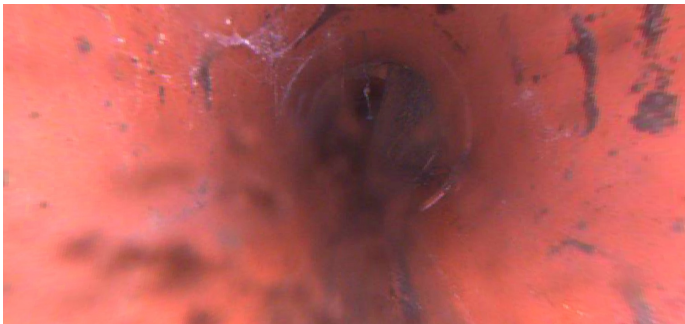
Code:	TFD
Description:	Tap Factory Defective

Distance (ft):	8.8
Structural Grade:	0
O&M Grade:	2
Clock Start/From:	12
Clock To:	
1st Value:	4.000
2nd Value:	
Value Percent:	
Continuous Index:	
Within 8" of Joint:	
Remarks:	root infiltration

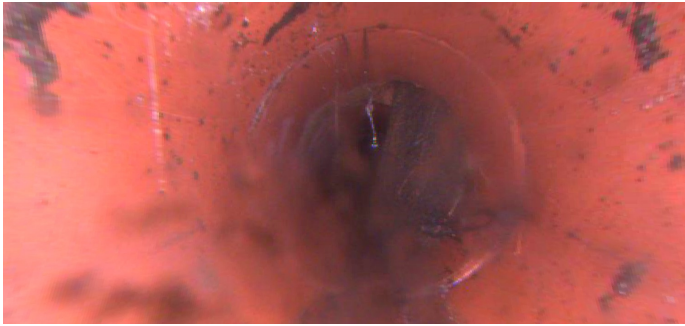
Code: **RFJ**
Description: **Roots Fine Joint**

Distance (ft): **9.2**
Structural Grade: **0**
O&M Grade: **1**
Clock Start/From: **7**
Clock To: **5**
1st Value:
2nd Value:
Value Percent:
Continuous Index:
Within 8" of Joint: **YES**
Remarks:

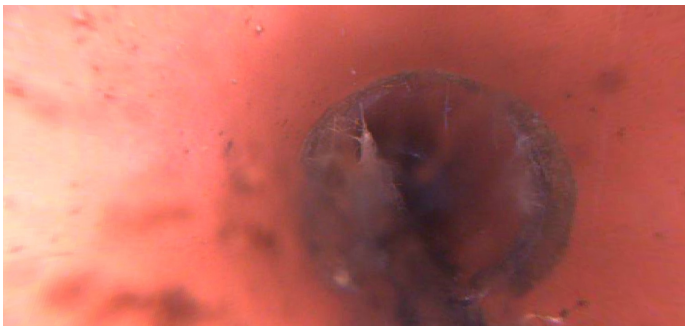
Code: **RMJ**
Description: **Roots Medium Joint**

Distance (ft): **11.2**
Structural Grade: **0**
O&M Grade: **3**
Clock Start/From: **7**
Clock To: **5**
1st Value:
2nd Value:
Value Percent: **20.000**
Continuous Index:
Within 8" of Joint: **YES**
Remarks:

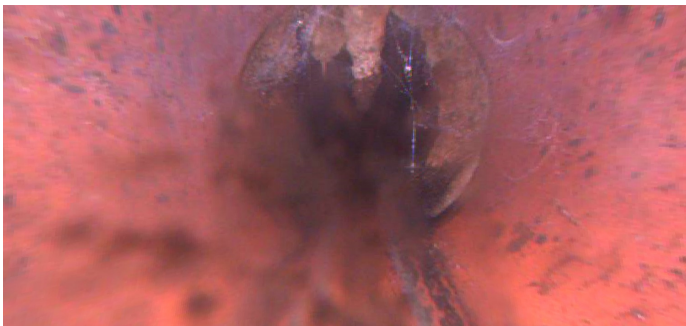
Code: **RMJ**
Description: **Roots Medium Joint**

Distance (ft): **39.0**
Structural Grade: **0**
O&M Grade: **3**
Clock Start/From: **7**
Clock To: **5**
1st Value:
2nd Value:
Value Percent: **40.000**
Continuous Index:
Within 8" of Joint: **YES**
Remarks:

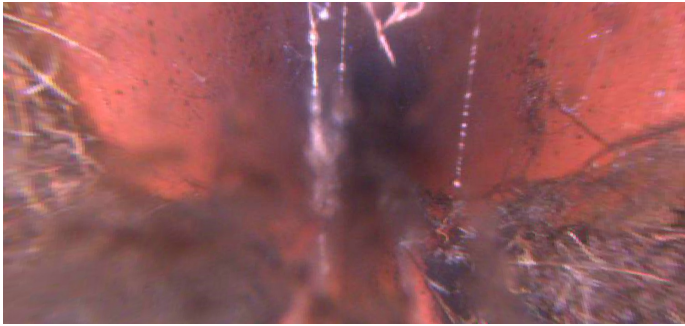
Code: **RMB**
Description: **Roots Medium Barrel**

Distance (ft): **40.0**
Structural Grade: **0**
O&M Grade: **4**
Clock Start/From: **5**
Clock To:
1st Value:
2nd Value:
Value Percent: **15.000**
Continuous Index:
Within 8" of Joint: **NO**
Remarks:

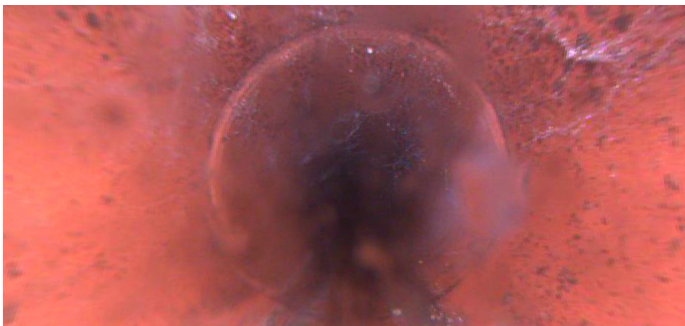
Code: **RFJ**
Description: **Roots Fine Joint**

Distance (ft): **54.9**
Structural Grade: **0**
O&M Grade: **1**
Clock Start/From: **7**
Clock To: **5**
1st Value:
2nd Value:
Value Percent:
Continuous Index:
Within 8" of Joint: **YES**
Remarks:

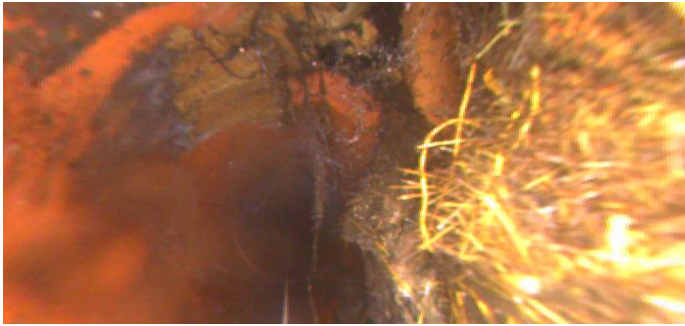
Code: **TFD**
Description: **Tap Factory Defective**

Distance (ft): **120.9**
Structural Grade: **0**
O&M Grade: **2**
Clock Start/From: **1**
Clock To:
1st Value: **4.000**
2nd Value:
Value Percent:
Continuous Index:
Within 8" of Joint:
Remarks: **root infiltration**

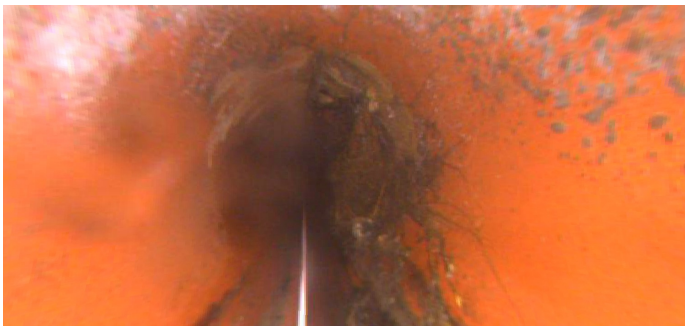
Code: **RMB**
Description: **Roots Medium Barrel**

Distance (ft): **122.5**
Structural Grade: **0**
O&M Grade: **4**
Clock Start/From: **12**
Clock To: **5**
1st Value:
2nd Value:
Value Percent: **40.000**
Continuous Index:
Within 8" of Joint: **NO**
Remarks:

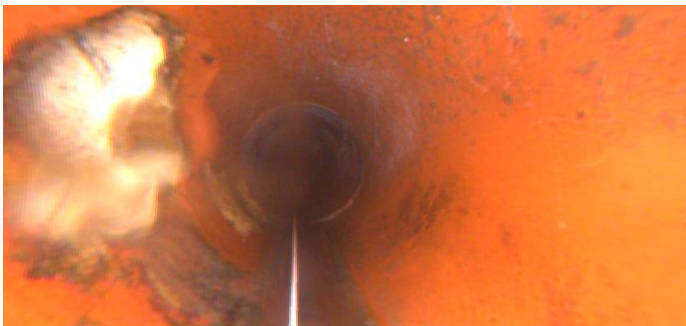
Code: **FL**
Description: **Fracture Longitudinal**

Distance (ft): **143.2**
Structural Grade: **3**
O&M Grade: **0**
Clock Start/From: **9**
Clock To:
1st Value:
2nd Value:
Value Percent:
Continuous Index:
Within 8" of Joint: **YES**
Remarks:

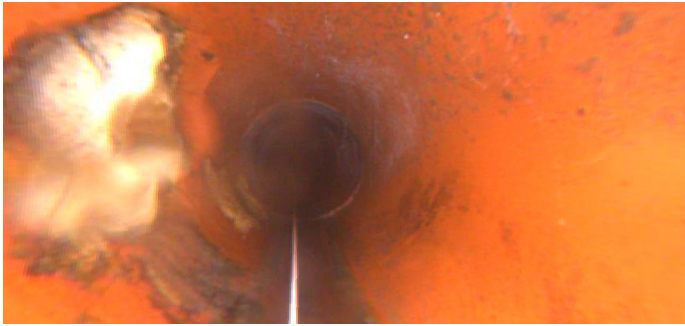
Code: **DAE**
Description: **Deposits Attached Encrustation**

Distance (ft): **143.2**
Structural Grade: **0**
O&M Grade: **3**
Clock Start/From: **6**
Clock To: **9**
1st Value:
2nd Value:
Value Percent: **20.000**
Continuous Index:
Within 8" of Joint:
Remarks:
