## Profile/Photo Observation Report

Date:	<b>09/25/2018</b>	Weather:		Coding:	<b>PACP 6.0</b>
Pipe Length (ft):	<b>91.2</b>	Owner:	<b>NA</b>	Pre Clean:	<b>Not Known</b>
P.O.#:		Surveyor:	<b>Selasie Honu</b>	PSR:	<b>P-203-069-029</b>
Customer:		Clean Date:	<b>01/01/1900</b>	Shape:	<b>C</b>

Street:	<b>ALLEY BETWEEN SHERMAN ST &amp; MO</b>	Flow Control:	<b>Not Controlled</b>
City:	<b>Hobart, IN</b>	Year Renewed:	
Location:	<b>Light Highway</b>	Tape/Media #:	
Purpose:	<b>Routine Assessment</b>	Dia/Height:	<b>10"</b>
Use:	<b>Sanitary</b>	Material:	<b>VCP</b>
Drain Area:	<b>NA</b>	Lining:	
Category:	<b>NA</b>		
Comment:

Location Details:		Direction of Survey:	<b>Upstream</b>
US MH:	<b>M-203-029</b>	DS MH:	<b>M-203-069</b>
		Total Length Surveyed (ft):	<b>83.9</b>

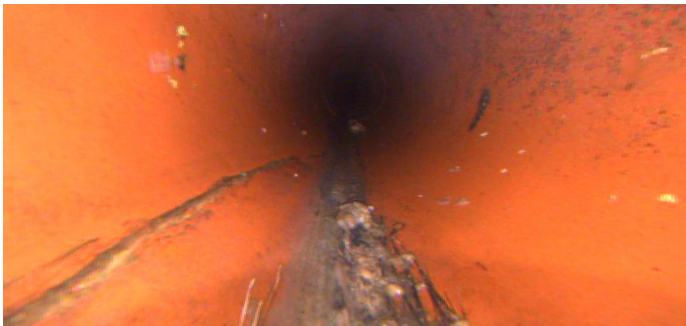
Code:	<b>FL</b>
Description:	<b>Fracture Longitudinal</b>

Distance (ft):	<b>.0</b>
Structural Grade:	<b>3</b>
O&M Grade:	<b>0</b>
Clock Start/From:	<b>8</b>
Clock To:	
1st Value:	
2nd Value:	
Value Percent:	
Continuous Index:	
Within 8" of Joint:	
Remarks:

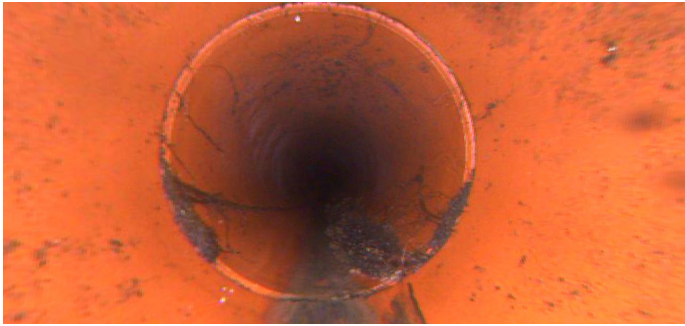
Code: **RFJ**  
Description: **Roots Fine Joint**

Distance (ft): **4.3**  
Structural Grade: **0**  
O&M Grade: **1**  
Clock Start/From: **8**  
Clock To: **5**  
1st Value:  
2nd Value:  
Value Percent:  
Continuous Index:  
Within 8" of Joint: **YES**  
Remarks:

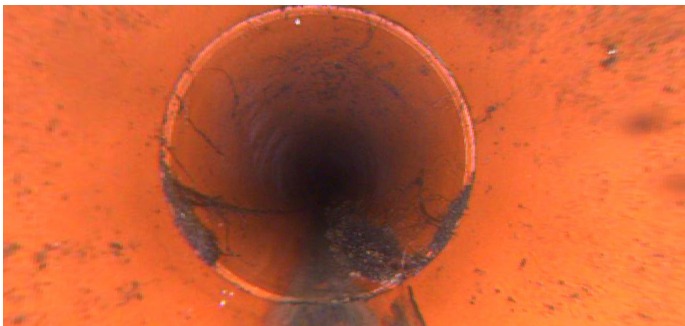
Code: **RFB**  
Description: **Roots Fine Barrel**

Distance (ft): **4.3**  
Structural Grade: **0**  
O&M Grade: **2**  
Clock Start/From: **8**  
Clock To: **5**  
1st Value:  
2nd Value:  
Value Percent:  
Continuous Index:  
Within 8" of Joint: **NO**  
Remarks:

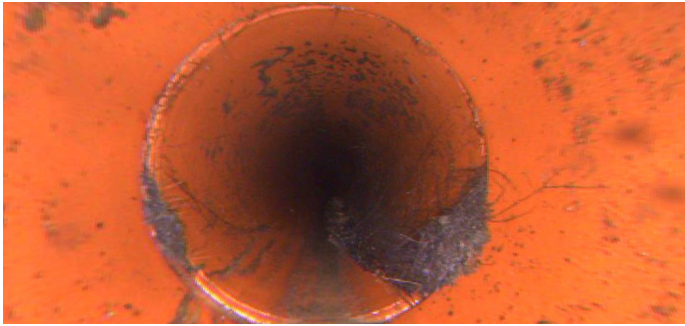
Code: **RFJ**  
Description: **Roots Fine Joint**

Distance (ft): **14.3**  
Structural Grade: **0**  
O&M Grade: **1**  
Clock Start/From: **8**  
Clock To: **4**  
1st Value:  
2nd Value:  
Value Percent:  
Continuous Index:  
Within 8" of Joint: **YES**  
Remarks:

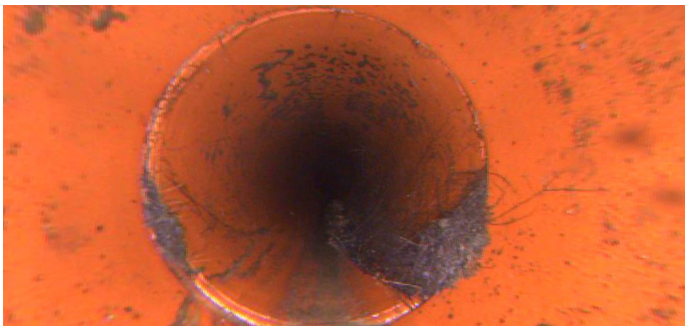
Code: **RFB**  
Description: **Roots Fine Barrel**

Distance (ft): **14.3**  
Structural Grade: **0**  
O&M Grade: **2**  
Clock Start/From: **8**  
Clock To: **5**  
1st Value:  
2nd Value:  
Value Percent:  
Continuous Index:  
Within 8" of Joint: **NO**  
Remarks:

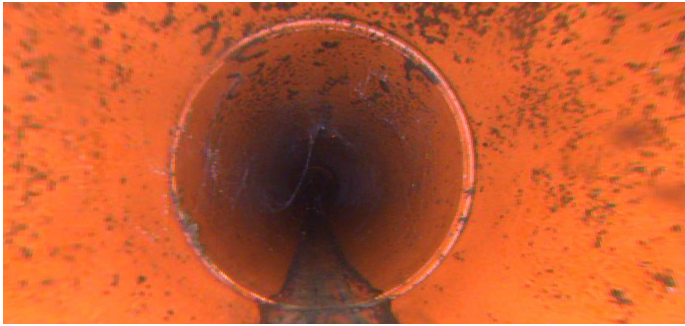
Code: **RFJ**  
Description: **Roots Fine Joint**

Distance (ft): **19.4**  
Structural Grade: **0**  
O&M Grade: **1**  
Clock Start/From: **8**  
Clock To: **4**  
1st Value:  
2nd Value:  
Value Percent:  
Continuous Index:  
Within 8" of Joint: **YES**  
Remarks:

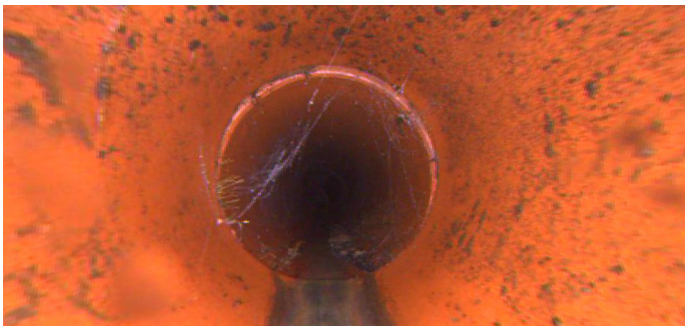
Code: **RFJ**  
Description: **Roots Fine Joint**

Distance (ft): **24.1**  
Structural Grade: **0**  
O&M Grade: **1**  
Clock Start/From: **7**  
Clock To: **5**  
1st Value:  
2nd Value:  
Value Percent:  
Continuous Index:  
Within 8" of Joint: **YES**  
Remarks:

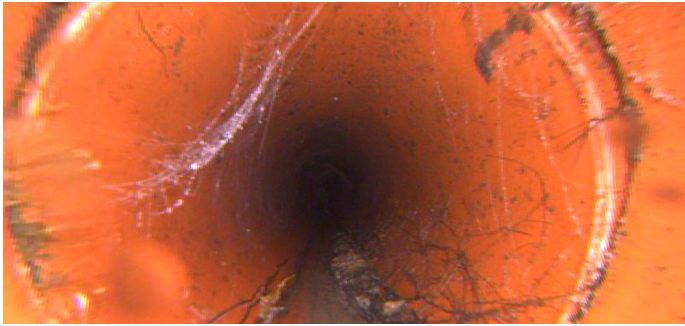
Code: **RFB**  
Description: **Roots Fine Barrel**

Distance (ft): **24.8**  
Structural Grade: **0**  
O&M Grade: **2**  
Clock Start/From: **7**  
Clock To: **5**  
1st Value:  
2nd Value:  
Value Percent:  
Continuous Index:  
Within 8" of Joint: **NO**  
Remarks:

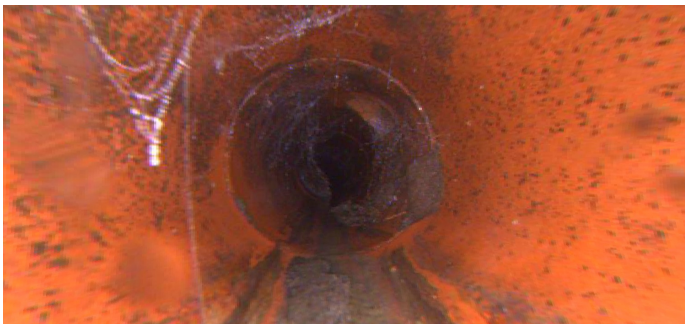
Code: **TFD**  
Description: **Tap Factory Defective**

Distance (ft): **29.1**  
Structural Grade: **0**  
O&M Grade: **2**  
Clock Start/From: **1**  
Clock To:  
1st Value: **4.000**  
2nd Value:  
Value Percent:  
Continuous Index:  
Within 8" of Joint:  
Remarks: **root infiltration**

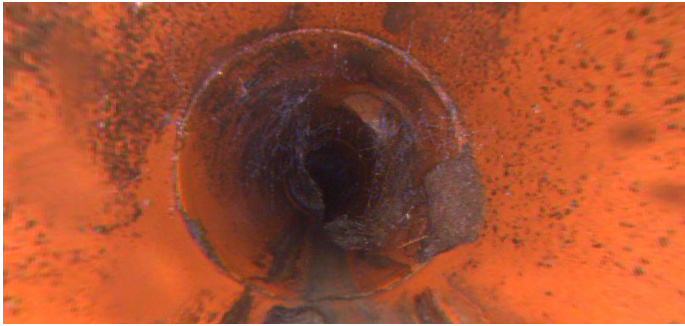
Code: **RFJ**  
Description: **Roots Fine Joint**

Distance (ft): **29.4**  
Structural Grade: **0**  
O&M Grade: **1**  
Clock Start/From: **7**  
Clock To: **5**  
1st Value:  
2nd Value:  
Value Percent:  
Continuous Index:  
Within 8" of Joint: **YES**  
Remarks:

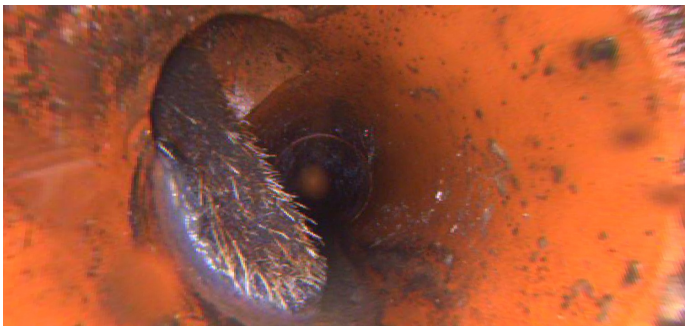
Code: **TFD**  
Description: **Tap Factory Defective**

Distance (ft): **31.8**  
Structural Grade: **0**  
O&M Grade: **2**  
Clock Start/From: **11**  
Clock To:  
1st Value: **4.000**  
2nd Value:  
Value Percent:  
Continuous Index:  
Within 8" of Joint:  
Remarks: **root infiltration**

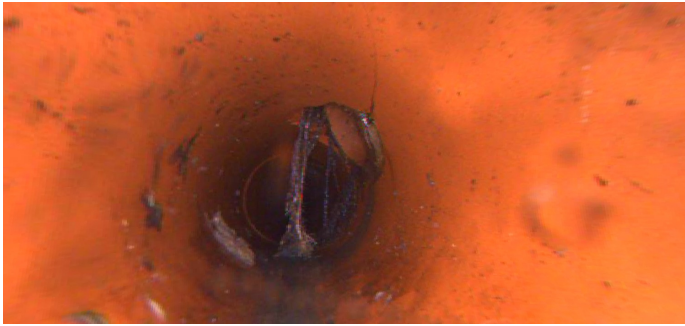
Code: **FL**  
Description: **Fracture Longitudinal**

Distance (ft): **41.7**  
Structural Grade: **3**  
O&M Grade: **0**  
Clock Start/From: **1**  
Clock To:  
1st Value:  
2nd Value:  
Value Percent:  
Continuous Index:  
Within 8" of Joint:  
Remarks:

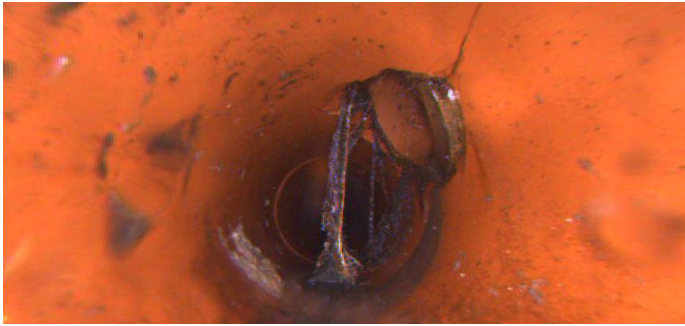
Code: **RFB**  
Description: **Roots Fine Barrel**

Distance (ft): **42.1**  
Structural Grade: **0**  
O&M Grade: **2**  
Clock Start/From: **12**  
Clock To: **6**  
1st Value:  
2nd Value:  
Value Percent:  
Continuous Index:  
Within 8" of Joint: **NO**  
Remarks:

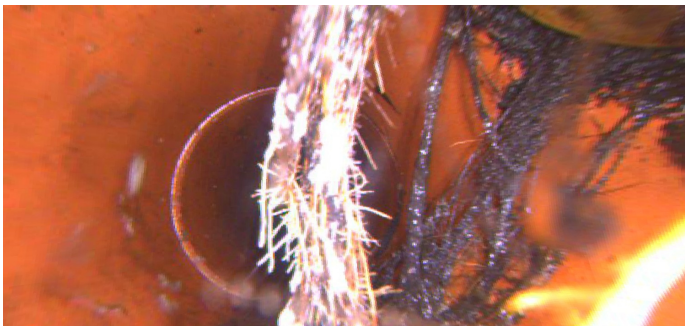
Code: **RFJ**  
Description: **Roots Fine Joint**

Distance (ft): **43.1**  
Structural Grade: **0**  
O&M Grade: **1**  
Clock Start/From: **7**  
Clock To: **5**  
1st Value:  
2nd Value:  
Value Percent:  
Continuous Index:  
Within 8" of Joint: **YES**  
Remarks:

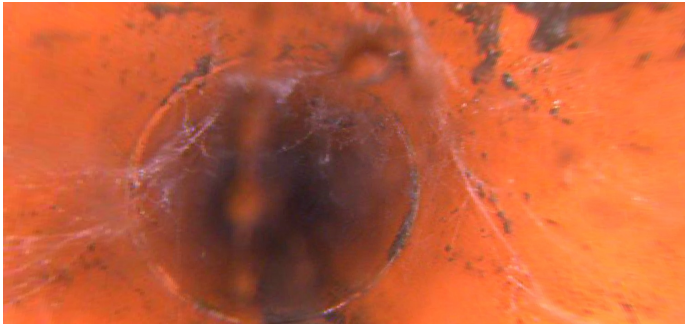
Code: **RFJ**  
Description: **Roots Fine Joint**

Distance (ft): **58.4**  
Structural Grade: **0**  
O&M Grade: **1**  
Clock Start/From: **7**  
Clock To: **5**  
1st Value:  
2nd Value:  
Value Percent:  
Continuous Index:  
Within 8" of Joint: **YES**  
Remarks:

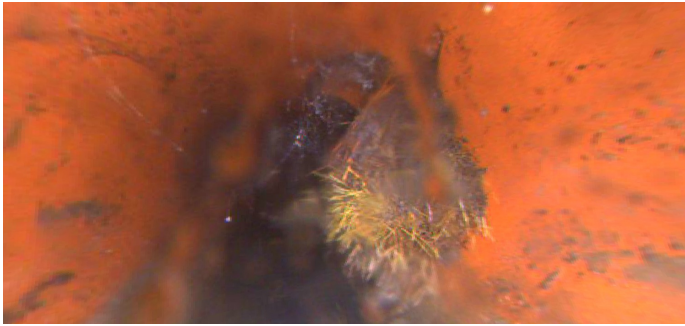
Code: **FC**  
Description: **Fracture Circumferential**

Distance (ft): **79.3**  
Structural Grade: **2**  
O&M Grade: **0**  
Clock Start/From: **1**  
Clock To: **5**  
1st Value:  
2nd Value:  
Value Percent:  
Continuous Index:  
Within 8" of Joint:  
Remarks:

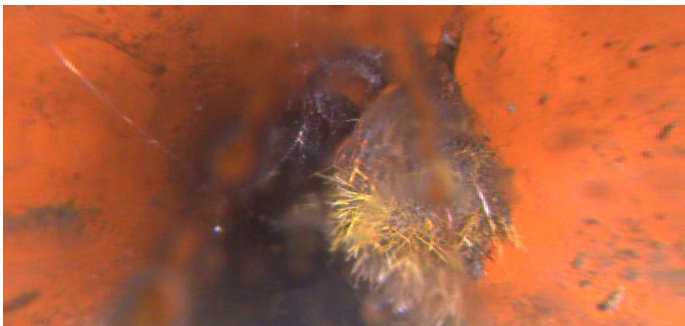
Code: **RMB**  
Description: **Roots Medium Barrel**

Distance (ft): **79.4**  
Structural Grade: **0**  
O&M Grade: **4**  
Clock Start/From: **1**  
Clock To: **5**  
1st Value:  
2nd Value:  
Value Percent: **30.000**  
Continuous Index:  
Within 8" of Joint: **NO**  
Remarks:

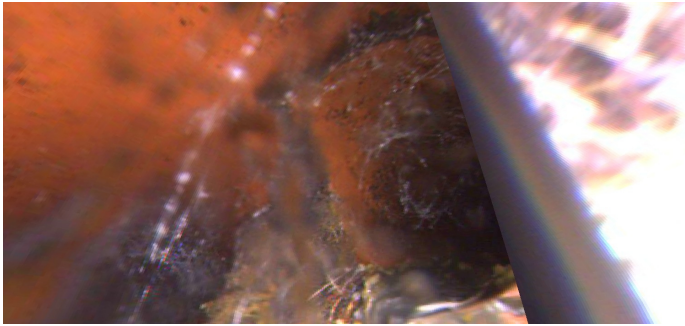
Code: **TFD**  
Description: **Tap Factory Defective**

Distance (ft): **80.0**  
Structural Grade: **0**  
O&M Grade: **2**  
Clock Start/From: **1**  
Clock To:  
1st Value: **4.000**  
2nd Value:  
Value Percent:  
Continuous Index:  
Within 8" of Joint:  
Remarks: **root infiltraiton**

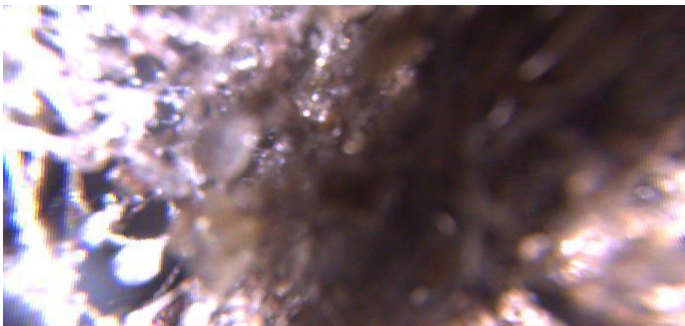
Code: **MSA**  
Description: **Abandoned Survey**

Distance (ft): **83.9**  
Structural Grade: **0**  
O&M Grade: **0**  
Clock Start/From:  
Clock To:  
1st Value:  
2nd Value:  
Value Percent:  
Continuous Index:  
Within 8" of Joint: **NO**  
Remarks: **root infiltration**
