Profile/Photo Observation Report

Street:	39th. Ave.	Flow Control:	Not Controlled
City:	Hobart, IN	Year Renewed:	
Location:	Light Highway	Tape/Media #:	
Purpose:	Routine Assessment	Dia/Height:	10"
Use:	Sanitary	Material:	VCP
Drain Area:	NA	Lining:	
Category:	NA		
Comment:

Location Details:		Direction of Survey:	Upstream
US MH:	M-203-029	DS MH:	M-203-069
		Total Length Surveyed (ft):	83.9

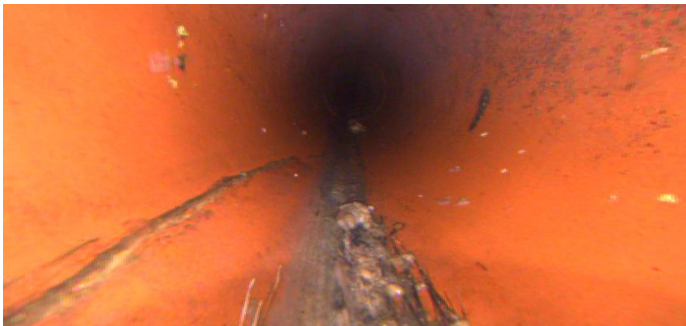
Code:	FL
Description:	Fracture Longitudinal

Distance (ft):	.0
Structural Grade:	3
O&M Grade:	0
Clock Start/From:	8
Clock To:	
1st Value:	
2nd Value:	
Value Percent:	
Continuous Index:	
Within 8" of Joint:	
Remarks:

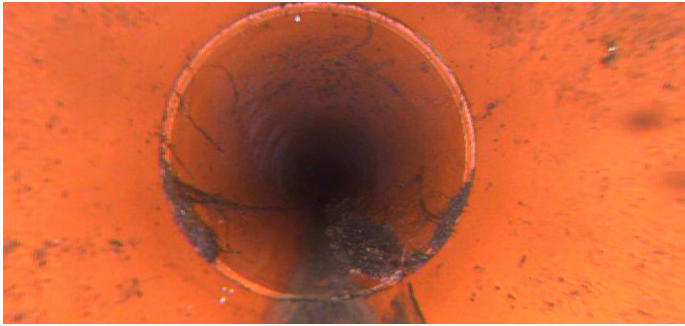
Code: **RFJ**
Description: **Roots Fine Joint**

Distance (ft): **4.3**
Structural Grade: **0**
O&M Grade: **1**
Clock Start/From: **8**
Clock To: **5**
1st Value:
2nd Value:
Value Percent:
Continuous Index:
Within 8" of Joint: **YES**
Remarks:

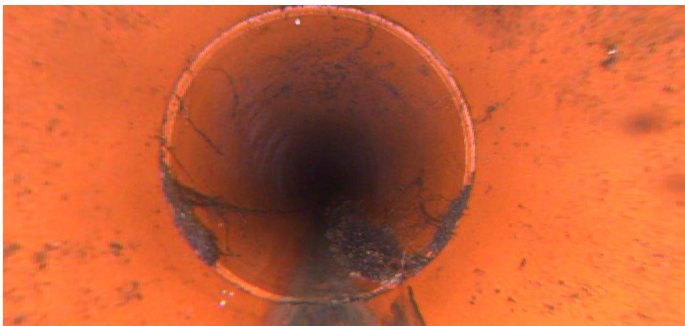
Code: **RFB**
Description: **Roots Fine Barrel**

Distance (ft): **4.3**
Structural Grade: **0**
O&M Grade: **2**
Clock Start/From: **8**
Clock To: **5**
1st Value:
2nd Value:
Value Percent:
Continuous Index:
Within 8" of Joint: **NO**
Remarks:

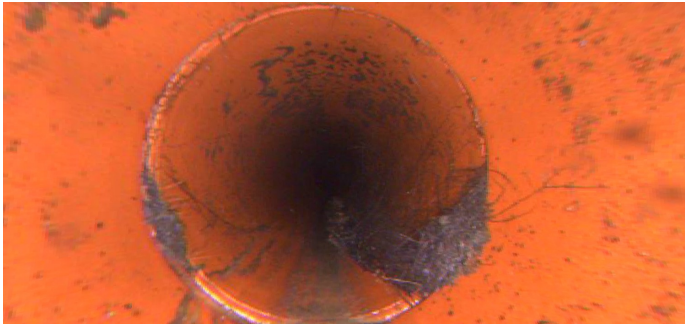
Code: **RFJ**
Description: **Roots Fine Joint**

Distance (ft): **14.3**
Structural Grade: **0**
O&M Grade: **1**
Clock Start/From: **8**
Clock To: **4**
1st Value:
2nd Value:
Value Percent:
Continuous Index:
Within 8" of Joint: **YES**
Remarks:

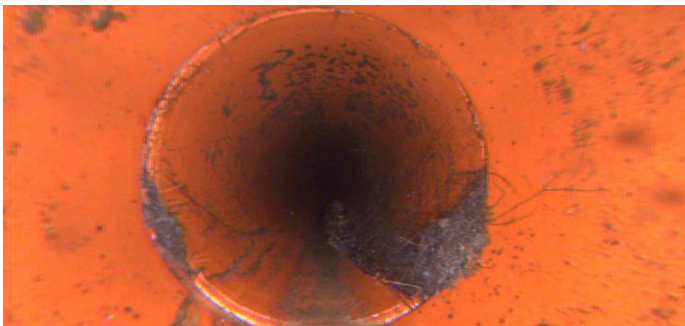
Code: **RFB**
Description: **Roots Fine Barrel**

Distance (ft): **14.3**
Structural Grade: **0**
O&M Grade: **2**
Clock Start/From: **8**
Clock To: **5**
1st Value:
2nd Value:
Value Percent:
Continuous Index:
Within 8" of Joint: **NO**
Remarks:

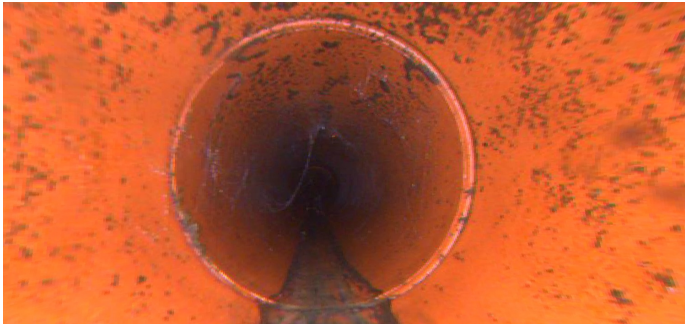
Code: **RFJ**
Description: **Roots Fine Joint**

Distance (ft): **19.4**
Structural Grade: **0**
O&M Grade: **1**
Clock Start/From: **8**
Clock To: **4**
1st Value:
2nd Value:
Value Percent:
Continuous Index:
Within 8" of Joint: **YES**
Remarks:

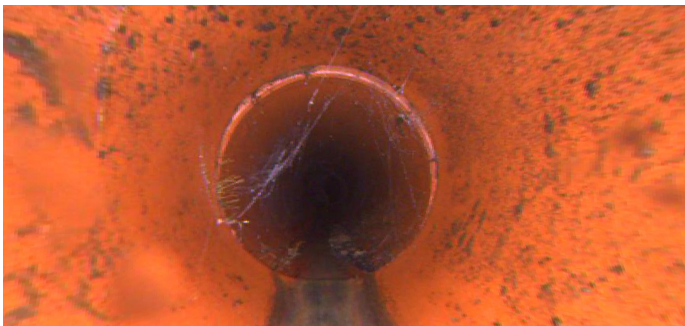
Code: **RFJ**
Description: **Roots Fine Joint**

Distance (ft): **24.1**
Structural Grade: **0**
O&M Grade: **1**
Clock Start/From: **7**
Clock To: **5**
1st Value:
2nd Value:
Value Percent:
Continuous Index:
Within 8" of Joint: **YES**
Remarks:

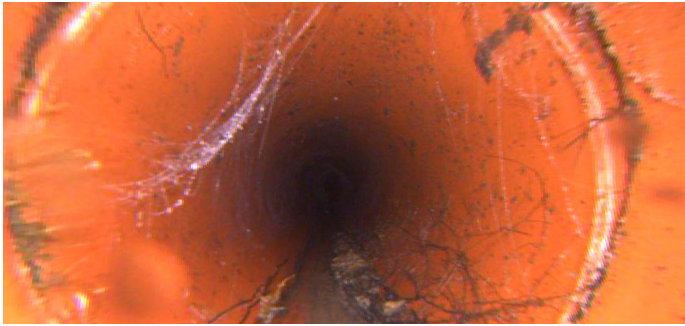
Code: **RFB**
Description: **Roots Fine Barrel**

Distance (ft): **24.8**
Structural Grade: **0**
O&M Grade: **2**
Clock Start/From: **7**
Clock To: **5**
1st Value:
2nd Value:
Value Percent:
Continuous Index:
Within 8" of Joint: **NO**
Remarks:

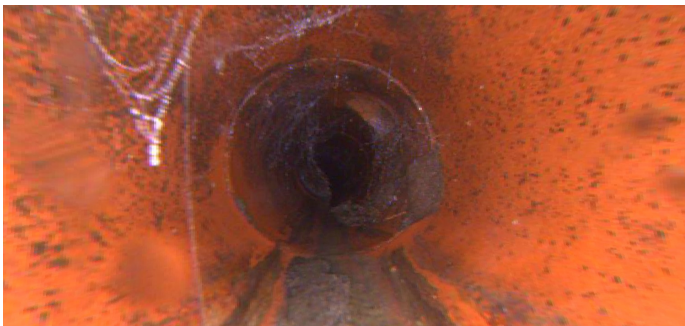
Code: **TFD**
Description: **Tap Factory Defective**

Distance (ft): **29.1**
Structural Grade: **0**
O&M Grade: **2**
Clock Start/From: **1**
Clock To:
1st Value: **4.000**
2nd Value:
Value Percent:
Continuous Index:
Within 8" of Joint:
Remarks: **root infiltration**

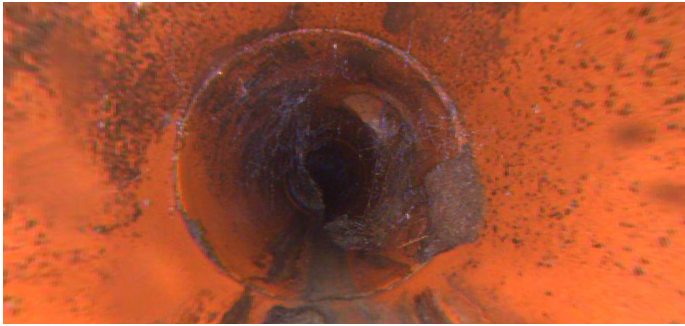
Code: **RFJ**
Description: **Roots Fine Joint**

Distance (ft): **29.4**
Structural Grade: **0**
O&M Grade: **1**
Clock Start/From: **7**
Clock To: **5**
1st Value:
2nd Value:
Value Percent:
Continuous Index:
Within 8" of Joint: **YES**
Remarks:

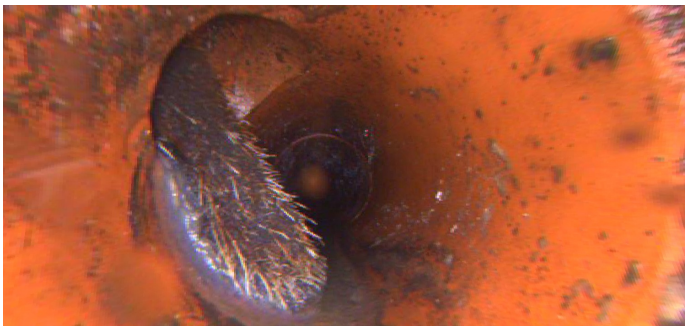
Code: **TFD**
Description: **Tap Factory Defective**

Distance (ft): **31.8**
Structural Grade: **0**
O&M Grade: **2**
Clock Start/From: **11**
Clock To:
1st Value: **4.000**
2nd Value:
Value Percent:
Continuous Index:
Within 8" of Joint:
Remarks: **root infiltration**

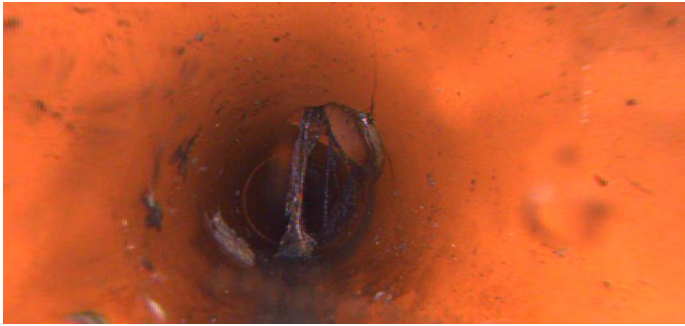
Code: **FL**
Description: **Fracture Longitudinal**

Distance (ft): **41.7**
Structural Grade: **3**
O&M Grade: **0**
Clock Start/From: **1**
Clock To:
1st Value:
2nd Value:
Value Percent:
Continuous Index:
Within 8" of Joint:
Remarks:

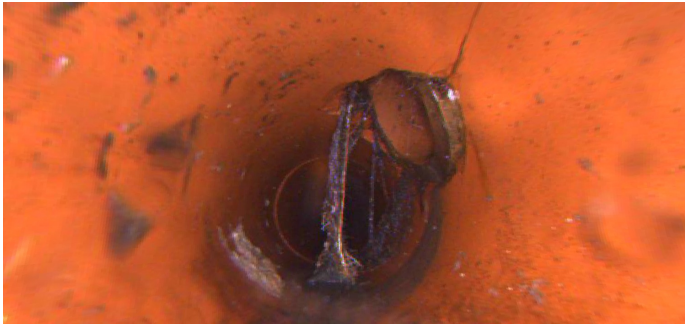
Code: **RFB**
Description: **Roots Fine Barrel**

Distance (ft): **42.1**
Structural Grade: **0**
O&M Grade: **2**
Clock Start/From: **12**
Clock To: **6**
1st Value:
2nd Value:
Value Percent:
Continuous Index:
Within 8" of Joint: **NO**
Remarks:

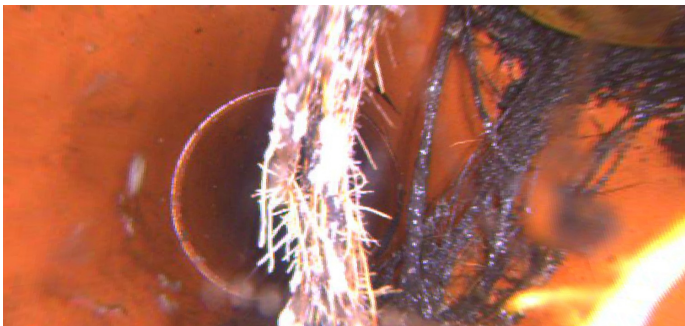
Code: **RFJ**
Description: **Roots Fine Joint**

Distance (ft): **43.1**
Structural Grade: **0**
O&M Grade: **1**
Clock Start/From: **7**
Clock To: **5**
1st Value:
2nd Value:
Value Percent:
Continuous Index:
Within 8" of Joint: **YES**
Remarks:

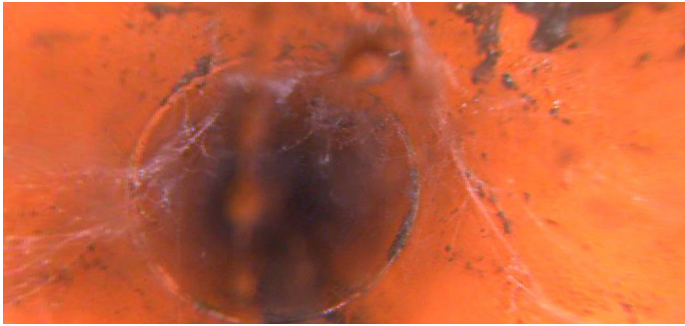
Code: **RFJ**
Description: **Roots Fine Joint**

Distance (ft): **58.4**
Structural Grade: **0**
O&M Grade: **1**
Clock Start/From: **7**
Clock To: **5**
1st Value:
2nd Value:
Value Percent:
Continuous Index:
Within 8" of Joint: **YES**
Remarks:

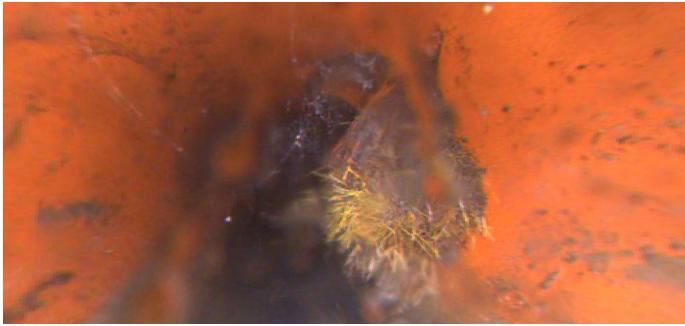
Code: **FC**
Description: **Fracture Circumferential**

Distance (ft): **79.3**
Structural Grade: **2**
O&M Grade: **0**
Clock Start/From: **1**
Clock To: **5**
1st Value:
2nd Value:
Value Percent:
Continuous Index:
Within 8" of Joint:
Remarks:

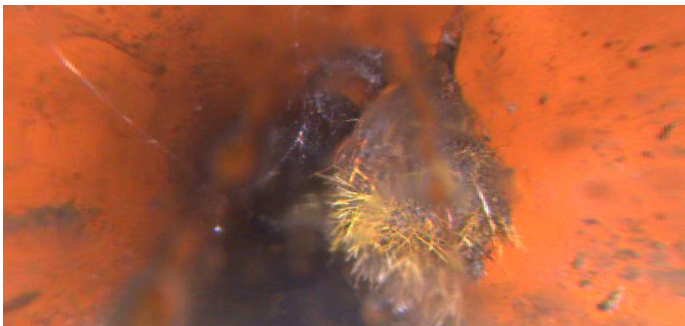
Code: **RMB**
Description: **Roots Medium Barrel**

Distance (ft): **79.4**
Structural Grade: **0**
O&M Grade: **4**
Clock Start/From: **1**
Clock To: **5**
1st Value:
2nd Value:
Value Percent: **30.000**
Continuous Index:
Within 8" of Joint: **NO**
Remarks:

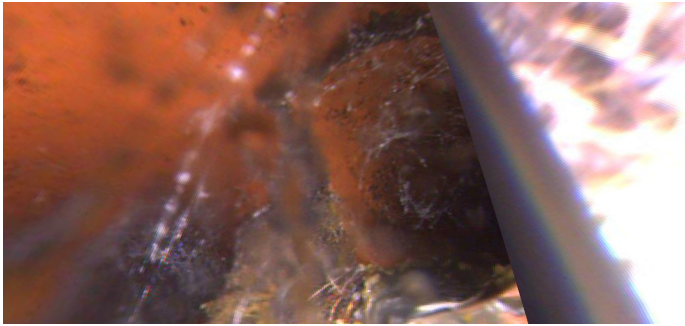
Code: **TFD**
Description: **Tap Factory Defective**

Distance (ft): **80.0**
Structural Grade: **0**
O&M Grade: **2**
Clock Start/From: **1**
Clock To:
1st Value: **4.000**
2nd Value:
Value Percent:
Continuous Index:
Within 8" of Joint:
Remarks: **root infiltraiton**

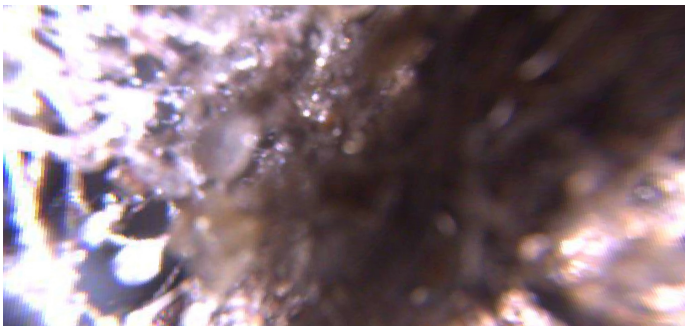
Code: **MSA**
Description: **Abandoned Survey**

Distance (ft): **83.9**
Structural Grade: **0**
O&M Grade: **0**
Clock Start/From:
Clock To:
1st Value:
2nd Value:
Value Percent:
Continuous Index:
Within 8" of Joint: **NO**
Remarks: **root infiltration**
