Profile/Photo Observation Report

Date:	10/18/2021	Weather:		Coding:	PACP 6.0
Pipe Length (ft):		Owner:	Hobart, IN	Pre Clean:	Not Known
P.O.#:	872_1	Surveyor:	M. Pielacha	PSR:	P-203-030-027
Customer:	Hobart, IN	Clean Date:		Shape:	C

Street:	38th Avenue	Flow Control:	
City:	Hobart, IN	Year Renewed:	
Location:	Alley	Tape/Media #:	872
Purpose:	Routine Assessment	Dia/Height:	10"
Use:	Sanitary	Material:	VCP
Drain Area:		Lining:	
Category:	NA		
Comment:

Location Details:		Direction of Survey:	Upstream
US MH:	M-203-30	DS MH:	M-203-27
		Total Length Surveyed (ft):	155.5

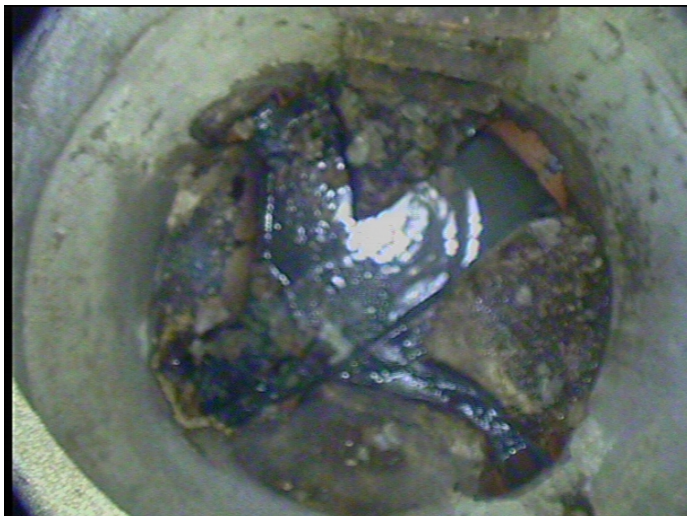
Code: **AMH**
 Description: **Manhole**

Distance (ft): **.0**
 Structural Grade: **0**
 O&M Grade: **0**
 Clock Start/From:
 Clock To:
 1st Value:
 2nd Value:
 Value Percent:
 Continuous Index:
 Within 8" of Joint: **NO**
 Remarks: **M-203-27**

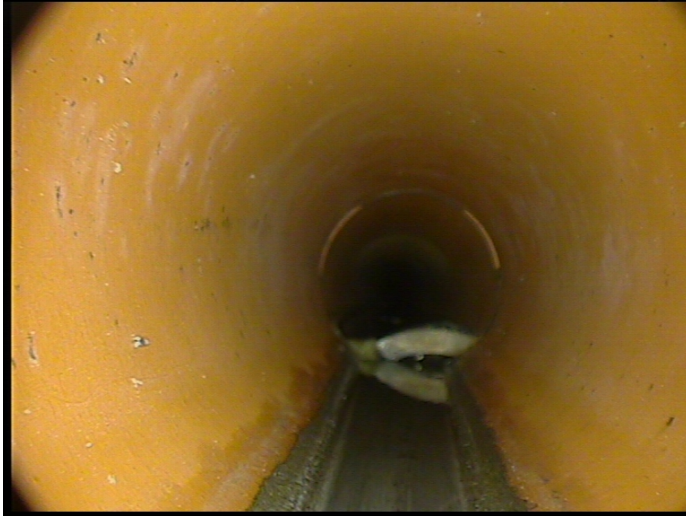
Code:	MWL
Description:	Water Level
Distance (ft):	.0
Structural Grade:	0
O&M Grade:	0
Clock Start/From:	
Clock To:	
1st Value:	
2nd Value:	
Value Percent:	5.000
Continuous Index:	
Within 8" of Joint:	NO
Remarks:

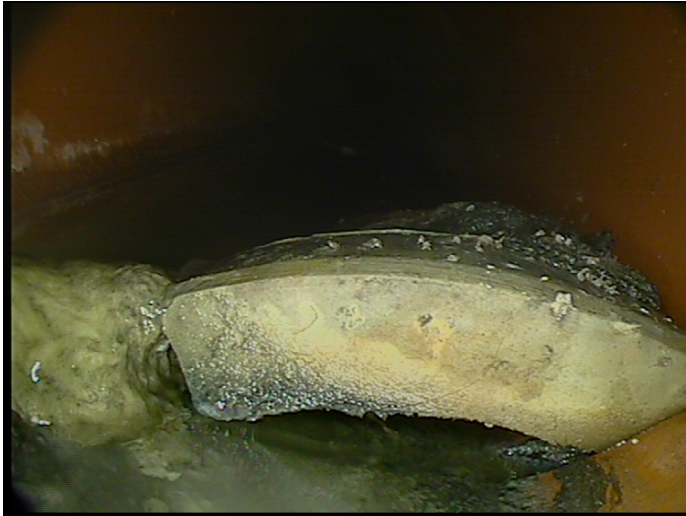
Code:	OBM
Description:	Obstacle Pipe Material
Distance (ft):	6.1
Structural Grade:	0
O&M Grade:	2
Clock Start/From:	5
Clock To:	7
1st Value:	
2nd Value:	
Value Percent:	10.000
Continuous Index:	
Within 8" of Joint:	NO
Remarks:

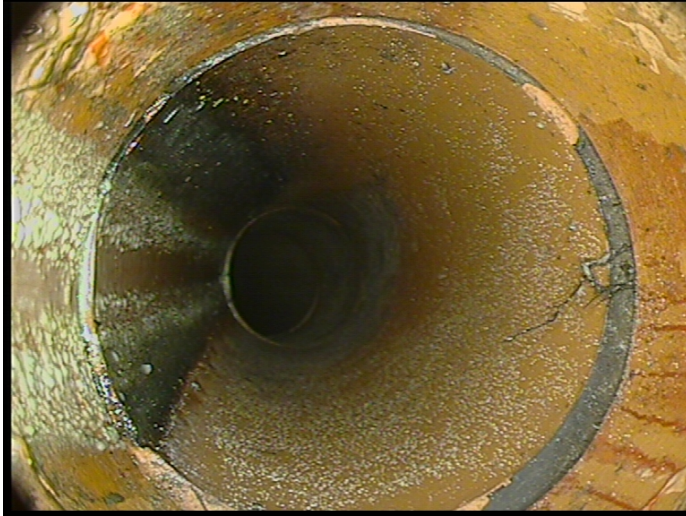
Code: **TF**
Description: **Tap Factory**

Distance (ft): **33.3**
Structural Grade: **0**
O&M Grade: **0**
Clock Start/From: **10**
Clock To:
1st Value: **4.000**
2nd Value:
Value Percent:
Continuous Index:
Within 8" of Joint: **NO**
Remarks:

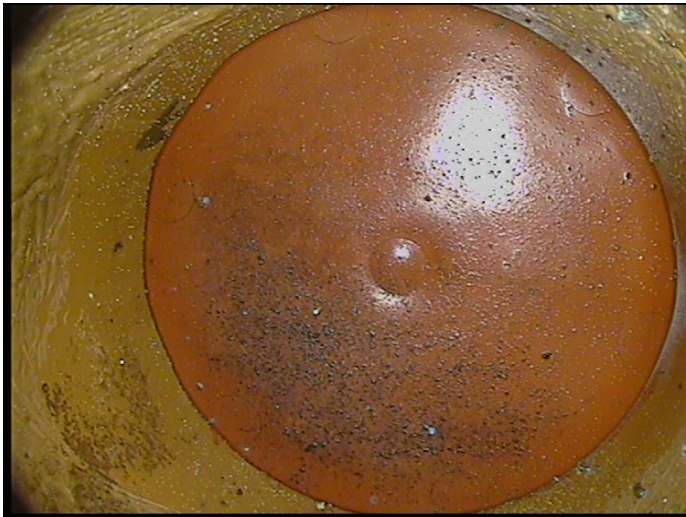
Code: **TFC**
Description: **Tap Factory Capped**

Distance (ft): **68.3**
Structural Grade: **0**
O&M Grade: **0**
Clock Start/From: **2**
Clock To:
1st Value: **4.000**
2nd Value:
Value Percent:
Continuous Index:
Within 8" of Joint: **NO**
Remarks:

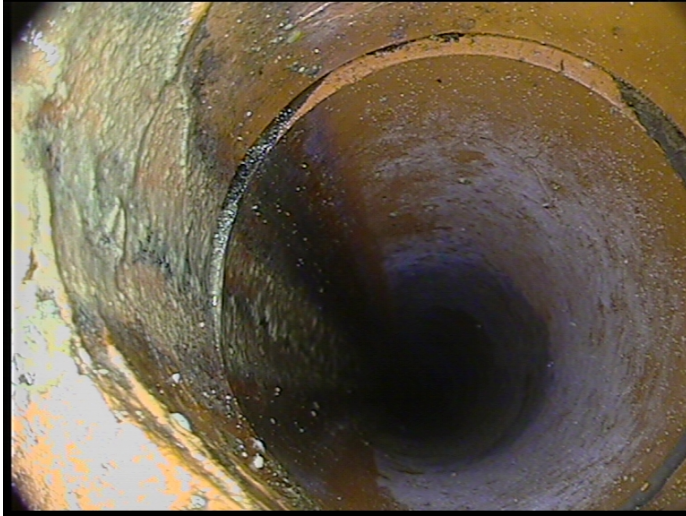
Code: **TF**
Description: **Tap Factory**

Distance (ft): **85.8**
Structural Grade: **0**
O&M Grade: **0**
Clock Start/From: **9**
Clock To:
1st Value: **4.000**
2nd Value:
Value Percent:
Continuous Index:
Within 8" of Joint: **NO**
Remarks:

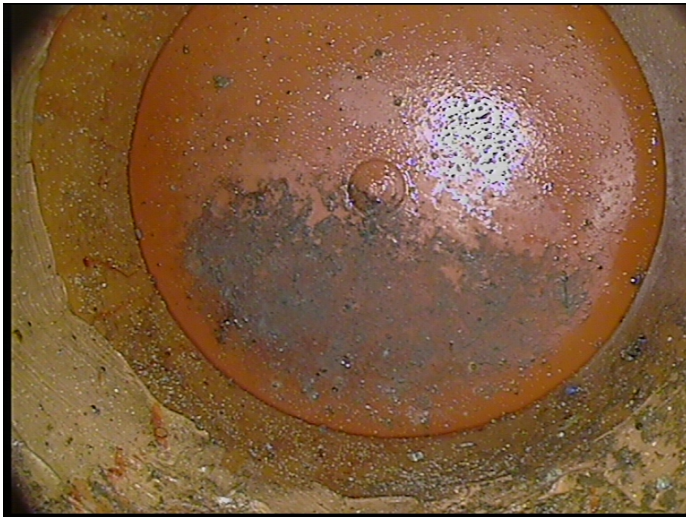
Code: **TFC**
Description: **Tap Factory Capped**

Distance (ft): **116.1**
Structural Grade: **0**
O&M Grade: **0**
Clock Start/From: **2**
Clock To:
1st Value: **4.000**
2nd Value:
Value Percent:
Continuous Index:
Within 8" of Joint: **NO**
Remarks:

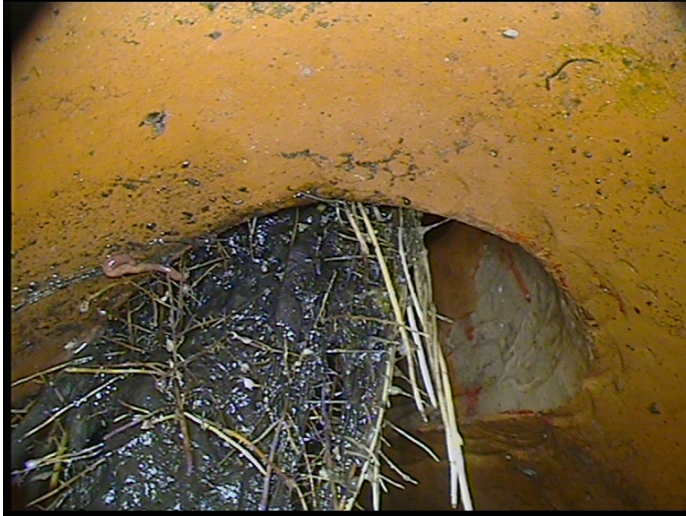
Code: **TFD**
Description: **Tap Factory Defective**

Distance (ft): **123.9**
Structural Grade: **0**
O&M Grade: **2**
Clock Start/From: **11**
Clock To:
1st Value: **4.000**
2nd Value:
Value Percent:
Continuous Index:
Within 8" of Joint: **NO**
Remarks: **roots**

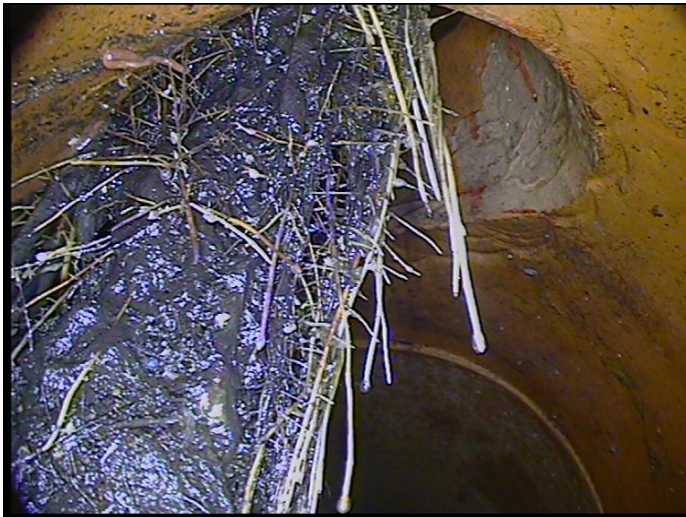
Code: **RML**
Description: **Roots Medium Lateral**

Distance (ft): **123.9**
Structural Grade: **0**
O&M Grade: **3**
Clock Start/From: **7**
Clock To: **11**
1st Value:
2nd Value:
Value Percent: **15.000**
Continuous Index:
Within 8" of Joint: **NO**
Remarks:

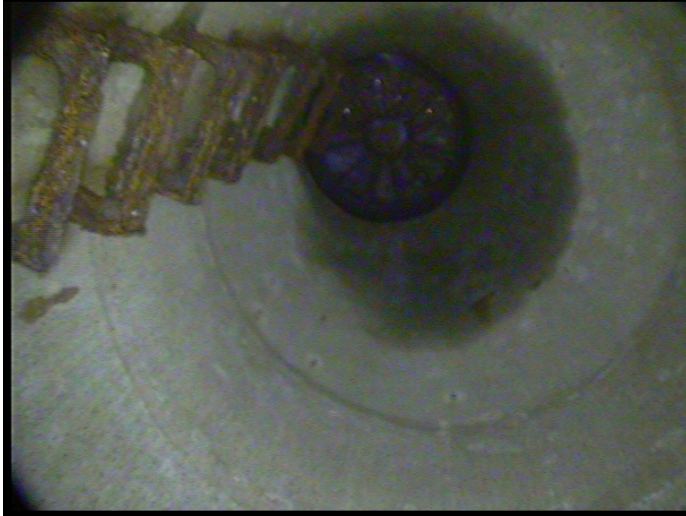
Code:	AMH
Description:	Manhole
Distance (ft):	155.5
Structural Grade:	0
O&M Grade:	0
Clock Start/From:	
Clock To:	
1st Value:	
2nd Value:	
Value Percent:	
Continuous Index:	
Within 8" of Joint:	NO
Remarks:	M-203-30
