Profile/Photo Observation Report

Street:	ALLEY BETWEEN BARNES ST & MON	Flow Control:	Not Controlled
City:	Hobart, IN	Year Renewed:	
Location:	Other	Tape/Media #:	
Purpose:	Not Known	Dia/Height:	8"
Use:	Sanitary	Material:	VCP
Drain Area:	NA	Lining:	
Category:	NA		
Comment:

Location Details:		Direction of Survey:	Downstream
US MH:	M-203-031	DS MH:	M-203-032
		Total Length Surveyed (ft):	35.2

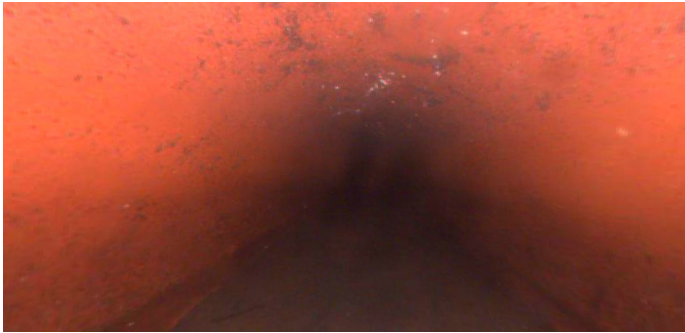
Code:	MWL
Description:	Water Level

Distance (ft):	.0
Structural Grade:	0
O&M Grade:	0
Clock Start/From:	
Clock To:	
1st Value:	
2nd Value:	
Value Percent:	5.000
Continuous Index:	
Within 8" of Joint:	NO
Remarks:

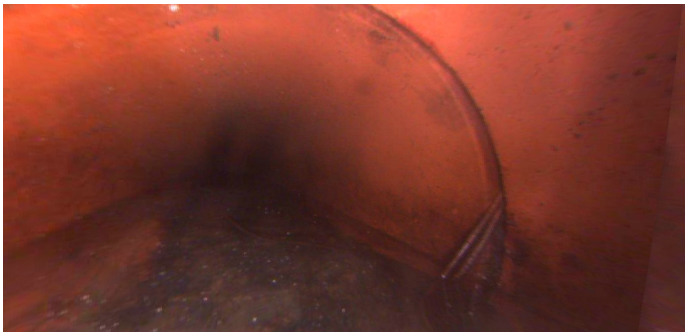
Code:	RFJ
Description:	Roots Fine Joint

Distance (ft):	19.6
Structural Grade:	0
O&M Grade:	1
Clock Start/From:	3
Clock To:	
1st Value:	
2nd Value:	
Value Percent:	
Continuous Index:	
Within 8" of Joint:	YES
Remarks:

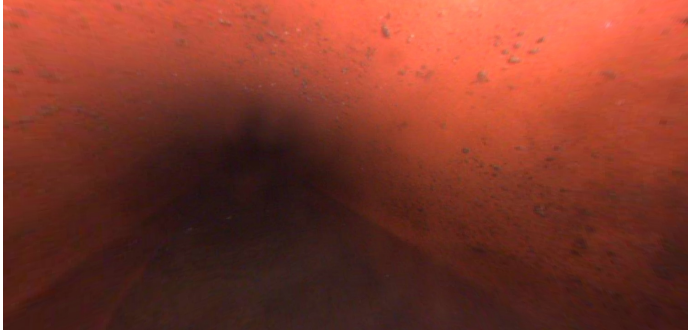
Code:	MSA
Description:	Abandoned Survey
Distance (ft):	35.2
Structural Grade:	0
O&M Grade:	0
Clock Start/From:	
Clock To:	
1st Value:	
2nd Value:	
Value Percent:	
Continuous Index:	
Within 8" of Joint:	NO
Remarks:	camera stopped/no blockage
