## Profile/Photo Observation Report

Street:	<b>E 38th Ave</b>	Flow Control:	<b>Not Controlled</b>
City:	<b>Hobart, IN</b>	Year Renewed:	
Location:	<b>Other</b>	Tape/Media #:	
Purpose:	<b>Not Known</b>	Dia/Height:	<b>8"</b>
Use:	<b>Sanitary</b>	Material:	<b>VCP</b>
Drain Area:	<b>NA</b>	Lining:	
Category:	<b>NA</b>		
Comment:

Location Details:		Direction of Survey:	<b>Downstream</b>
US MH:	<b>M-203-031</b>	DS MH:	<b>M-203-032</b>
		Total Length Surveyed (ft):	<b>35.2</b>

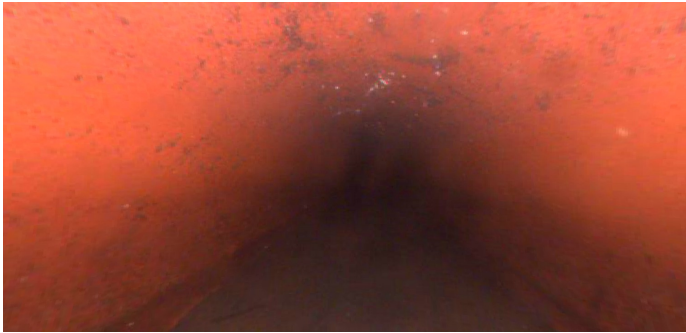
Code:	<b>MWL</b>
Description:	<b>Water Level</b>

Distance (ft):	<b>.0</b>
Structural Grade:	<b>0</b>
O&M Grade:	<b>0</b>
Clock Start/From:	
Clock To:	
1st Value:	
2nd Value:	
Value Percent:	<b>5.000</b>
Continuous Index:	
Within 8" of Joint:	<b>NO</b>
Remarks:

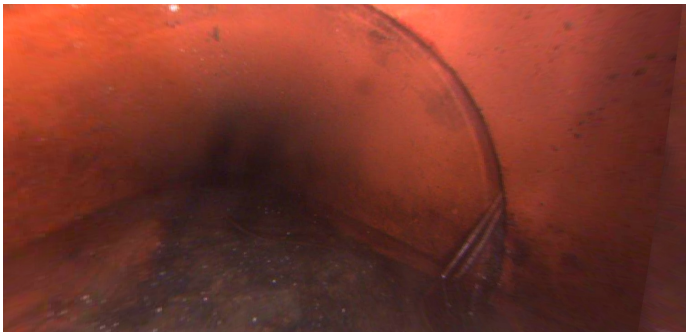
Code:	<b>RFJ</b>
Description:	<b>Roots Fine Joint</b>

Distance (ft):	<b>19.6</b>
Structural Grade:	<b>0</b>
O&M Grade:	<b>1</b>
Clock Start/From:	<b>3</b>
Clock To:	
1st Value:	
2nd Value:	
Value Percent:	
Continuous Index:	
Within 8" of Joint:	<b>YES</b>
Remarks:

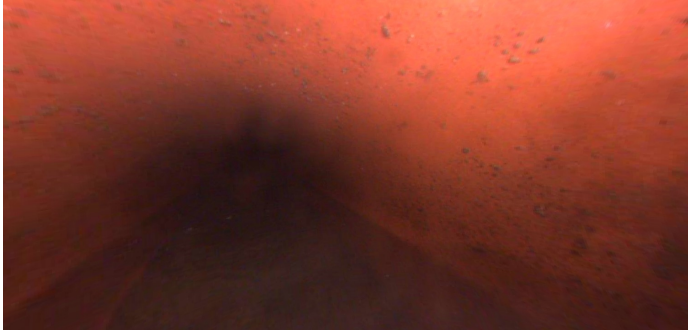
Code:	<b>MSA</b>
Description:	<b>Abandoned Survey</b>
Distance (ft):	<b>35.2</b>
Structural Grade:	<b>0</b>
O&M Grade:	<b>0</b>
Clock Start/From:	
Clock To:	
1st Value:	
2nd Value:	
Value Percent:	
Continuous Index:	
Within 8" of Joint:	<b>NO</b>
Remarks:	<b>camera stopped/no blockage</b>
