Profile/Photo Observation Report

Date:	03/25/2018	Weather:		Coding:	PACP 6.0
Pipe Length (ft):	269.1	Owner:	NA	Pre Clean:	Not Known
P.O.#:		Surveyor:	Byrd Fitzgerald	PSR:	P-203-032-030
Customer:		Clean Date:	01/01/1900	Shape:	C

Street:	ALLEY BETWEEN BARNES ST & MON	Flow Control:	Not Controlled
City:	Hobart, IN	Year Renewed:	
Location:	Other	Tape/Media #:	
Purpose:	Not Known	Dia/Height:	10"
Use:	Sanitary	Material:	VCP
Drain Area:	NA	Lining:	
Category:	NA		
Comment:	6 inch pipe. Damaged

Location Details:		Direction of Survey:	Downstream
US MH:	M-203-032	DS MH:	M-203-030
		Total Length Surveyed (ft):	39.7

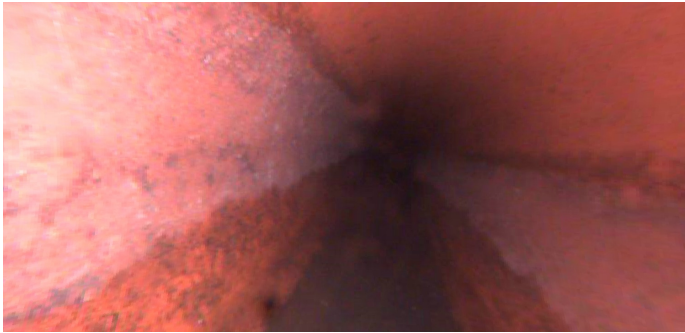
Code:	MWL
Description:	Water Level

Distance (ft):	.0
Structural Grade:	0
O&M Grade:	0
Clock Start/From:	
Clock To:	
1st Value:	
2nd Value:	
Value Percent:	5.000
Continuous Index:	
Within 8" of Joint:	NO
Remarks:

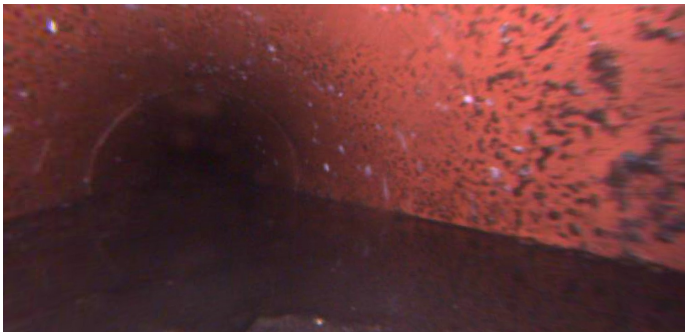
Code:	MWL
Description:	Water Level

Distance (ft):	18.2
Structural Grade:	0
O&M Grade:	0
Clock Start/From:	
Clock To:	
1st Value:	
2nd Value:	
Value Percent:	40.000
Continuous Index:	
Within 8" of Joint:	NO
Remarks:

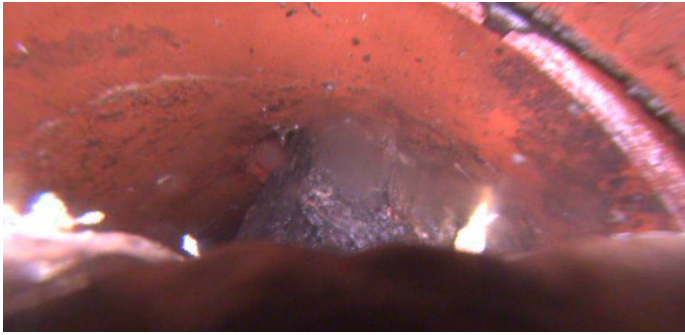
Code: **TFD**
Description: **Tap Factory Defective**

Distance (ft): **39.2**
Structural Grade: **0**
O&M Grade: **2**
Clock Start/From: **1**
Clock To:
1st Value: **4.000**
2nd Value:
Value Percent:
Continuous Index:
Within 8" of Joint:
Remarks: **RML**

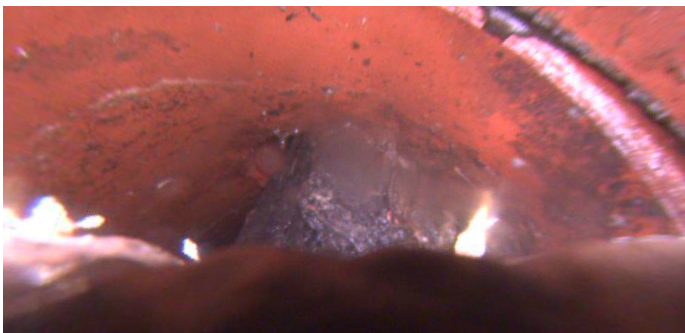
Code: **RML**
Description: **Roots Medium Lateral**

Distance (ft): **39.2**
Structural Grade: **0**
O&M Grade: **3**
Clock Start/From: **12**
Clock To: **6**
1st Value:
2nd Value:
Value Percent: **30.000**
Continuous Index:
Within 8" of Joint: **NO**
Remarks:

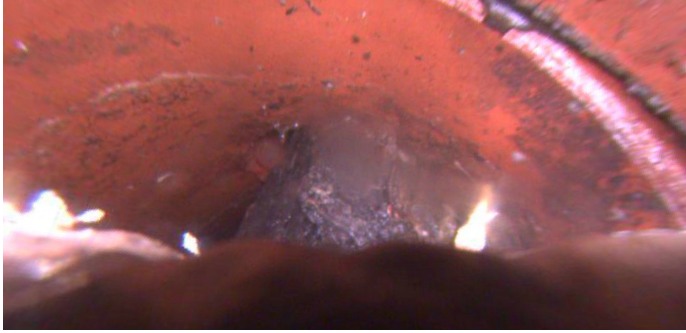
Code: **CC**
Description: **Crack Circumferential**

Distance (ft): **39.2**
Structural Grade: **1**
O&M Grade: **0**
Clock Start/From: **10**
Clock To: **12**
1st Value:
2nd Value:
Value Percent:
Continuous Index:
Within 8" of Joint:
Remarks:
