## Profile/Photo Observation Report

Date:	<b>03/25/2018</b>	Weather:		Coding:	<b>PACP 6.0</b>
Pipe Length (ft):	<b>269.1</b>	Owner:	<b>NA</b>	Pre Clean:	<b>Not Known</b>
P.O.#:		Surveyor:	<b>Byrd Fitzgerald</b>	PSR:	<b>P-203-032-030</b>
Customer:		Clean Date:	<b>01/01/1900</b>	Shape:	<b>C</b>

Street:	<b>E 38th Ave</b>	Flow Control:	<b>Not Controlled</b>
City:	<b>Hobart, IN</b>	Year Renewed:	
Location:	<b>Other</b>	Tape/Media #:	
Purpose:	<b>Not Known</b>	Dia/Height:	<b>10"</b>
Use:	<b>Sanitary</b>	Material:	<b>VCP</b>
Drain Area:	<b>NA</b>	Lining:	
Category:	<b>NA</b>		
Comment:	<b>6 inch pipe. Damaged</b>

Location Details:		Direction of Survey:	<b>Downstream</b>
US MH:	<b>M-203-032</b>	DS MH:	<b>M-203-030</b>
		Total Length Surveyed (ft):	<b>39.7</b>

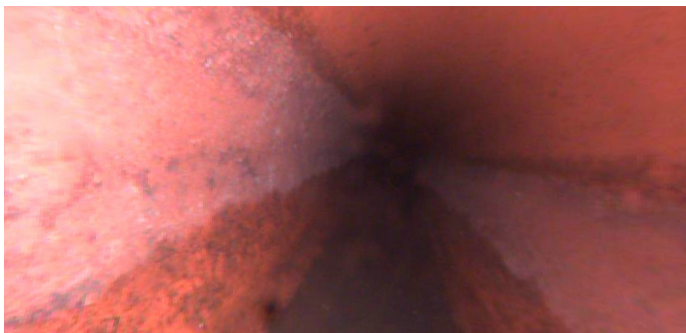
Code: **AMH**  
Description: **Manhole**

Distance (ft): **.0**  
Structural Grade: **0**  
O&M Grade: **0**  
Clock Start/From:  
Clock To:  
1st Value:  
2nd Value:  
Value Percent:  
Continuous Index:  
Within 8" of Joint: **NO**  
Remarks: **M-203-032**

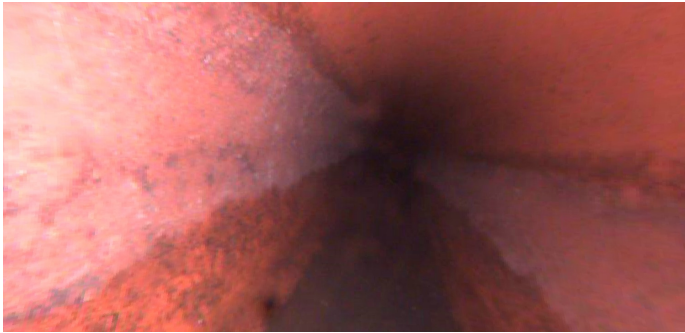
Code:	<b>MWL</b>
Description:	<b>Water Level</b>

Distance (ft):	<b>.0</b>
Structural Grade:	<b>0</b>
O&M Grade:	<b>0</b>
Clock Start/From:	
Clock To:	
1st Value:	
2nd Value:	
Value Percent:	<b>5.000</b>
Continuous Index:	
Within 8" of Joint:	<b>NO</b>
Remarks:

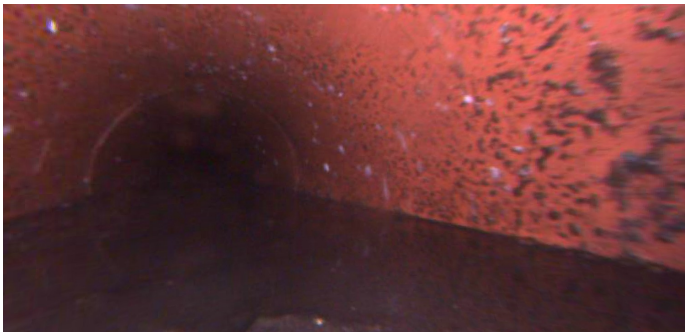
Code:	<b>MWL</b>
Description:	<b>Water Level</b>

Distance (ft):	<b>18.2</b>
Structural Grade:	<b>0</b>
O&M Grade:	<b>0</b>
Clock Start/From:	
Clock To:	
1st Value:	
2nd Value:	
Value Percent:	<b>40.000</b>
Continuous Index:	
Within 8" of Joint:	<b>NO</b>
Remarks:

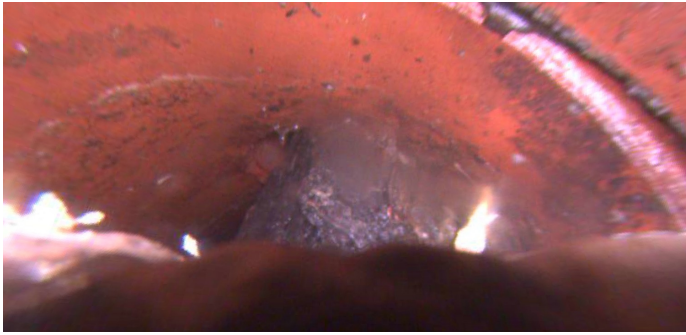
Code: **TFD**  
Description: **Tap Factory Defective**

Distance (ft): **39.2**  
Structural Grade: **0**  
O&M Grade: **2**  
Clock Start/From: **1**  
Clock To:  
1st Value: **4.000**  
2nd Value:  
Value Percent:  
Continuous Index:  
Within 8" of Joint:  
Remarks: **RML**

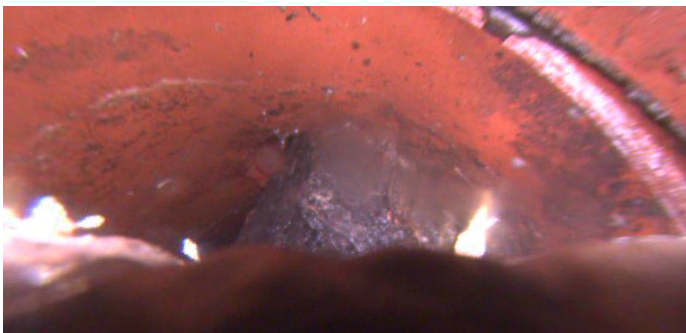
Code: **RML**  
Description: **Roots Medium Lateral**

Distance (ft): **39.2**  
Structural Grade: **0**  
O&M Grade: **3**  
Clock Start/From: **12**  
Clock To: **6**  
1st Value:  
2nd Value:  
Value Percent: **30.000**  
Continuous Index:  
Within 8" of Joint: **NO**  
Remarks:

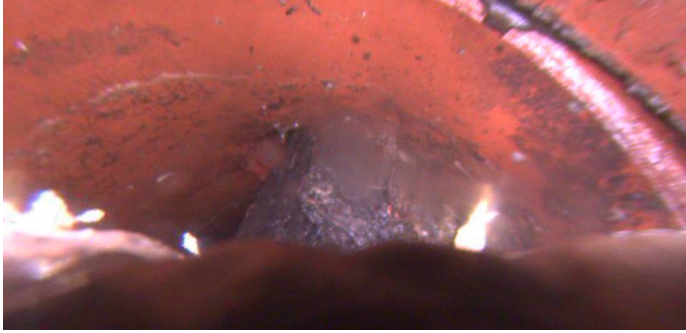
Code: **CC**  
Description: **Crack Circumferential**

Distance (ft): **39.2**  
Structural Grade: **1**  
O&M Grade: **0**  
Clock Start/From: **10**  
Clock To: **12**  
1st Value:  
2nd Value:  
Value Percent:  
Continuous Index:  
Within 8" of Joint:  
Remarks:

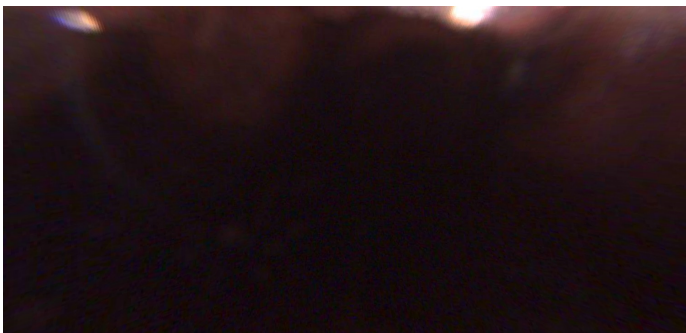
Code: **MCU**  
Description: **Camera Underwater**

Distance (ft): **39.3**  
Structural Grade: **0**  
O&M Grade: **4**  
Clock Start/From:  
Clock To:  
1st Value:  
2nd Value:  
Value Percent:  
Continuous Index:  
Within 8" of Joint: **NO**  
Remarks:
