## Profile/Photo Observation Report

Street:	<b>ALLEY BETWEEN BARNES ST &amp; MON</b>	Flow Control:	<b>Not Controlled</b>
City:	<b>Hobart, IN</b>	Year Renewed:	
Location:	<b>Other</b>	Tape/Media #:	
Purpose:	<b>Not Known</b>	Dia/Height:	<b>8"</b>
Use:	<b>Sanitary</b>	Material:	<b>VCP</b>
Drain Area:	<b>NA</b>	Lining:	
Category:	<b>NA</b>		
Comment:

Location Details:		Direction of Survey:	<b>Downstream</b>
US MH:	<b>M-203-032</b>	DS MH:	<b>M-203-033</b>
		Total Length Surveyed (ft):	<b>16.3</b>

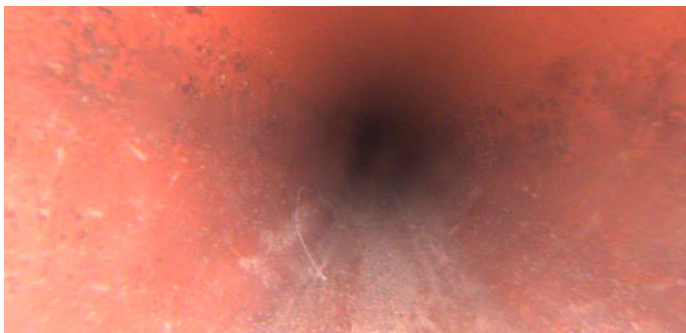
Code: **AMH**  
Description: **Manhole**

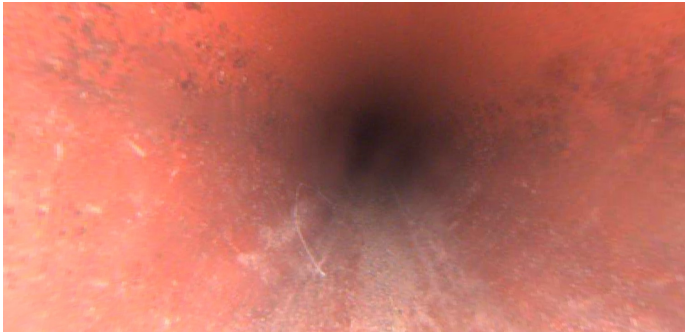
Code:	<b>MWL</b>
Description:	<b>Water Level</b>

Distance (ft):	<b>.0</b>
Structural Grade:	<b>0</b>
O&M Grade:	<b>0</b>
Clock Start/From:	
Clock To:	
1st Value:	
2nd Value:	
Value Percent:	<b>5.000</b>
Continuous Index:	
Within 8" of Joint:	<b>NO</b>
Remarks:

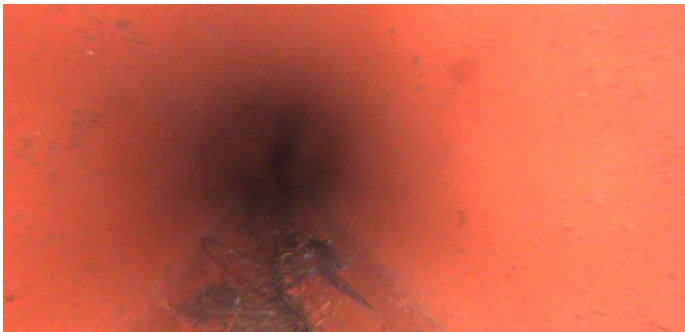
Code:	<b>RFB</b>
Description:	<b>Roots Fine Barrel</b>

Distance (ft):	<b>5.9</b>
Structural Grade:	<b>0</b>
O&M Grade:	<b>2</b>
Clock Start/From:	<b>6</b>
Clock To:	
1st Value:	
2nd Value:	
Value Percent:	
Continuous Index:	<b>S01</b>
Within 8" of Joint:	<b>NO</b>
Remarks:

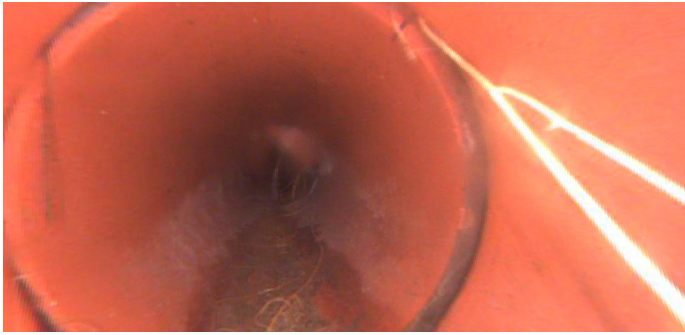
Code: **RFJ**  
Description: **Roots Fine Joint**

Distance (ft): **13.9**  
Structural Grade: **0**  
O&M Grade: **1**  
Clock Start/From: **1**  
Clock To:  
1st Value:  
2nd Value:  
Value Percent:  
Continuous Index:  
Within 8" of Joint: **YES**  
Remarks:

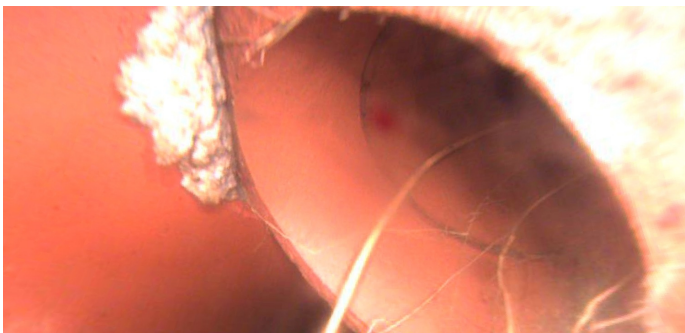
Code: **TBI**  
Description: **Tap Break-in Intruding**

Distance (ft): **16.0**  
Structural Grade: **0**  
O&M Grade: **2**  
Clock Start/From: **4**  
Clock To:  
1st Value: **4.000**  
2nd Value: **2.000**  
Value Percent:  
Continuous Index:  
Within 8" of Joint:  
Remarks: **ROOTS**

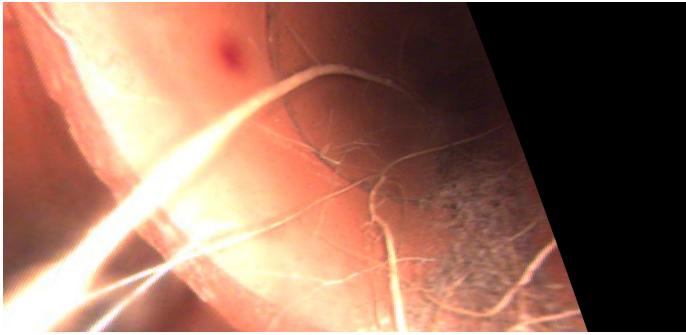
Code: **RFL**  
Description: **Roots Fine Lateral**

Distance (ft): **16.2**  
Structural Grade: **0**  
O&M Grade: **1**  
Clock Start/From: **3**  
Clock To: **9**  
1st Value:  
2nd Value:  
Value Percent:  
Continuous Index:  
Within 8" of Joint: **NO**  
Remarks:

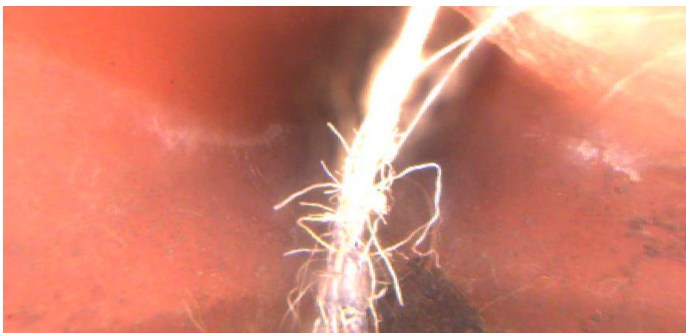
Code: **MSA**  
Description: **Abandoned Survey**

Distance (ft): **16.3**  
Structural Grade: **0**  
O&M Grade: **0**  
Clock Start/From:  
Clock To:  
1st Value:  
2nd Value:  
Value Percent:  
Continuous Index:  
Within 8" of Joint: **NO**  
Remarks: **tfi**

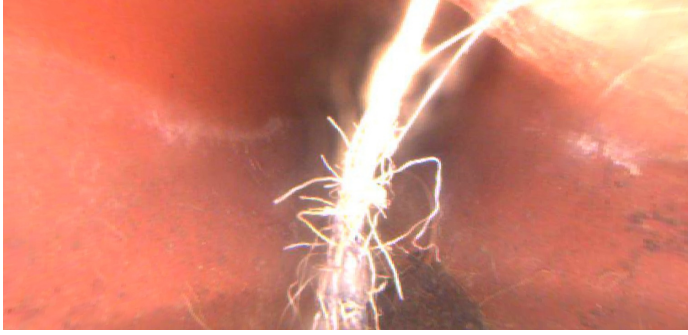
Code:	<b>RFB</b>
Description:	<b>Roots Fine Barrel</b>
Distance (ft):	<b>16.3</b>
Structural Grade:	<b>0</b>
O&M Grade:	<b>2</b>
Clock Start/From:	<b>6</b>
Clock To:	
1st Value:	
2nd Value:	
Value Percent:	
Continuous Index:	<b>F01</b>
Within 8" of Joint:	<b>NO</b>
Remarks:
