Profile/Photo Observation Report

Date:	03/25/2018	Weather:		Coding:	PACP 6.0
Pipe Length (ft):	93.5	Owner:	NA	Pre Clean:	Not Known
P.O.#:		Surveyor:	Byrd Fitzgerald	PSR:	P-203-033-032
Customer:		Clean Date:	01/01/1900	Shape:	C

Street:	E 38th Ave	Flow Control:	Not Controlled
City:	Hobart, IN	Year Renewed:	
Location:	Other	Tape/Media #:	
Purpose:	Not Known	Dia/Height:	8"
Use:	Sanitary	Material:	VCP
Drain Area:	NA	Lining:	
Category:	NA		
Comment:

Location Details:		Direction of Survey:	Downstream
US MH:	M-203-032	DS MH:	M-203-033
		Total Length Surveyed (ft):	16.3

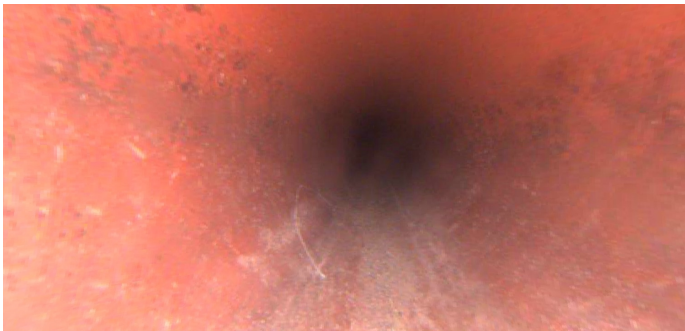
Code: **AMH**
Description: **Manhole**

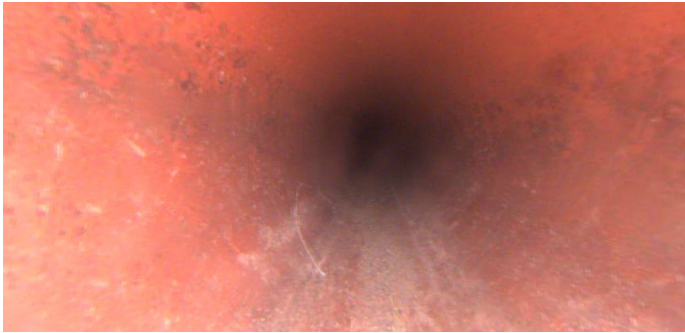
Code:	MWL
Description:	Water Level

Distance (ft):	.0
Structural Grade:	0
O&M Grade:	0
Clock Start/From:	
Clock To:	
1st Value:	
2nd Value:	
Value Percent:	5.000
Continuous Index:	
Within 8" of Joint:	NO
Remarks:

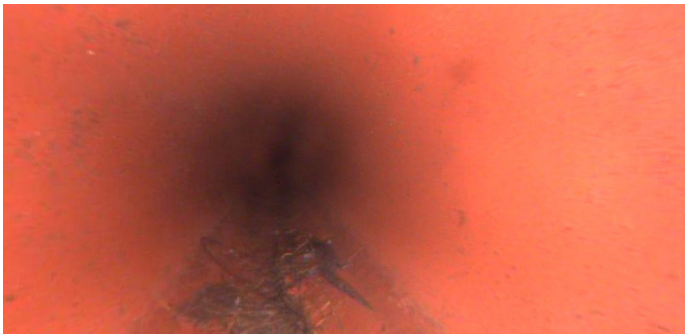
Code:	RFB
Description:	Roots Fine Barrel

Distance (ft):	5.9
Structural Grade:	0
O&M Grade:	2
Clock Start/From:	6
Clock To:	
1st Value:	
2nd Value:	
Value Percent:	
Continuous Index:	S01
Within 8" of Joint:	NO
Remarks:

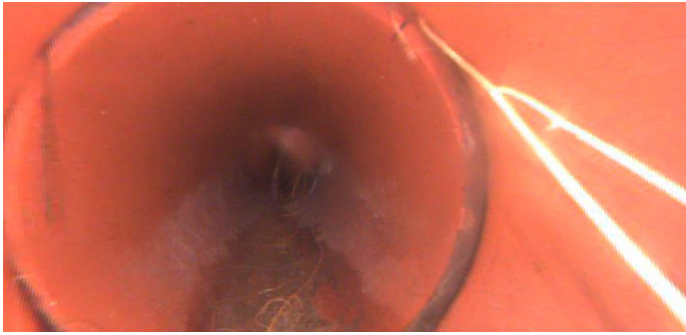
Code: **RFJ**
Description: **Roots Fine Joint**

Distance (ft): **13.9**
Structural Grade: **0**
O&M Grade: **1**
Clock Start/From: **1**
Clock To:
1st Value:
2nd Value:
Value Percent:
Continuous Index:
Within 8" of Joint: **YES**
Remarks:

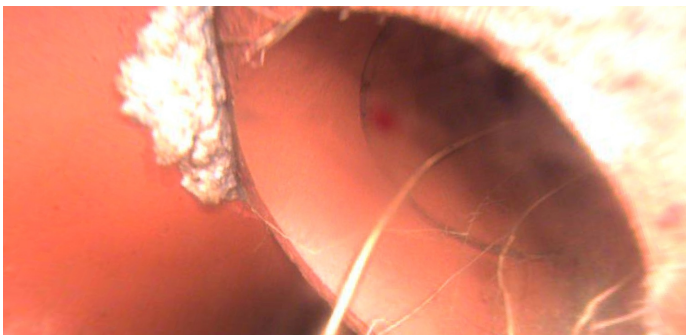
Code: **TBI**
Description: **Tap Break-in Intruding**

Distance (ft): **16.0**
Structural Grade: **0**
O&M Grade: **2**
Clock Start/From: **4**
Clock To:
1st Value: **4.000**
2nd Value: **2.000**
Value Percent:
Continuous Index:
Within 8" of Joint:
Remarks: **ROOTS**

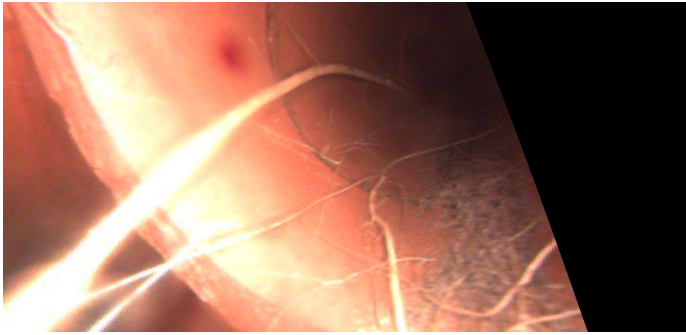
Code: **RFL**
Description: **Roots Fine Lateral**

Distance (ft): **16.2**
Structural Grade: **0**
O&M Grade: **1**
Clock Start/From: **3**
Clock To: **9**
1st Value:
2nd Value:
Value Percent:
Continuous Index:
Within 8" of Joint: **NO**
Remarks:

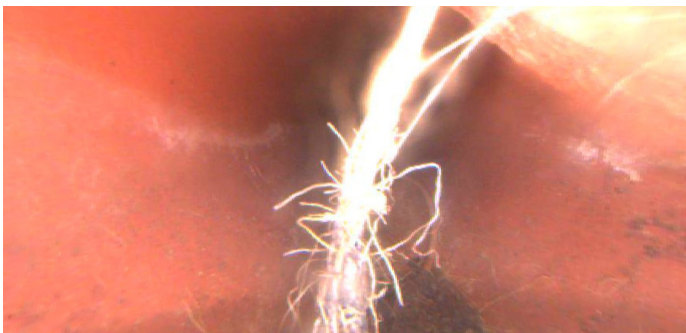
Code: **MSA**
Description: **Abandoned Survey**

Distance (ft): **16.3**
Structural Grade: **0**
O&M Grade: **0**
Clock Start/From:
Clock To:
1st Value:
2nd Value:
Value Percent:
Continuous Index:
Within 8" of Joint: **NO**
Remarks: **tfi**

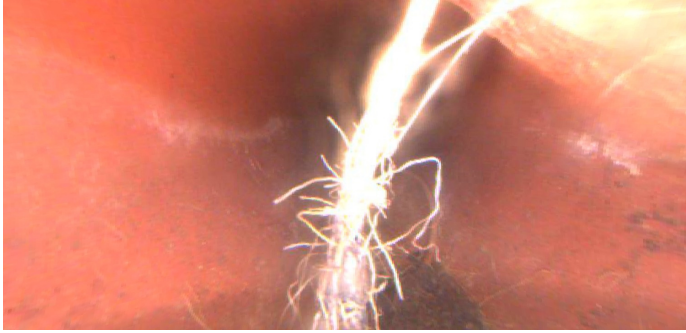
Code:	RFB
Description:	Roots Fine Barrel
Distance (ft):	16.3
Structural Grade:	0
O&M Grade:	2
Clock Start/From:	6
Clock To:	
1st Value:	
2nd Value:	
Value Percent:	
Continuous Index:	F01
Within 8" of Joint:	NO
Remarks:
