## Profile/Photo Observation Report

Street:	<b>W 38TH AVE</b>	Flow Control:	<b>Not Controlled</b>
City:	<b>Hobart, IN</b>	Year Renewed:	
Location:	<b>Other</b>	Tape/Media #:	
Purpose:	<b>Not Known</b>	Dia/Height:	<b>12"</b>
Use:	<b>Sanitary</b>	Material:	<b>VCP</b>
Drain Area:	<b>NA</b>	Lining:	
Category:	<b>NA</b>		
Comment:

Location Details:		Direction of Survey:	<b>Downstream</b>
US MH:	<b>M-203-034</b>	DS MH:	<b>M-203-027</b>
		Total Length Surveyed (ft):	<b>7.9</b>

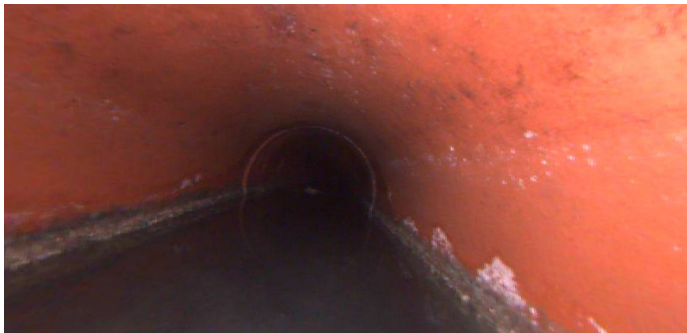
Code: **AMH**  
 Description: **Manhole**  
 Distance (ft): **.0**  
 Structural Grade: **0**  
 O&M Grade: **0**  
 Clock Start/From:  
 Clock To:  
 1st Value:  
 2nd Value:  
 Value Percent:  
 Continuous Index:  
 Within 8" of Joint: **NO**  
 Remarks: **M-203-034**

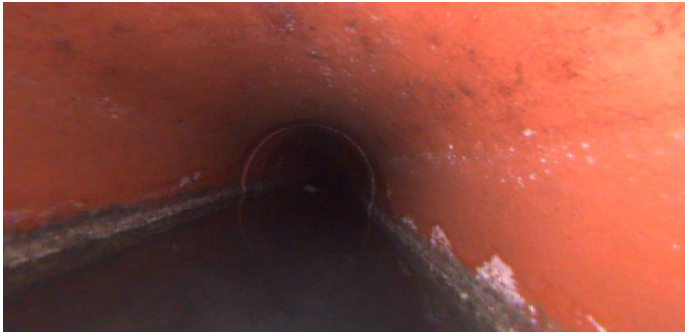
Code:	<b>MWL</b>
Description:	<b>Water Level</b>

Distance (ft):	<b>.0</b>
Structural Grade:	<b>0</b>
O&M Grade:	<b>0</b>
Clock Start/From:	
Clock To:	
1st Value:	
2nd Value:	
Value Percent:	<b>25.000</b>
Continuous Index:	
Within 8" of Joint:	<b>NO</b>
Remarks:

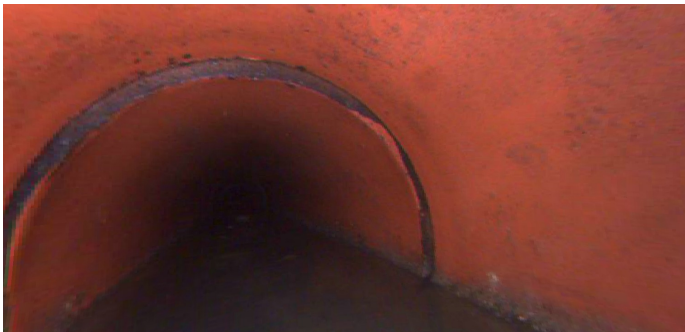
Code:	<b>MSA</b>
Description:	<b>Abandoned Survey</b>

Distance (ft):	<b>7.9</b>
Structural Grade:	<b>0</b>
O&M Grade:	<b>0</b>
Clock Start/From:	
Clock To:	
1st Value:	
2nd Value:	
Value Percent:	
Continuous Index:	
Within 8" of Joint:	<b>NO</b>
Remarks:	<b>no blockage</b>
