Profile/Photo Observation Report

Date:	03/24/2018	Weather:		Coding:	PACP 6.0
Pipe Length (ft):	171.2	Owner:	NA	Pre Clean:	Not Known
P.O.#:		Surveyor:	Justin Gonzales	PSR:	P-203-035-034
Customer:		Clean Date:	01/01/1900	Shape:	C

Street:	W 38TH AVE	Flow Control:	Not Controlled
City:	Hobart, IN	Year Renewed:	
Location:	Other	Tape/Media #:	
Purpose:	Not Known	Dia/Height:	10"
Use:	Sanitary	Material:	PVC
Drain Area:	NA	Lining:	
Category:	NA		
Comment:

Location Details:		Direction of Survey:	Downstream
US MH:	M-203-034	DS MH:	M-203-035
		Total Length Surveyed (ft):	171.1

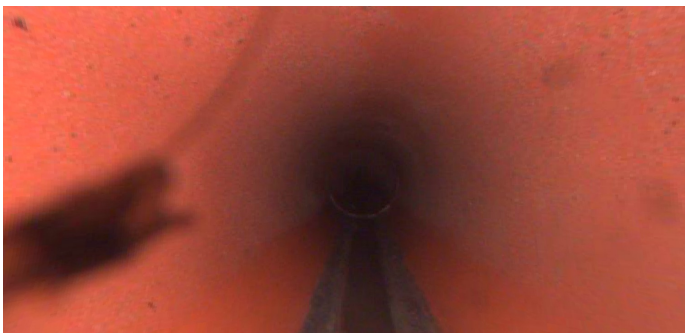
Code: **AMH**
Description: **Manhole**

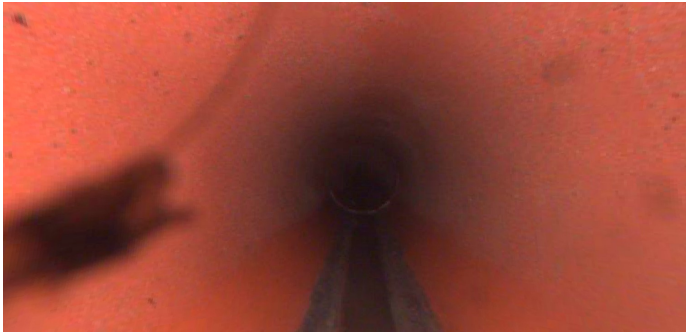
Code:	MWL
Description:	Water Level

Distance (ft):	.0
Structural Grade:	0
O&M Grade:	0
Clock Start/From:	
Clock To:	
1st Value:	
2nd Value:	
Value Percent:	5.000
Continuous Index:	
Within 8" of Joint:	NO
Remarks:

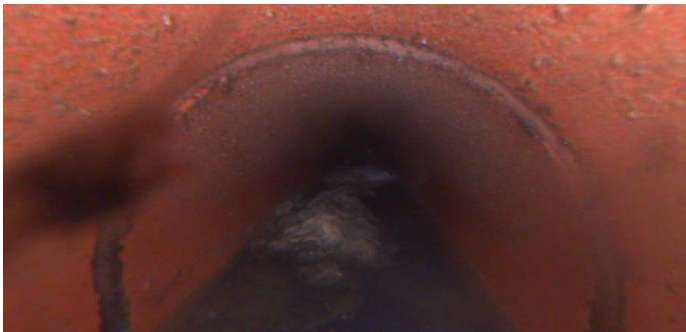
Code:	MGO
Description:	General Observation

Distance (ft):	49.1
Structural Grade:	0
O&M Grade:	0
Clock Start/From:	
Clock To:	
1st Value:	
2nd Value:	
Value Percent:	
Continuous Index:	
Within 8" of Joint:	NO
Remarks:	TOILET TISSUE

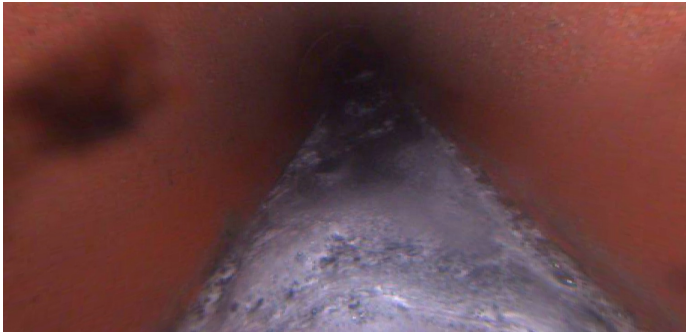
Code: **MGO**
Description: **General Observation**

Distance (ft): **52.3**
Structural Grade: **0**
O&M Grade: **0**
Clock Start/From:
Clock To:
1st Value:
2nd Value:
Value Percent:
Continuous Index:
Within 8" of Joint: **NO**
Remarks: **SOAP SUDS**

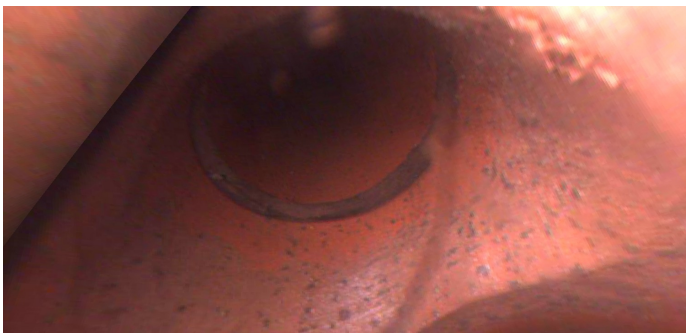
Code: **TF**
Description: **Tap Factory**

Distance (ft): **55.5**
Structural Grade: **0**
O&M Grade: **0**
Clock Start/From: **11**
Clock To:
1st Value: **4.000**
2nd Value:
Value Percent:
Continuous Index:
Within 8" of Joint:
Remarks:

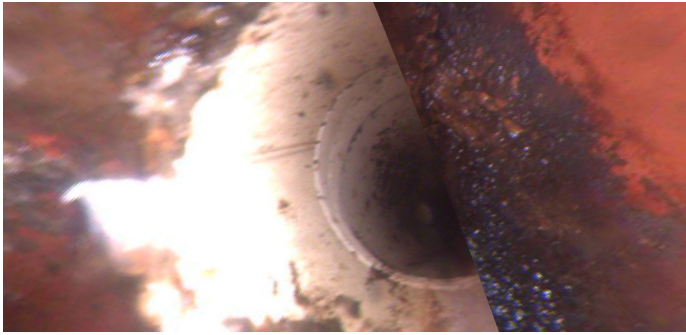
Code: **TBI**
Description: **Tap Break-in Intruding**

Distance (ft): **57.3**
Structural Grade: **0**
O&M Grade: **2**
Clock Start/From: **2**
Clock To:
1st Value: **4.000**
2nd Value: **2.000**
Value Percent:
Continuous Index:
Within 8" of Joint:
Remarks:

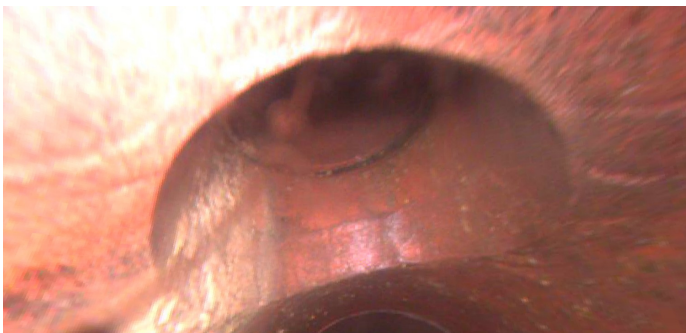
Code: **TF**
Description: **Tap Factory**

Distance (ft): **77.5**
Structural Grade: **0**
O&M Grade: **0**
Clock Start/From: **11**
Clock To:
1st Value: **4.000**
2nd Value:
Value Percent:
Continuous Index:
Within 8" of Joint:
Remarks:

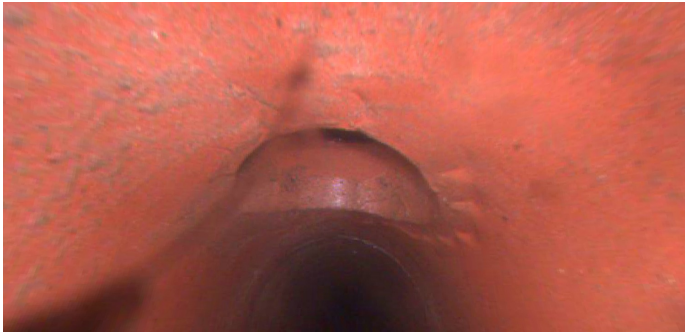
Code: **TF**
Description: **Tap Factory**

Distance (ft): **89.3**
Structural Grade: **0**
O&M Grade: **0**
Clock Start/From: **12**
Clock To:
1st Value: **4.000**
2nd Value:
Value Percent:
Continuous Index:
Within 8" of Joint:
Remarks:

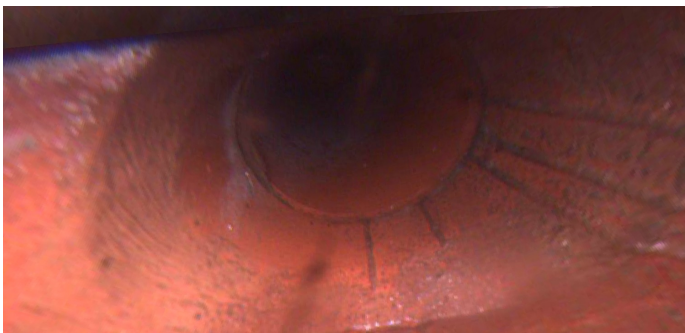
Code: **TF**
Description: **Tap Factory**

Distance (ft): **116.6**
Structural Grade: **0**
O&M Grade: **0**
Clock Start/From: **12**
Clock To:
1st Value: **4.000**
2nd Value:
Value Percent:
Continuous Index:
Within 8" of Joint:
Remarks:

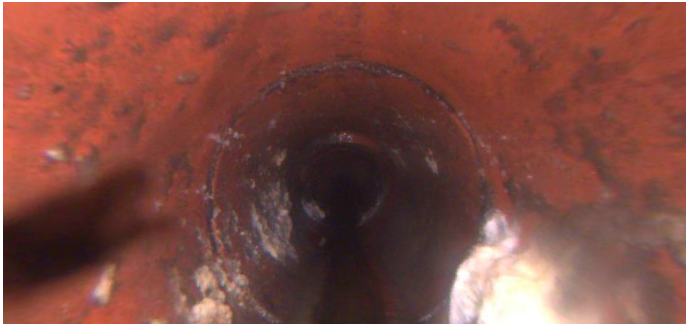
Code: **DAGS**
Description: **Deposits Attached Grease**

Distance (ft): **126.8**
Structural Grade: **0**
O&M Grade: **2**
Clock Start/From: **8**
Clock To: **4**
1st Value:
2nd Value:
Value Percent: **10.000**
Continuous Index:
Within 8" of Joint: **YES**
Remarks:

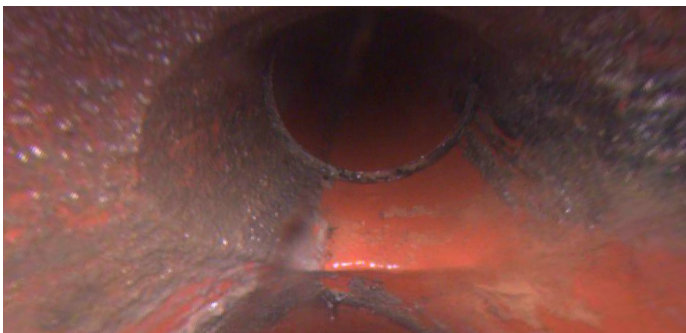
Code: **TF**
Description: **Tap Factory**

Distance (ft): **128.6**
Structural Grade: **0**
O&M Grade: **0**
Clock Start/From: **12**
Clock To:
1st Value: **4.000**
2nd Value:
Value Percent:
Continuous Index:
Within 8" of Joint:
Remarks:

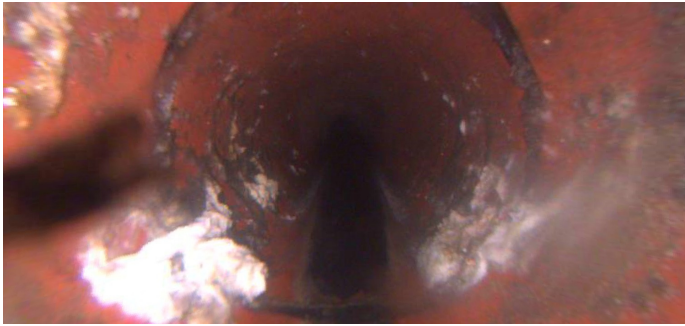
Code: **DAGS**
Description: **Deposits Attached Grease**

Distance (ft): **129.1**
Structural Grade: **0**
O&M Grade: **2**
Clock Start/From: **8**
Clock To: **4**
1st Value:
2nd Value:
Value Percent: **10.000**
Continuous Index:
Within 8" of Joint: **YES**
Remarks:

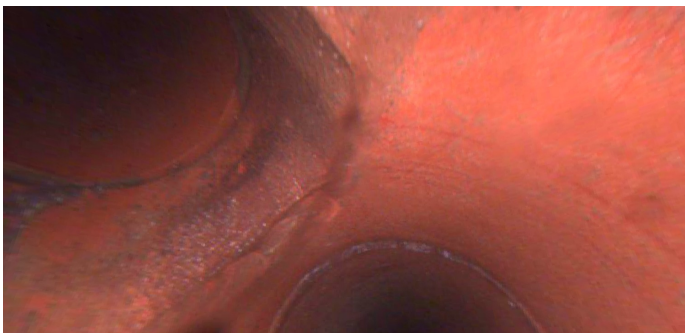
Code: **TF**
Description: **Tap Factory**

Distance (ft): **145.8**
Structural Grade: **0**
O&M Grade: **0**
Clock Start/From: **10**
Clock To:
1st Value: **4.000**
2nd Value:
Value Percent:
Continuous Index:
Within 8" of Joint:
Remarks:

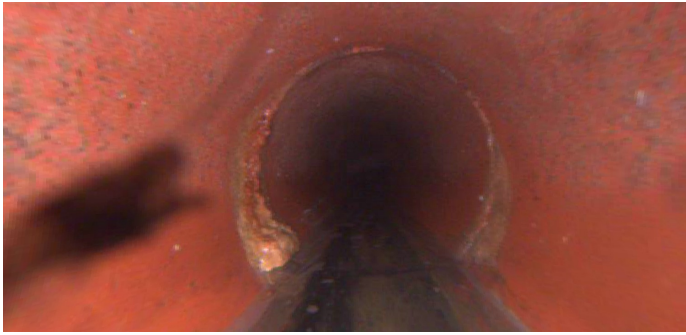
Code: **DAE**
Description: **Deposits Attached Encrustation**

Distance (ft): **165.8**
Structural Grade: **0**
O&M Grade: **2**
Clock Start/From: **7**
Clock To: **11**
1st Value:
2nd Value:
Value Percent: **5.000**
Continuous Index:
Within 8" of Joint: **YES**
Remarks:

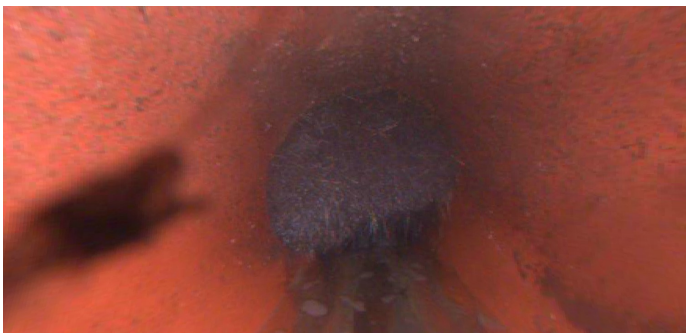
Code: **RBB**
Description: **Roots Ball Barrel**

Distance (ft): **169.7**
Structural Grade: **0**
O&M Grade: **5**
Clock Start/From: **7**
Clock To: **4**
1st Value:
2nd Value:
Value Percent: **90.000**
Continuous Index:
Within 8" of Joint: **NO**
Remarks:
