Profile/Photo Observation Report

Street:	E 38th Ave	Flow Control:	Not Controlled
City:	Hobart, IN	Year Renewed:	
Location:	Other	Tape/Media #:	
Purpose:	Not Known	Dia/Height:	10"
Use:	Sanitary	Material:	PVC
Drain Area:	NA	Lining:	
Category:	NA		
Comment:

Location Details:		Direction of Survey:	Downstream
US MH:	M-203-034	DS MH:	M-203-035
		Total Length Surveyed (ft):	171.1

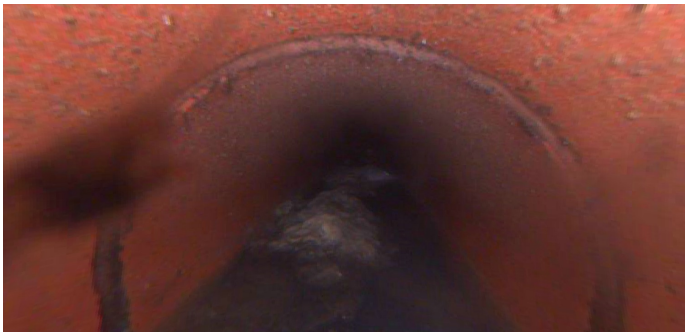
Code:	MGO
Description:	General Observation

Distance (ft):	49.1
Structural Grade:	0
O&M Grade:	0
Clock Start/From:	
Clock To:	
1st Value:	
2nd Value:	
Value Percent:	
Continuous Index:	
Within 8" of Joint:	NO
Remarks:	TOILET TISSUE

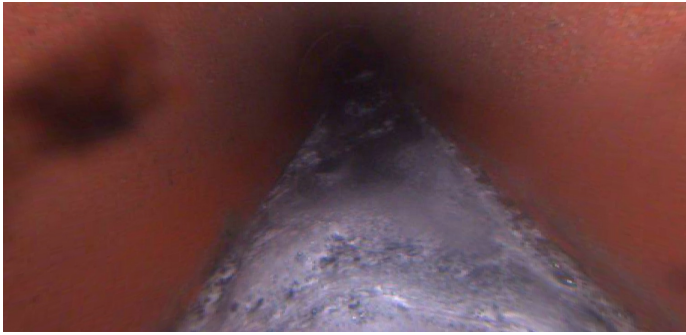
Code: **MGO**
Description: **General Observation**

Distance (ft): **52.3**
Structural Grade: **0**
O&M Grade: **0**
Clock Start/From:
Clock To:
1st Value:
2nd Value:
Value Percent:
Continuous Index:
Within 8" of Joint: **NO**
Remarks: **SOAP SUDS**

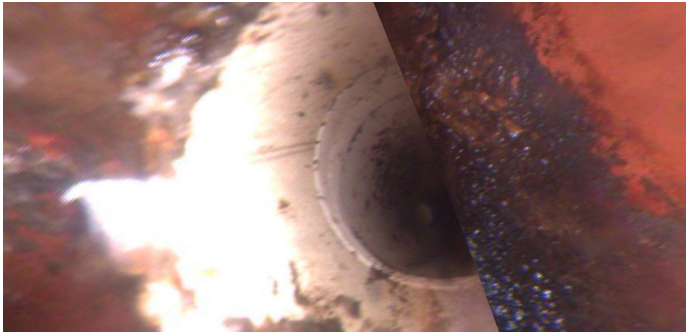
Code: **TBI**
Description: **Tap Break-in Intruding**

Distance (ft): **57.3**
Structural Grade: **0**
O&M Grade: **2**
Clock Start/From: **2**
Clock To:
1st Value: **4.000**
2nd Value: **2.000**
Value Percent:
Continuous Index:
Within 8" of Joint:
Remarks:

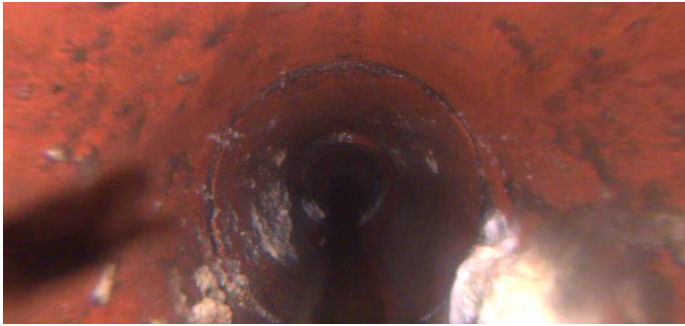
Code: **DAGS**
Description: **Deposits Attached Grease**

Distance (ft): **126.8**
Structural Grade: **0**
O&M Grade: **2**
Clock Start/From: **8**
Clock To: **4**
1st Value:
2nd Value:
Value Percent: **10.000**
Continuous Index:
Within 8" of Joint: **YES**
Remarks:

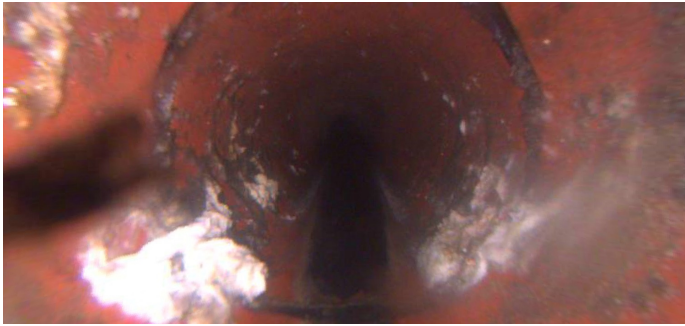
Code: **DAGS**
Description: **Deposits Attached Grease**

Distance (ft): **129.1**
Structural Grade: **0**
O&M Grade: **2**
Clock Start/From: **8**
Clock To: **4**
1st Value:
2nd Value:
Value Percent: **10.000**
Continuous Index:
Within 8" of Joint: **YES**
Remarks:

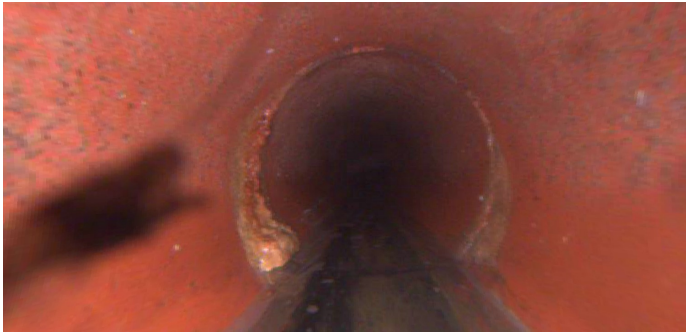
Code: **DAE**
Description: **Deposits Attached Encrustation**

Distance (ft): **165.8**
Structural Grade: **0**
O&M Grade: **2**
Clock Start/From: **7**
Clock To: **11**
1st Value:
2nd Value:
Value Percent: **5.000**
Continuous Index:
Within 8" of Joint: **YES**
Remarks:

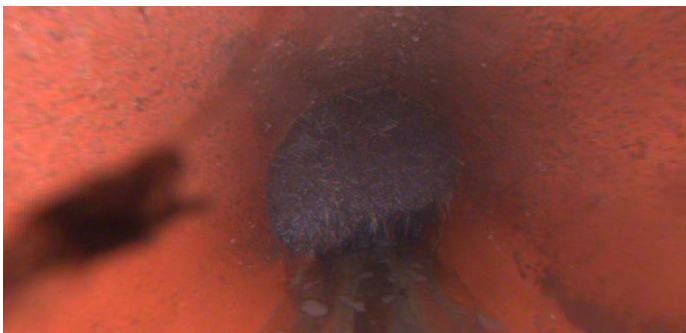
Code: **RBB**
Description: **Roots Ball Barrel**

Distance (ft): **169.7**
Structural Grade: **0**
O&M Grade: **5**
Clock Start/From: **7**
Clock To: **4**
1st Value:
2nd Value:
Value Percent: **90.000**
Continuous Index:
Within 8" of Joint: **NO**
Remarks:
