Profile/Photo Observation Report

Date:	03/25/2018	Weather:		Coding:	PACP 6.0
Pipe Length (ft):	263.0	Owner:	NA	Pre Clean:	Not Known
P.O.#:		Surveyor:	Byrd Fitzgerald	PSR:	P-203-039-037
Customer:		Clean Date:	01/01/1900	Shape:	C

Street:	ALLEY BETWEEN MAITLAND ST & M	Flow Control:	Not Controlled
City:	Hobart, IN	Year Renewed:	
Location:	Other	Tape/Media #:	
Purpose:	Not Known	Dia/Height:	10"
Use:	Sanitary	Material:	VCP
Drain Area:	NA	Lining:	
Category:	NA		
Comment:	Rootball at pipe entrance.		
Location Details:		Direction of Survey:	Upstream
US MH:	M-203-037	DS MH:	M-203-039
		Total Length Surveyed (ft):	238.3

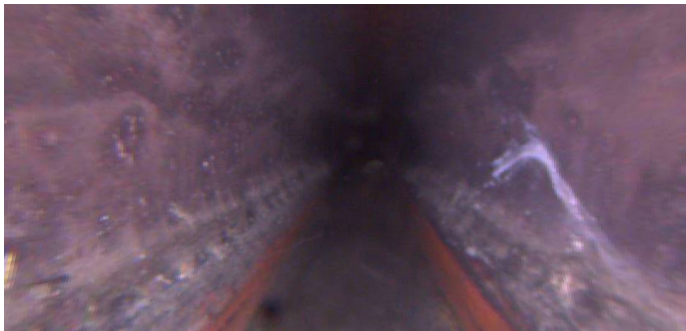
Code: **AMH**
Description: **Manhole**

Distance (ft): **.0**
Structural Grade: **0**
O&M Grade: **0**
Clock Start/From:
Clock To:
1st Value:
2nd Value:
Value Percent:
Continuous Index:
Within 8" of Joint: **NO**
Remarks: **M-203-039**

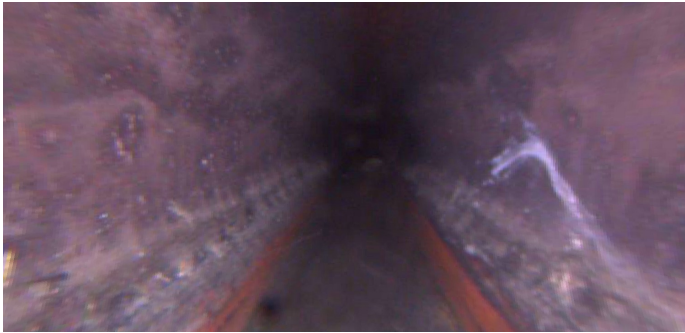
Code:	MWL
Description:	Water Level

Distance (ft):	.0
Structural Grade:	0
O&M Grade:	0
Clock Start/From:	
Clock To:	
1st Value:	
2nd Value:	
Value Percent:	5.000
Continuous Index:	
Within 8" of Joint:	NO
Remarks:

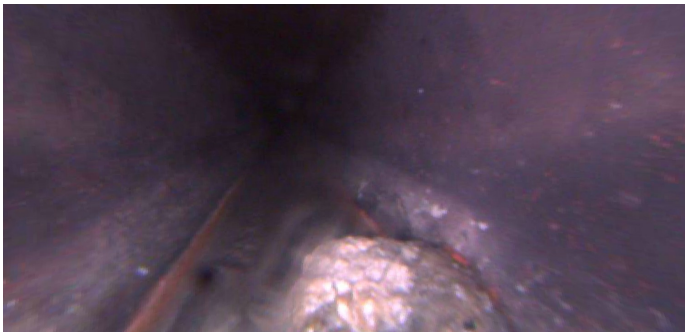
Code:	OBR
Description:	Obstacle Rocks

Distance (ft):	2.7
Structural Grade:	0
O&M Grade:	2
Clock Start/From:	6
Clock To:	
1st Value:	
2nd Value:	
Value Percent:	5.000
Continuous Index:	
Within 8" of Joint:	NO
Remarks:

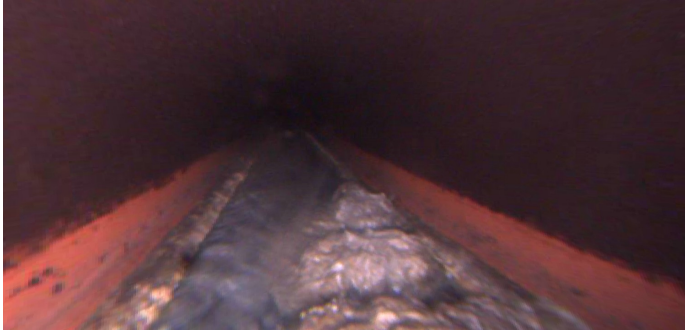
Code: **DSZ**
Description: **Deposits Settled Other**

Distance (ft): **28.1**
Structural Grade: **0**
O&M Grade: **2**
Clock Start/From: **6**
Clock To:
1st Value:
2nd Value:
Value Percent: **5.000**
Continuous Index: **S01**
Within 8" of Joint: **NO**
Remarks: **tissue/debris**

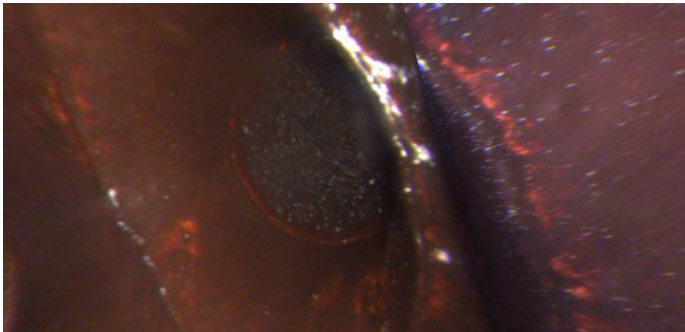
Code: **TFC**
Description: **Tap Factory Capped**

Distance (ft): **126.2**
Structural Grade: **0**
O&M Grade: **0**
Clock Start/From: **10**
Clock To:
1st Value: **4.000**
2nd Value:
Value Percent:
Continuous Index:
Within 8" of Joint: **YES**
Remarks:

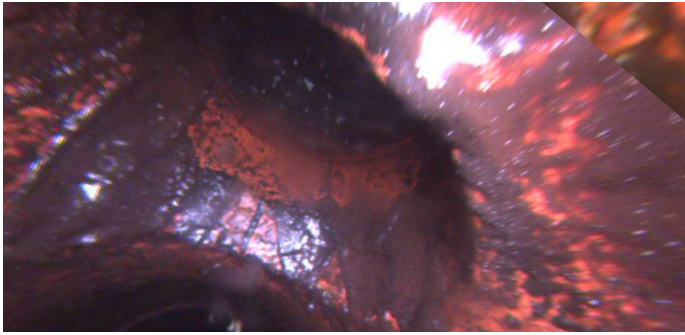
Code: **TF**
Description: **Tap Factory**

Distance (ft): **127.8**
Structural Grade: **0**
O&M Grade: **0**
Clock Start/From: **1**
Clock To:
1st Value: **4.000**
2nd Value:
Value Percent:
Continuous Index:
Within 8" of Joint:
Remarks:

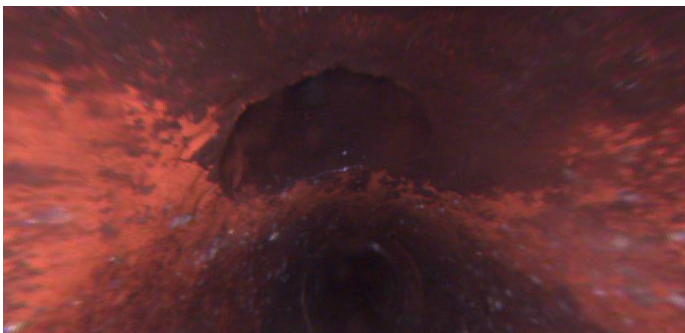
Code: **TF**
Description: **Tap Factory**

Distance (ft): **194.9**
Structural Grade: **0**
O&M Grade: **0**
Clock Start/From: **12**
Clock To:
1st Value: **4.000**
2nd Value:
Value Percent:
Continuous Index:
Within 8" of Joint:
Remarks:

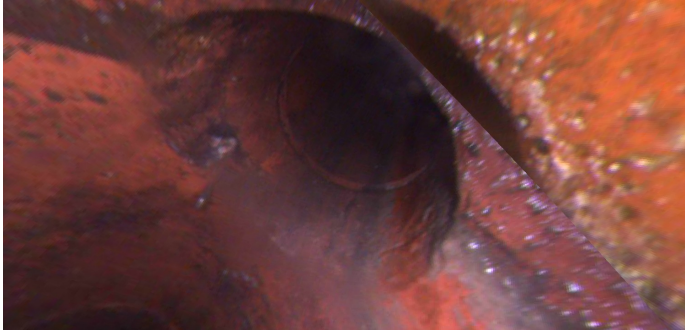
Code: **TF**
Description: **Tap Factory**

Distance (ft): **197.3**
Structural Grade: **0**
O&M Grade: **0**
Clock Start/From: **1**
Clock To:
1st Value: **4.000**
2nd Value:
Value Percent:
Continuous Index:
Within 8" of Joint:
Remarks:

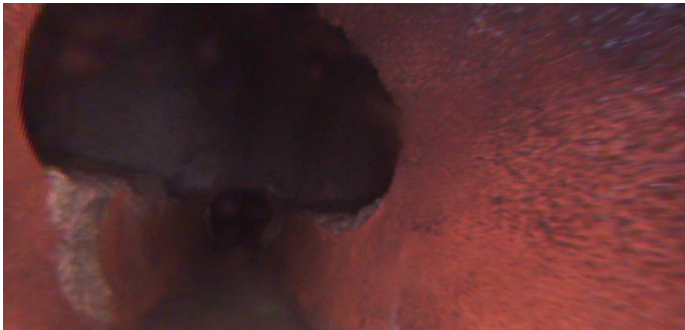
Code: **DSZ**
Description: **Deposits Settled Other**

Distance (ft): **236.2**
Structural Grade: **0**
O&M Grade: **2**
Clock Start/From: **6**
Clock To:
1st Value:
2nd Value:
Value Percent: **5.000**
Continuous Index: **F01**
Within 8" of Joint: **NO**
Remarks: **tissue/debris**

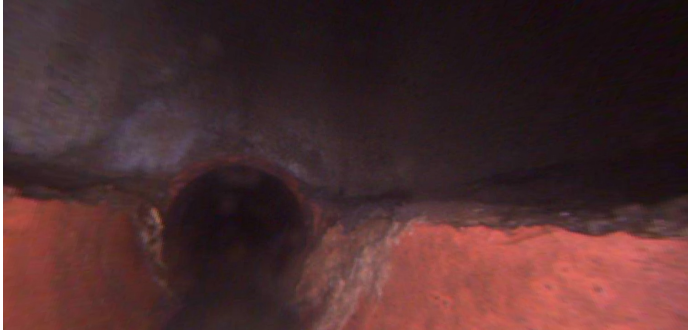
Code:	AMH
Description:	Manhole
Distance (ft):	238.3
Structural Grade:	0
O&M Grade:	0
Clock Start/From:	
Clock To:	
1st Value:	
2nd Value:	
Value Percent:	
Continuous Index:	
Within 8" of Joint:	NO
Remarks:	M-203-037
