Profile/Photo Observation Report

Date:	03/25/2018	Weather:		Coding:	PACP 6.0
Pipe Length (ft):	263.0	Owner:	NA	Pre Clean:	Not Known
P.O.#:		Surveyor:	Byrd Fitzgerald	PSR:	P-203-039-037
Customer:		Clean Date:	01/01/1900	Shape:	C

Street:	E 38th Ave	Flow Control:	Not Controlled
City:	Hobart, IN	Year Renewed:	
Location:	Other	Tape/Media #:	
Purpose:	Not Known	Dia/Height:	10"
Use:	Sanitary	Material:	VCP
Drain Area:	NA	Lining:	
Category:	NA		
Comment:	Rootball at pipe entrance.		
Location Details:		Direction of Survey:	Upstream
US MH:	M-203-037	DS MH:	M-203-039
		Total Length Surveyed (ft):	238.3

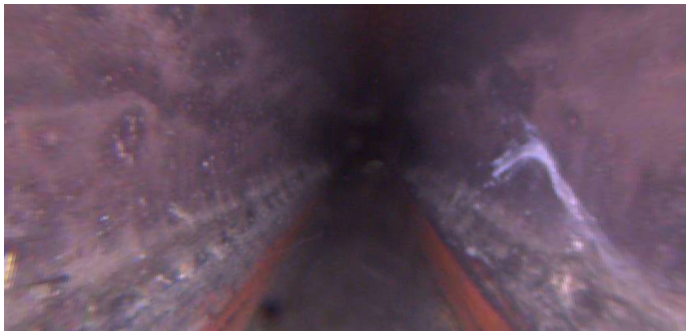
Code: **AMH**
Description: **Manhole**

Distance (ft): **.0**
Structural Grade: **0**
O&M Grade: **0**
Clock Start/From:
Clock To:
1st Value:
2nd Value:
Value Percent:
Continuous Index:
Within 8" of Joint: **NO**
Remarks: **M-203-039**

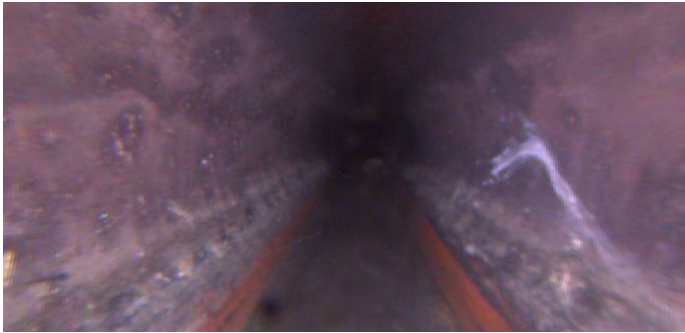
Code:	MWL
Description:	Water Level

Distance (ft):	.0
Structural Grade:	0
O&M Grade:	0
Clock Start/From:	
Clock To:	
1st Value:	
2nd Value:	
Value Percent:	5.000
Continuous Index:	
Within 8" of Joint:	NO
Remarks:

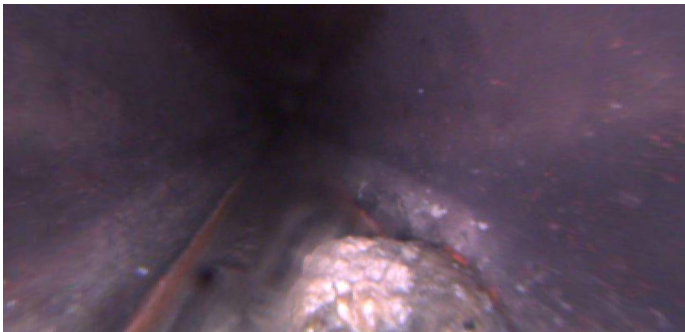
Code:	OBR
Description:	Obstacle Rocks

Distance (ft):	2.7
Structural Grade:	0
O&M Grade:	2
Clock Start/From:	6
Clock To:	
1st Value:	
2nd Value:	
Value Percent:	5.000
Continuous Index:	
Within 8" of Joint:	NO
Remarks:

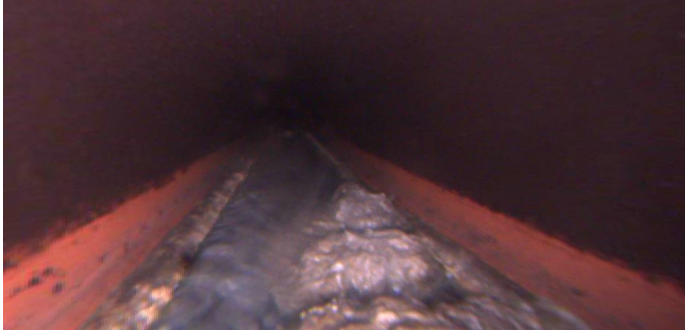
Code: **DSZ**
Description: **Deposits Settled Other**

Distance (ft): **28.1**
Structural Grade: **0**
O&M Grade: **2**
Clock Start/From: **6**
Clock To:
1st Value:
2nd Value:
Value Percent: **5.000**
Continuous Index: **S01**
Within 8" of Joint: **NO**
Remarks: **tissue/debris**

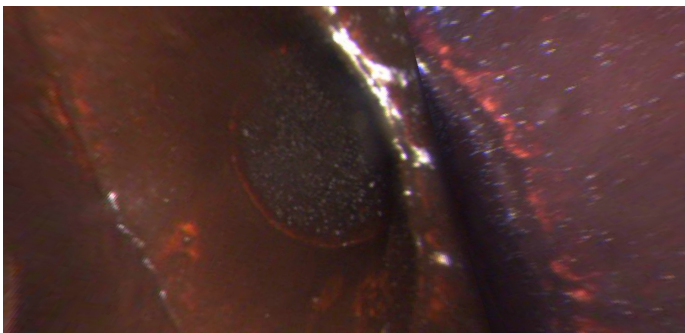
Code: **TFC**
Description: **Tap Factory Capped**

Distance (ft): **126.2**
Structural Grade: **0**
O&M Grade: **0**
Clock Start/From: **10**
Clock To:
1st Value: **4.000**
2nd Value:
Value Percent:
Continuous Index:
Within 8" of Joint: **YES**
Remarks:

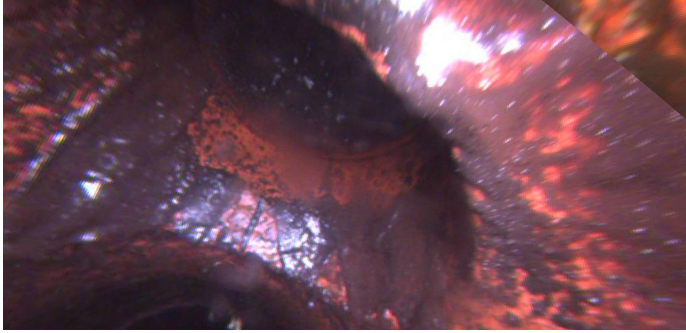
Code: **TF**
Description: **Tap Factory**

Distance (ft): **127.8**
Structural Grade: **0**
O&M Grade: **0**
Clock Start/From: **1**
Clock To:
1st Value: **4.000**
2nd Value:
Value Percent:
Continuous Index:
Within 8" of Joint:
Remarks:

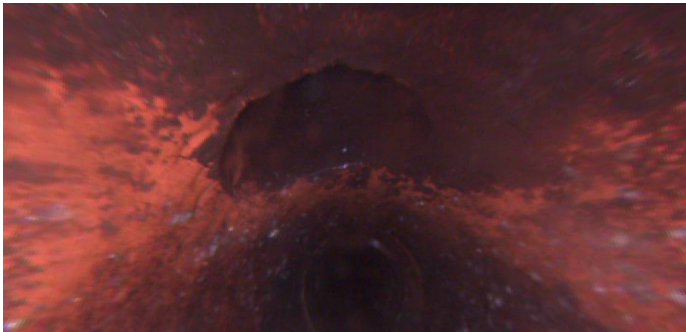
Code: **TF**
Description: **Tap Factory**

Distance (ft): **194.9**
Structural Grade: **0**
O&M Grade: **0**
Clock Start/From: **12**
Clock To:
1st Value: **4.000**
2nd Value:
Value Percent:
Continuous Index:
Within 8" of Joint:
Remarks:

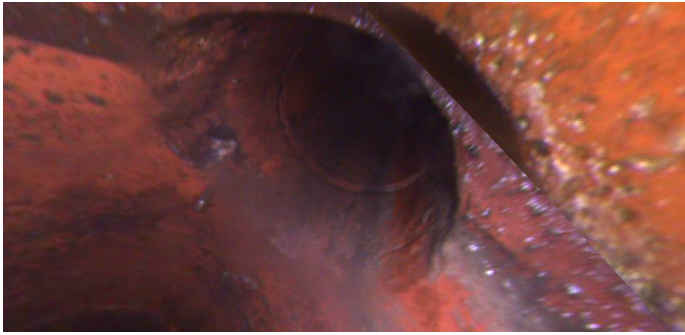
Code: **TF**
Description: **Tap Factory**

Distance (ft): **197.3**
Structural Grade: **0**
O&M Grade: **0**
Clock Start/From: **1**
Clock To:
1st Value: **4.000**
2nd Value:
Value Percent:
Continuous Index:
Within 8" of Joint:
Remarks:

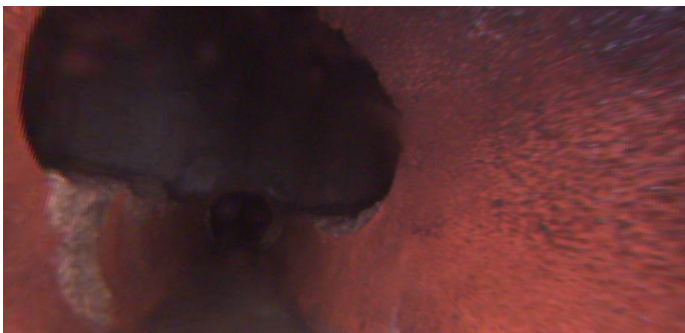
Code: **DSZ**
Description: **Deposits Settled Other**

Distance (ft): **236.2**
Structural Grade: **0**
O&M Grade: **2**
Clock Start/From: **6**
Clock To:
1st Value:
2nd Value:
Value Percent: **5.000**
Continuous Index: **F01**
Within 8" of Joint: **NO**
Remarks: **tissue/debris**

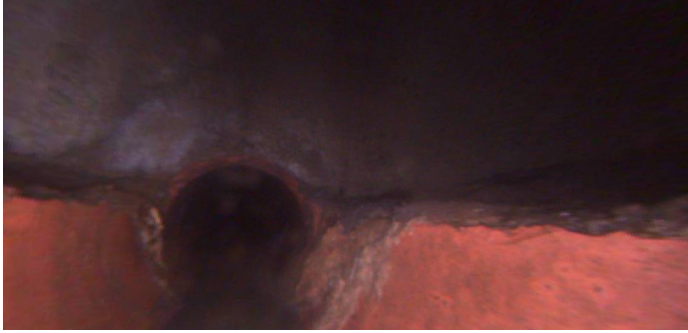
Code:	AMH
Description:	Manhole
Distance (ft):	238.3
Structural Grade:	0
O&M Grade:	0
Clock Start/From:	
Clock To:	
1st Value:	
2nd Value:	
Value Percent:	
Continuous Index:	
Within 8" of Joint:	NO
Remarks:	M-203-037
