## Profile/Photo Observation Report

Street:	<b>ALLEY BETWEEN MAITLAND ST &amp; M</b>	Flow Control:	<b>Not Controlled</b>
City:	<b>Hobart, IN</b>	Year Renewed:	
Location:	<b>Other</b>	Tape/Media #:	
Purpose:	<b>Not Known</b>	Dia/Height:	<b>8"</b>
Use:	<b>Sanitary</b>	Material:	<b>VCP</b>
Drain Area:	<b>NA</b>	Lining:	
Category:	<b>NA</b>		
Comment:

Location Details:		Direction of Survey:	<b>Downstream</b>
US MH:	<b>M-203-039</b>	DS MH:	<b>M-203-040</b>
		Total Length Surveyed (ft):	<b>103.8</b>

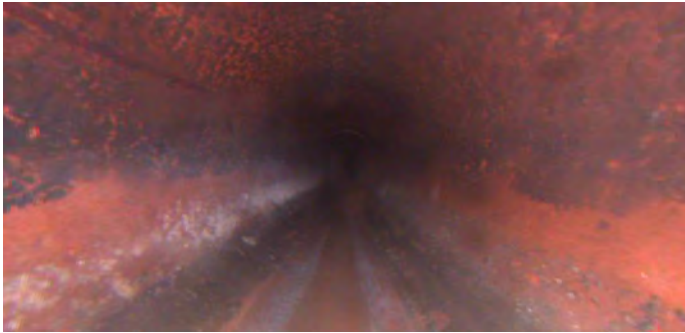
Code:	<b>MWL</b>
Description:	<b>Water Level</b>

Distance (ft):	<b>.0</b>
Structural Grade:	<b>0</b>
O&M Grade:	<b>0</b>
Clock Start/From:	
Clock To:	
1st Value:	
2nd Value:	
Value Percent:	<b>5.000</b>
Continuous Index:	
Within 8" of Joint:	<b>NO</b>
Remarks:

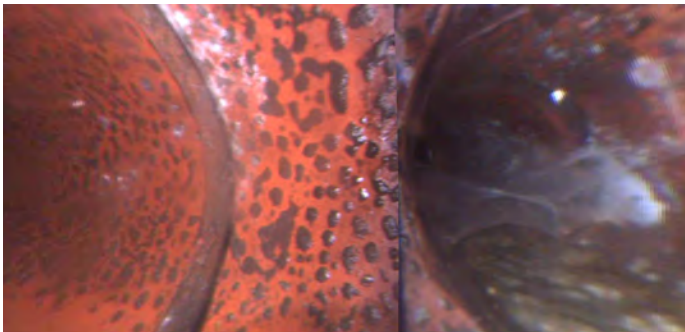
Code:	<b>TFD</b>
Description:	<b>Tap Factory Defective</b>

Distance (ft):	<b>56.0</b>
Structural Grade:	<b>0</b>
O&M Grade:	<b>2</b>
Clock Start/From:	<b>3</b>
Clock To:	
1st Value:	<b>4.000</b>
2nd Value:	
Value Percent:	
Continuous Index:	
Within 8" of Joint:	<b>YES</b>
Remarks:	<b>partially blocked</b>

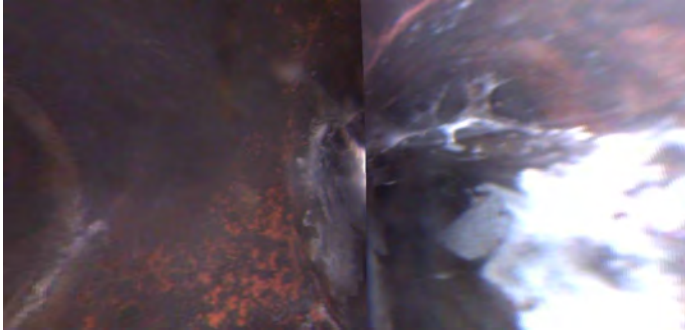
Code: **TF**  
Description: **Tap Factory**

Distance (ft): **87.7**  
Structural Grade: **0**  
O&M Grade: **0**  
Clock Start/From: **3**  
Clock To:  
1st Value: **4.000**  
2nd Value:  
Value Percent:  
Continuous Index:  
Within 8" of Joint: **YES**  
Remarks:

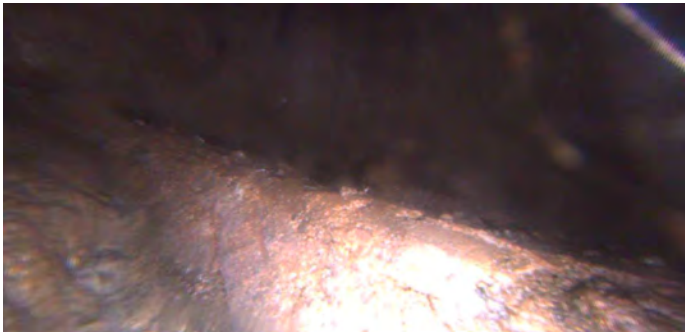
Code: **AMH**  
Description: **Manhole**

Distance (ft): **103.8**  
Structural Grade: **0**  
O&M Grade: **0**  
Clock Start/From:  
Clock To:  
1st Value:  
2nd Value:  
Value Percent:  
Continuous Index:  
Within 8" of Joint: **NO**  
Remarks: **M-203-040**
