## Profile/Photo Observation Report

Street:	<b>W 38TH AVE</b>	Flow Control:	<b>Not Controlled</b>
City:	<b>Hobart, IN</b>	Year Renewed:	
Location:	<b>Other</b>	Tape/Media #:	
Purpose:	<b>Not Known</b>	Dia/Height:	<b>12"</b>
Use:	<b>Sanitary</b>	Material:	<b>VCP</b>
Drain Area:	<b>NA</b>	Lining:	
Category:	<b>NA</b>		
Comment:	<b>pump</b>

Location Details:		Direction of Survey:	<b>Downstream</b>
US MH:	<b>M-203-041</b>	DS MH:	<b>M-203-034</b>
		Total Length Surveyed (ft):	<b>49.5</b>

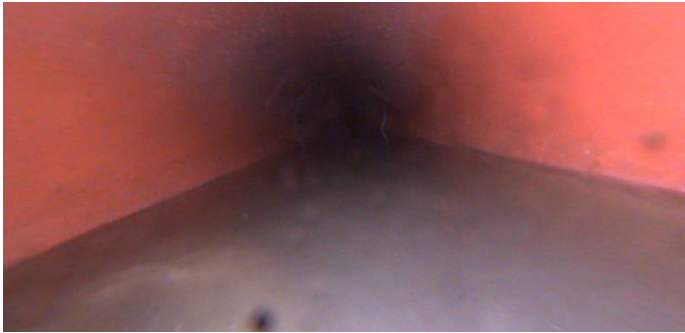
Code:	<b>MWL</b>
Description:	<b>Water Level</b>

Distance (ft):	<b>.0</b>
Structural Grade:	<b>0</b>
O&M Grade:	<b>0</b>
Clock Start/From:	
Clock To:	
1st Value:	
2nd Value:	
Value Percent:	<b>25.000</b>
Continuous Index:	
Within 8" of Joint:	<b>NO</b>
Remarks:

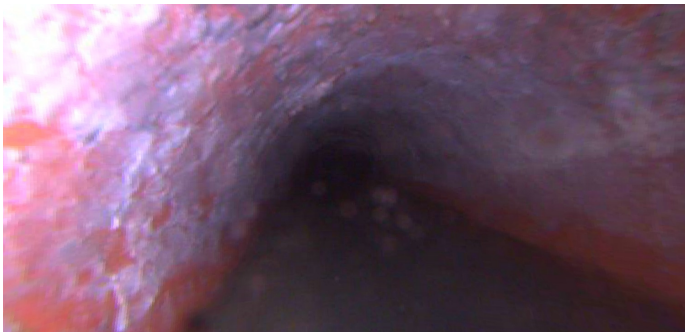
Code:	<b>MWL</b>
Description:	<b>Water Level</b>

Distance (ft):	<b>46.6</b>
Structural Grade:	<b>0</b>
O&M Grade:	<b>0</b>
Clock Start/From:	
Clock To:	
1st Value:	
2nd Value:	
Value Percent:	<b>20.000</b>
Continuous Index:	
Within 8" of Joint:	<b>NO</b>
Remarks:

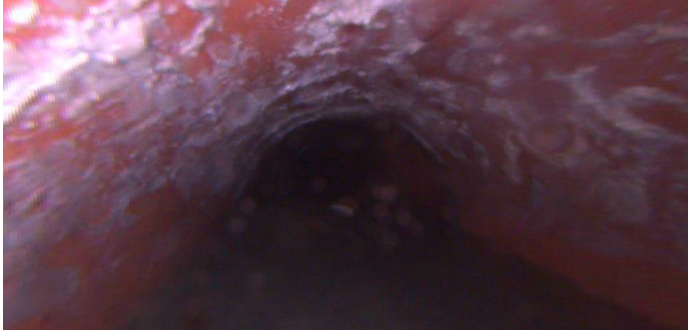
Code:	<b>MSA</b>
Description:	<b>Abandoned Survey</b>
Distance (ft):	<b>49.5</b>
Structural Grade:	<b>0</b>
O&M Grade:	<b>0</b>
Clock Start/From:	
Clock To:	
1st Value:	
2nd Value:	
Value Percent:	
Continuous Index:	
Within 8" of Joint:	<b>NO</b>
Remarks:	<b>debris under water</b>
