Profile/Photo Observation Report

Street:	E 38th Ave	Flow Control:	Not Controlled
City:	Hobart, IN	Year Renewed:	
Location:	Other	Tape/Media #:	
Purpose:	Not Known	Dia/Height:	12"
Use:	Sanitary	Material:	VCP
Drain Area:	NA	Lining:	
Category:	NA		
Comment:	pump

Location Details:		Direction of Survey:	Downstream
US MH:	M-203-041	DS MH:	M-203-034
		Total Length Surveyed (ft):	49.5

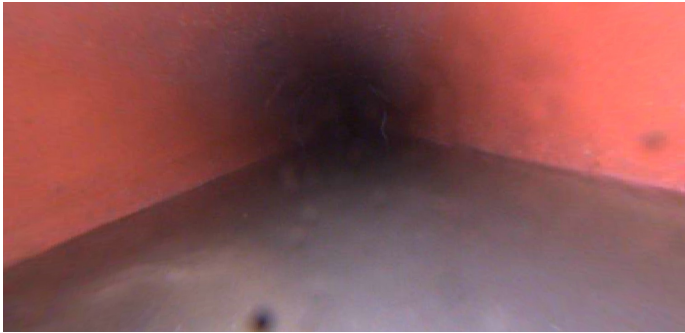
Code:	MWL
Description:	Water Level

Distance (ft):	.0
Structural Grade:	0
O&M Grade:	0
Clock Start/From:	
Clock To:	
1st Value:	
2nd Value:	
Value Percent:	25.000
Continuous Index:	
Within 8" of Joint:	NO
Remarks:

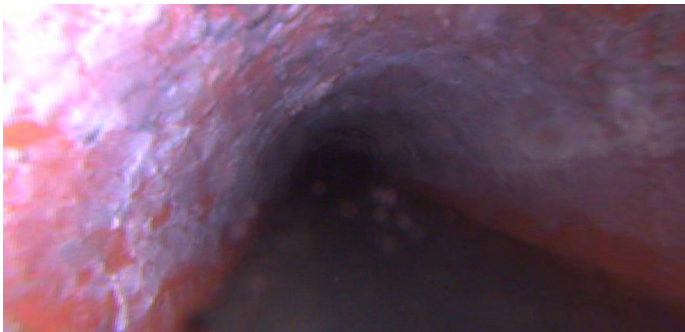
Code:	MWL
Description:	Water Level

Distance (ft):	46.6
Structural Grade:	0
O&M Grade:	0
Clock Start/From:	
Clock To:	
1st Value:	
2nd Value:	
Value Percent:	20.000
Continuous Index:	
Within 8" of Joint:	NO
Remarks:

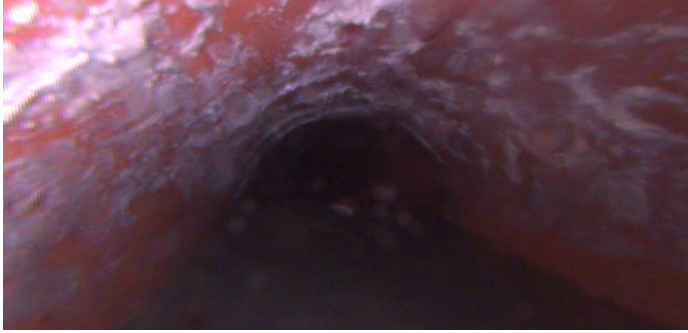
Code:	MSA
Description:	Abandoned Survey
Distance (ft):	49.5
Structural Grade:	0
O&M Grade:	0
Clock Start/From:	
Clock To:	
1st Value:	
2nd Value:	
Value Percent:	
Continuous Index:	
Within 8" of Joint:	NO
Remarks:	debris under water
