Profile/Photo Observation Report

Date:	03/24/2018	Weather:		Coding:	PACP 6.0
Pipe Length (ft):	326.5	Owner:	NA	Pre Clean:	Not Known
P.O.#:		Surveyor:	Byrd Fitzgerald	PSR:	P-203-034-041
Customer:		Clean Date:	01/01/1900	Shape:	C

Street:	W 38TH AVE	Flow Control:	Not Controlled
City:	Hobart, IN	Year Renewed:	
Location:	Other	Tape/Media #:	
Purpose:	Not Known	Dia/Height:	12"
Use:	Sanitary	Material:	VCP
Drain Area:	NA	Lining:	
Category:	NA		
Comment:	pump

Location Details:		Direction of Survey:	Upstream
US MH:	M-203-041	DS MH:	M-203-034
		Total Length Surveyed (ft):	72.5

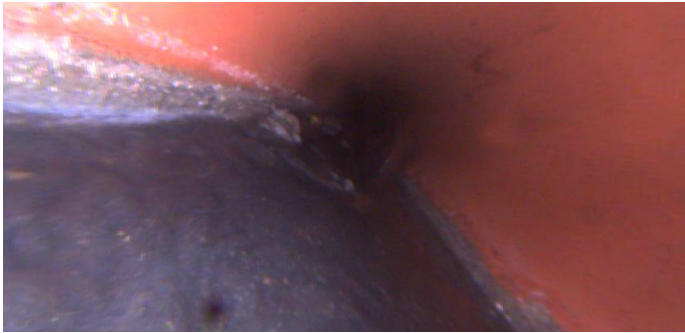
Code:	MWL
Description:	Water Level

Distance (ft):	.0
Structural Grade:	0
O&M Grade:	0
Clock Start/From:	
Clock To:	
1st Value:	
2nd Value:	
Value Percent:	5.000
Continuous Index:	
Within 8" of Joint:	NO
Remarks:

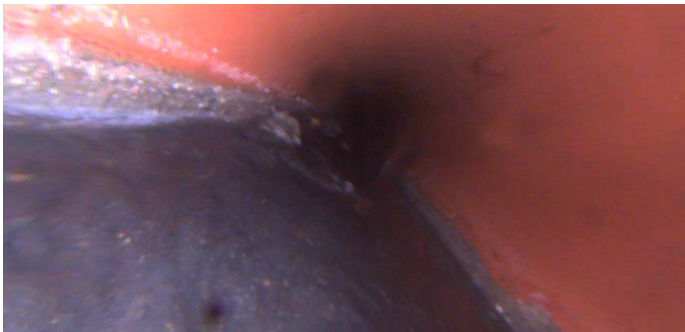
Code:	DSZ
Description:	Deposits Settled Other

Distance (ft):	.0
Structural Grade:	0
O&M Grade:	2
Clock Start/From:	6
Clock To:	
1st Value:	
2nd Value:	
Value Percent:	5.000
Continuous Index:	S01
Within 8" of Joint:	NO
Remarks:	tissue

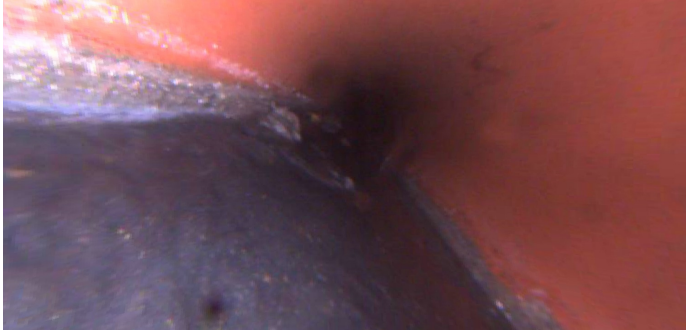
Code: **MGO**
Description: **General Observation**

Distance (ft): **.0**
Structural Grade: **0**
O&M Grade: **0**
Clock Start/From:
Clock To:
1st Value:
2nd Value:
Value Percent:
Continuous Index:
Within 8" of Joint: **NO**
Remarks: **heavy sediments in flow**

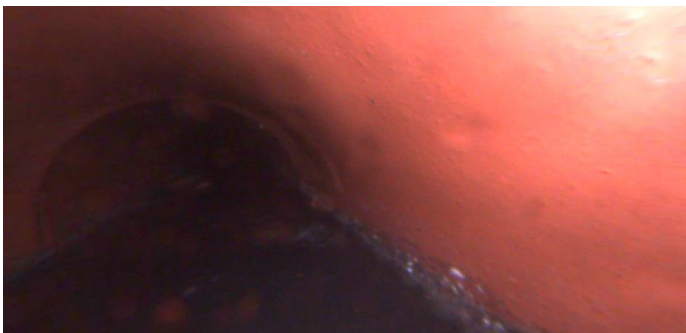
Code: **MWL**
Description: **Water Level**

Distance (ft): **13.3**
Structural Grade: **0**
O&M Grade: **0**
Clock Start/From:
Clock To:
1st Value:
2nd Value:
Value Percent: **30.000**
Continuous Index:
Within 8" of Joint: **NO**
Remarks:

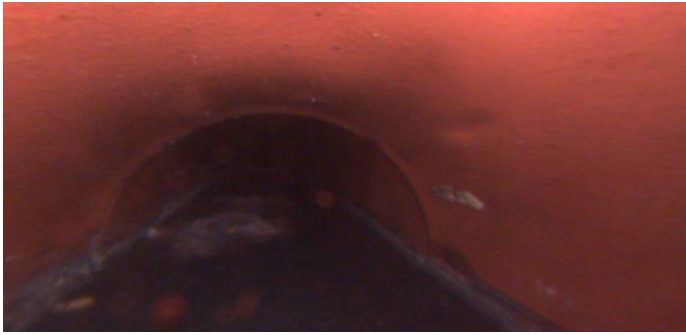
Code: **MWL**
Description: **Water Level**

Distance (ft): **63.7**
Structural Grade: **0**
O&M Grade: **0**
Clock Start/From:
Clock To:
1st Value:
2nd Value:
Value Percent: **50.000**
Continuous Index:
Within 8" of Joint: **NO**
Remarks:

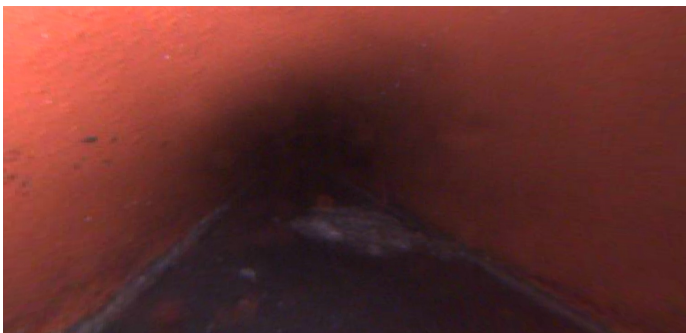
Code: **MSA**
Description: **Abandoned Survey**

Distance (ft): **72.5**
Structural Grade: **0**
O&M Grade: **0**
Clock Start/From:
Clock To:
1st Value:
2nd Value:
Value Percent:
Continuous Index:
Within 8" of Joint: **NO**
Remarks: **debris under water**

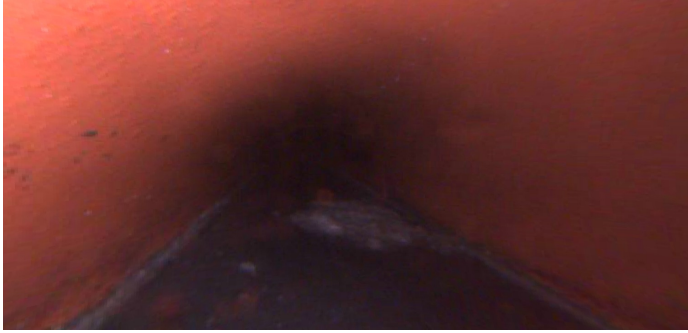
Code:	DSZ
Description:	Deposits Settled Other
Distance (ft):	72.5
Structural Grade:	0
O&M Grade:	2
Clock Start/From:	6
Clock To:	
1st Value:	
2nd Value:	
Value Percent:	5.000
Continuous Index:	F01
Within 8" of Joint:	NO
Remarks:	tissue
