Profile/Photo Observation Report

Street:	E 38th Ave	Flow Control:	Not Controlled
City:	Hobart, IN	Year Renewed:	
Location:	Other	Tape/Media #:	
Purpose:	Not Known	Dia/Height:	12"
Use:	Sanitary	Material:	VCP
Drain Area:	NA	Lining:	
Category:	NA		
Comment:	pump

Location Details:		Direction of Survey:	Upstream
US MH:	M-203-041	DS MH:	M-203-034
		Total Length Surveyed (ft):	72.5

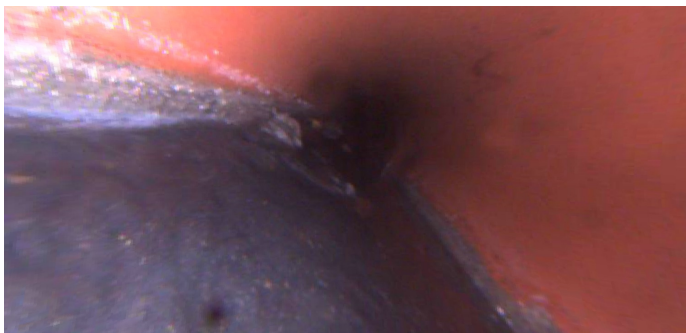
Code: **AMH**
Description: **Manhole**

Distance (ft): **.0**
Structural Grade: **0**
O&M Grade: **0**
Clock Start/From:
Clock To:
1st Value:
2nd Value:
Value Percent:
Continuous Index:
Within 8" of Joint: **NO**
Remarks: **M-203-034**

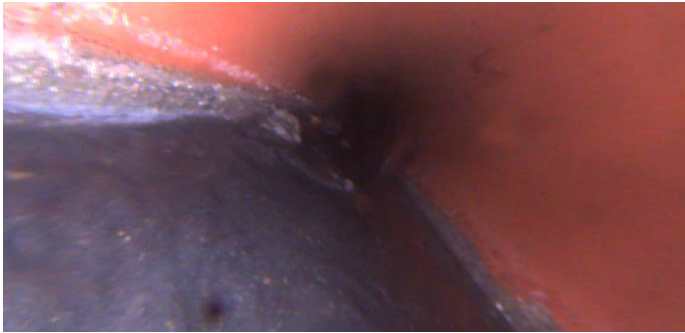
Code:	MWL
Description:	Water Level

Distance (ft):	.0
Structural Grade:	0
O&M Grade:	0
Clock Start/From:	
Clock To:	
1st Value:	
2nd Value:	
Value Percent:	5.000
Continuous Index:	
Within 8" of Joint:	NO
Remarks:

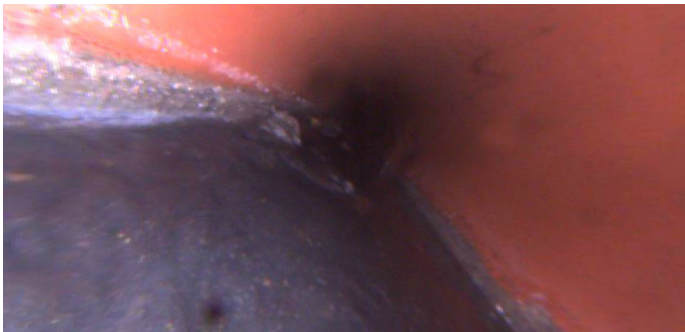
Code:	DSZ
Description:	Deposits Settled Other

Distance (ft):	.0
Structural Grade:	0
O&M Grade:	2
Clock Start/From:	6
Clock To:	
1st Value:	
2nd Value:	
Value Percent:	5.000
Continuous Index:	S01
Within 8" of Joint:	NO
Remarks:	tissue

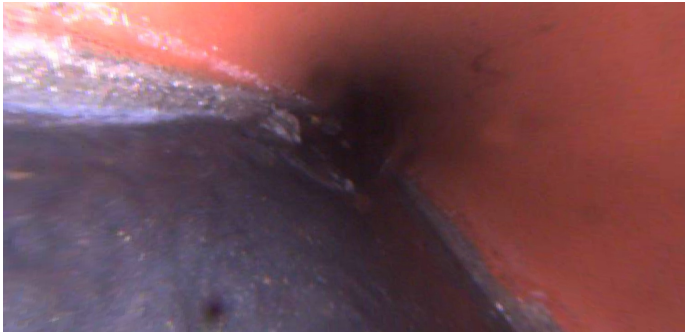
Code: **MGO**
Description: **General Observation**

Distance (ft): **.0**
Structural Grade: **0**
O&M Grade: **0**
Clock Start/From:
Clock To:
1st Value:
2nd Value:
Value Percent:
Continuous Index:
Within 8" of Joint: **NO**
Remarks: **heavy sediments in flow**

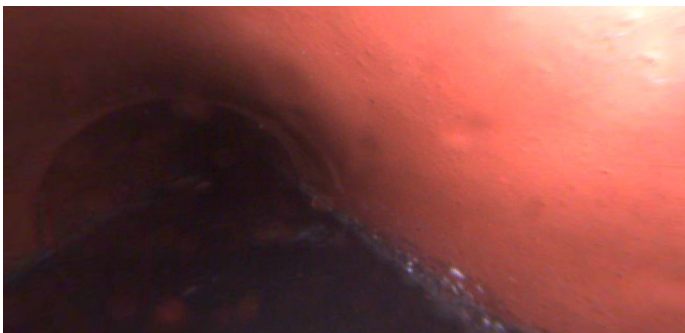
Code: **MWL**
Description: **Water Level**

Distance (ft): **13.3**
Structural Grade: **0**
O&M Grade: **0**
Clock Start/From:
Clock To:
1st Value:
2nd Value:
Value Percent: **30.000**
Continuous Index:
Within 8" of Joint: **NO**
Remarks:

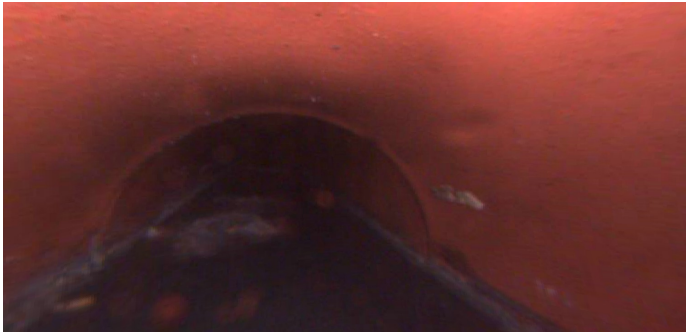
Code: **MWL**
Description: **Water Level**

Distance (ft): **63.7**
Structural Grade: **0**
O&M Grade: **0**
Clock Start/From:
Clock To:
1st Value:
2nd Value:
Value Percent: **50.000**
Continuous Index:
Within 8" of Joint: **NO**
Remarks:

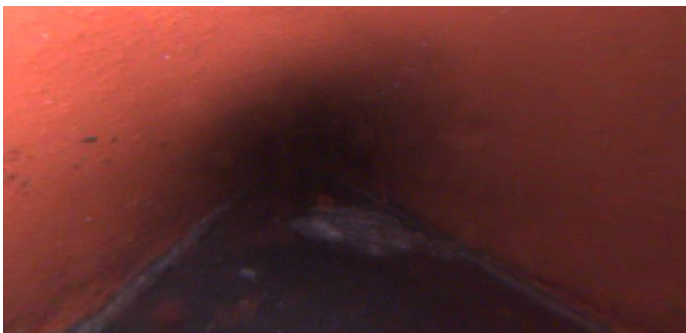
Code: **MSA**
Description: **Abandoned Survey**

Distance (ft): **72.5**
Structural Grade: **0**
O&M Grade: **0**
Clock Start/From:
Clock To:
1st Value:
2nd Value:
Value Percent:
Continuous Index:
Within 8" of Joint: **NO**
Remarks: **debris under water**

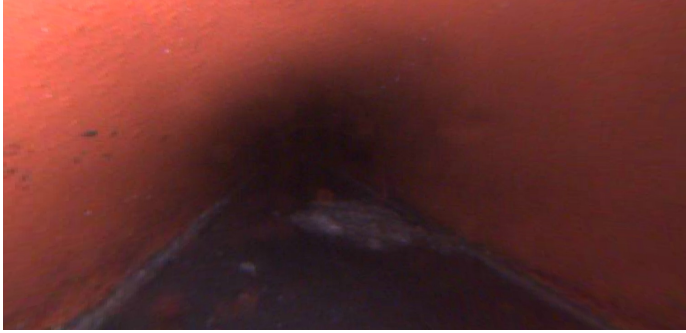
Code:	DSZ
Description:	Deposits Settled Other
Distance (ft):	72.5
Structural Grade:	0
O&M Grade:	2
Clock Start/From:	6
Clock To:	
1st Value:	
2nd Value:	
Value Percent:	5.000
Continuous Index:	F01
Within 8" of Joint:	NO
Remarks:	tissue
