Profile/Photo Observation Report

Street:	W 38TH AVE	Flow Control:	Not Controlled
City:	Hobart, IN	Year Renewed:	
Location:	Other	Tape/Media #:	
Purpose:	Not Known	Dia/Height:	10"
Use:	Sanitary	Material:	VCP
Drain Area:	NA	Lining:	
Category:	NA		
Comment:

Location Details:		Direction of Survey:	Downstream
US MH:	M-203-041	DS MH:	M-203-042
		Total Length Surveyed (ft):	102.8

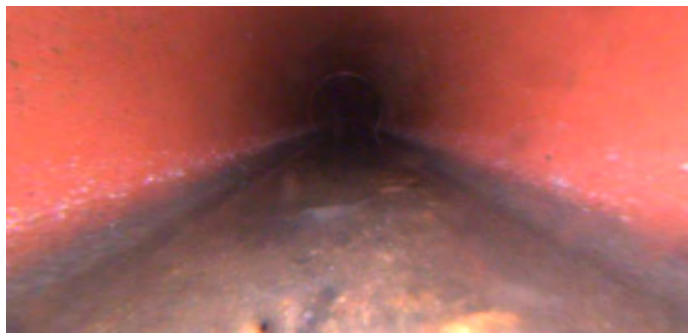
Code: **AMH**
Description: **Manhole**

Distance (ft): **.0**
Structural Grade: **0**
O&M Grade: **0**
Clock Start/From:
Clock To:
1st Value:
2nd Value:
Value Percent:
Continuous Index:
Within 8" of Joint: **NO**
Remarks: **M-203-041**

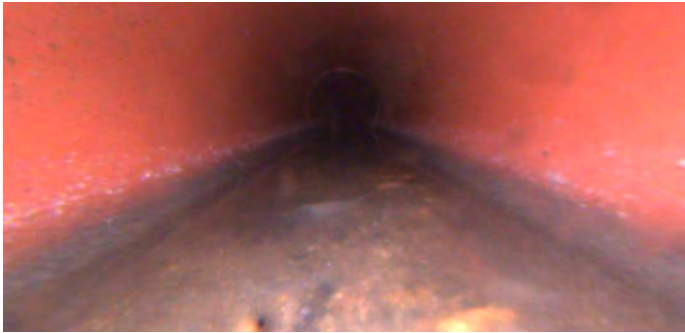
Code:	MWL
Description:	Water Level

Distance (ft):	.0
Structural Grade:	0
O&M Grade:	0
Clock Start/From:	
Clock To:	
1st Value:	
2nd Value:	
Value Percent:	5.000
Continuous Index:	
Within 8" of Joint:	NO
Remarks:

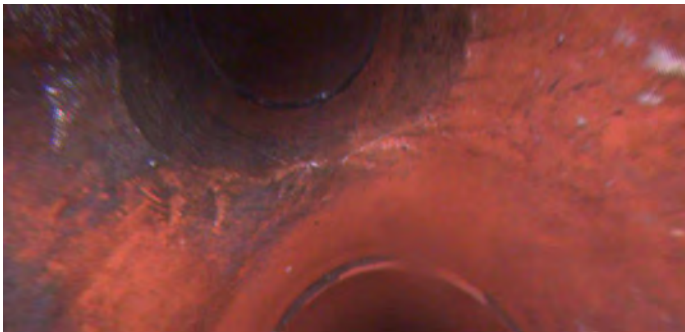
Code:	TF
Description:	Tap Factory

Distance (ft):	60.5
Structural Grade:	0
O&M Grade:	0
Clock Start/From:	11
Clock To:	
1st Value:	4.000
2nd Value:	
Value Percent:	
Continuous Index:	
Within 8" of Joint:	YES
Remarks:

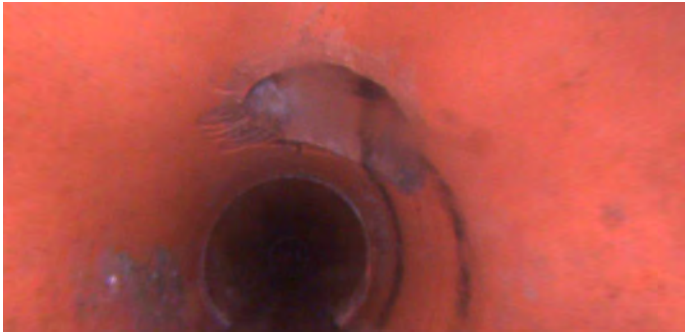
Code: **TF**
Description: **Tap Factory**

Distance (ft): **67.1**
Structural Grade: **0**
O&M Grade: **0**
Clock Start/From: **1**
Clock To:
1st Value: **4.000**
2nd Value:
Value Percent:
Continuous Index:
Within 8" of Joint: **YES**
Remarks:

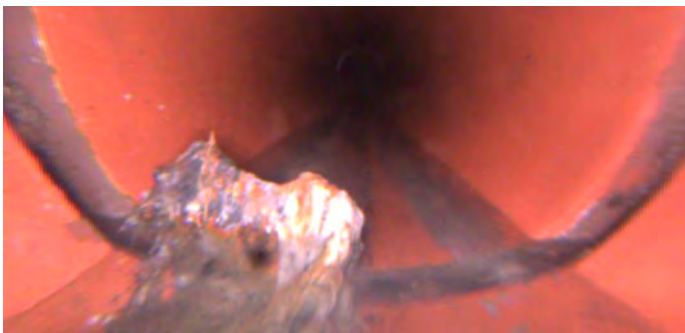
Code: **DAZ**
Description: **Deposits Attached Other**

Distance (ft): **93.3**
Structural Grade: **0**
O&M Grade: **2**
Clock Start/From: **6**
Clock To: **7**
1st Value:
2nd Value:
Value Percent: **5.000**
Continuous Index:
Within 8" of Joint: **YES**
Remarks: **unknown deposits**

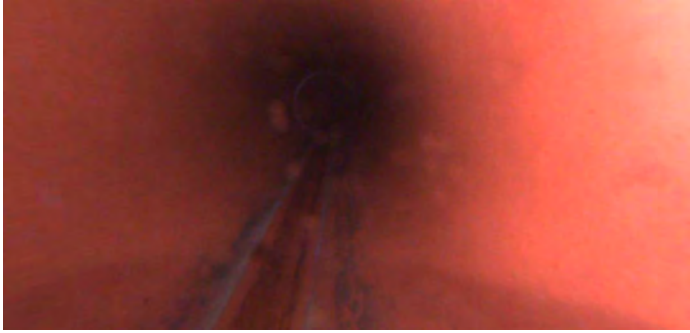
Code:	MSA
Description:	Abandoned Survey
Distance (ft):	102.8
Structural Grade:	0
O&M Grade:	0
Clock Start/From:	
Clock To:	
1st Value:	
2nd Value:	
Value Percent:	
Continuous Index:	
Within 8" of Joint:	NO
Remarks:	stuck on daz?
