## Profile/Photo Observation Report

| Street: | <b>E 38th Ave</b> | Flow Control: | <b>Not Controlled</b> |
| City: | <b>Hobart, IN</b> | Year Renewed: | |

| US MH: | <b>M-203-041</b> | DS MH: | <b>M-203-042</b> |

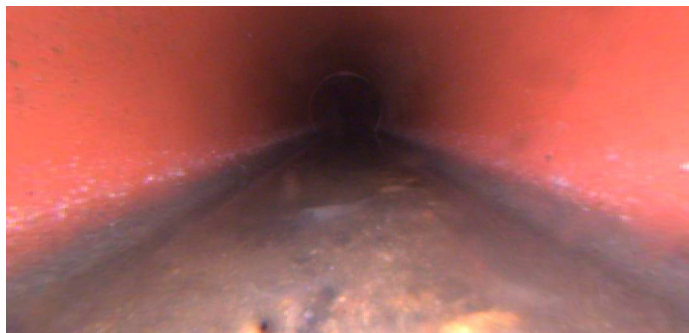
Code: **AMH**  
Description: **Manhole**

Distance (ft): **.0**  
Structural Grade: **0**  
O&M Grade: **0**  
Clock Start/From:  
Clock To:  
1st Value:  
2nd Value:  
Value Percent:  
Continuous Index:  
Within 8" of Joint: **NO**  
Remarks: **M-203-041**

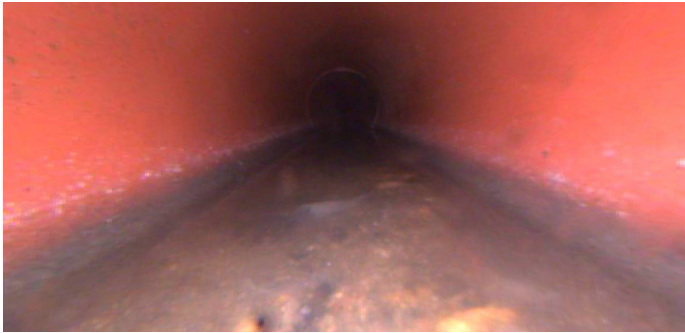
| Code: | <b>MWL</b> |
| Description: | <b>Water Level</b> |

| Value Percent: | <b>5.000</b> |

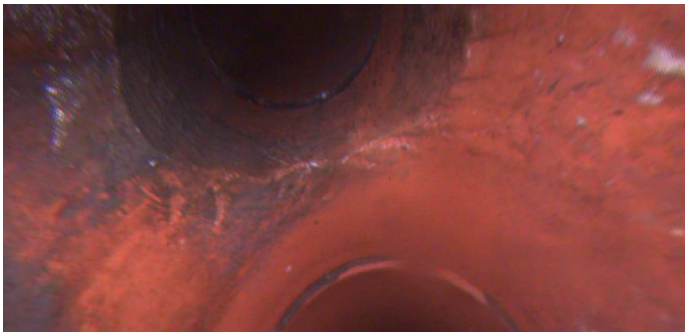
| Code: | <b>TF</b> |
| Description: | <b>Tap Factory</b> |

| Distance (ft): | <b>60.5</b> |
| Clock Start/From: | <b>11</b> |
| Within 8" of Joint: | <b>YES</b> |

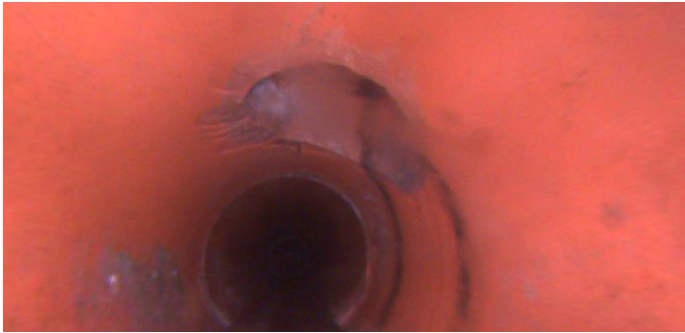
Code: **TF**  
Description: **Tap Factory**

Distance (ft): **67.1**  
Structural Grade: **0**  
O&M Grade: **0**  
Clock Start/From: **1**  
Clock To:  
1st Value: **4.000**  
2nd Value:  
Value Percent:  
Continuous Index:  
Within 8" of Joint: **YES**  
Remarks:

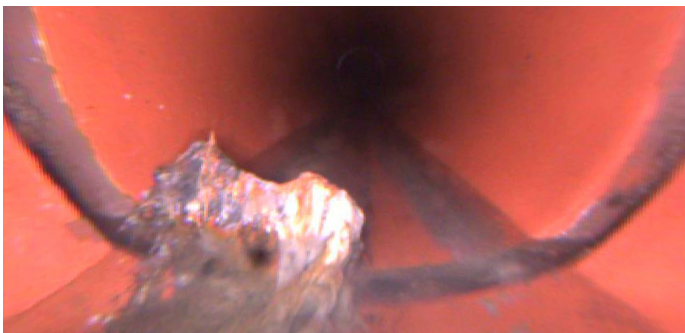
| | Position | Code | Observation | Video (sec) | Grade |
|--|---|---|---|---|---|
| | 93.3 | DAZ | Deposits Attached Other | 243 | M 2 |

Code: **DAZ**  
Description: **Deposits Attached Other**

Distance (ft): **93.3**  
Structural Grade: **0**  
O&M Grade: **2**  
Clock Start/From: **6**  
Clock To: **7**  
1st Value:  
2nd Value:  
Value Percent: **5.000**  
Continuous Index:  
Within 8" of Joint: **YES**  
Remarks: **unknown deposits**

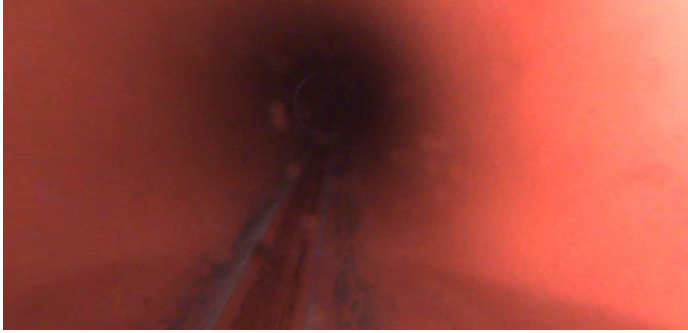
| Code: | <b>MSA</b> |
| Description: | <b>Abandoned Survey</b> |
| Distance (ft): | <b>102.8</b> |
| Remarks: | <b>stuck on daz?</b> |
