Profile/Photo Observation Report

Date:	03/25/2018	Weather:		Coding:	PACP 6.0
Pipe Length (ft):	146.0	Owner:	NA	Pre Clean:	Not Known
P.O.#:		Surveyor:	Byrd Fitzgerald	PSR:	P-203-042-041
Customer:		Clean Date:	01/01/1900	Shape:	C

Street:	W 38TH AVE	Flow Control:	Not Controlled
City:	Hobart, IN	Year Renewed:	
Location:	Other	Tape/Media #:	
Purpose:	Not Known	Dia/Height:	10"
Use:	Sanitary	Material:	VCP
Drain Area:	NA	Lining:	
Category:	NA		
Comment:

Location Details:		Direction of Survey:	Upstream
US MH:	M-203-041	DS MH:	M-203-042
		Total Length Surveyed (ft):	47.0

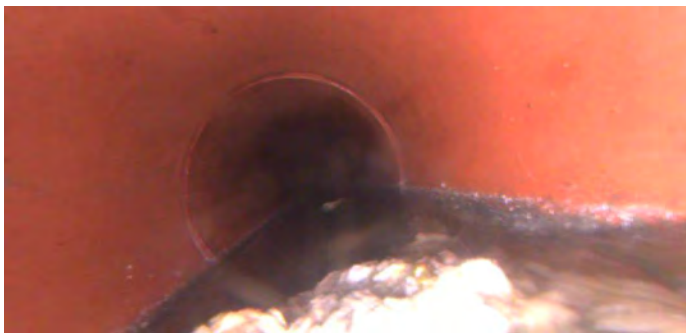
Code: **AMH**
Description: **Manhole**

Distance (ft): **.0**
Structural Grade: **0**
O&M Grade: **0**
Clock Start/From:
Clock To:
1st Value:
2nd Value:
Value Percent:
Continuous Index:
Within 8" of Joint: **NO**
Remarks: **M-203-042**

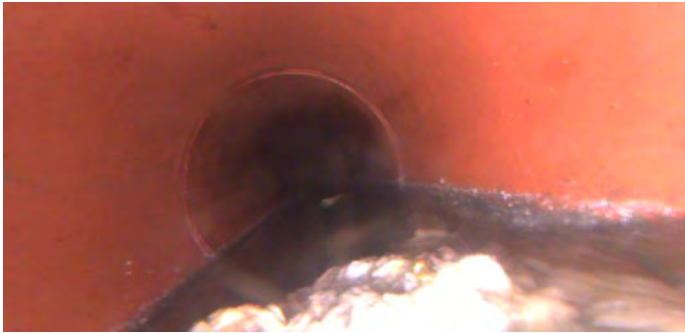
Code:	MWL
Description:	Water Level

Distance (ft):	.0
Structural Grade:	0
O&M Grade:	0
Clock Start/From:	
Clock To:	
1st Value:	
2nd Value:	
Value Percent:	5.000
Continuous Index:	
Within 8" of Joint:	NO
Remarks:

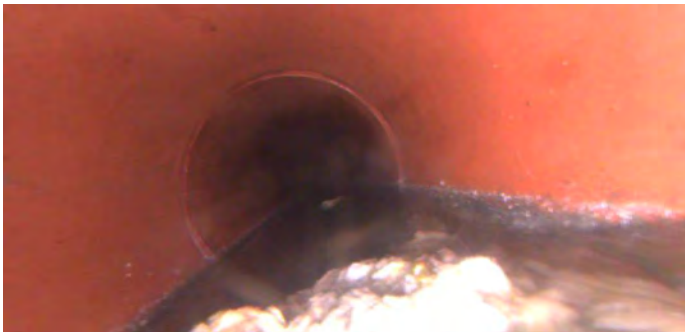
Code:	DSZ
Description:	Deposits Settled Other

Distance (ft):	.0
Structural Grade:	0
O&M Grade:	2
Clock Start/From:	6
Clock To:	
1st Value:	
2nd Value:	
Value Percent:	5.000
Continuous Index:	
Within 8" of Joint:	NO
Remarks:	debris

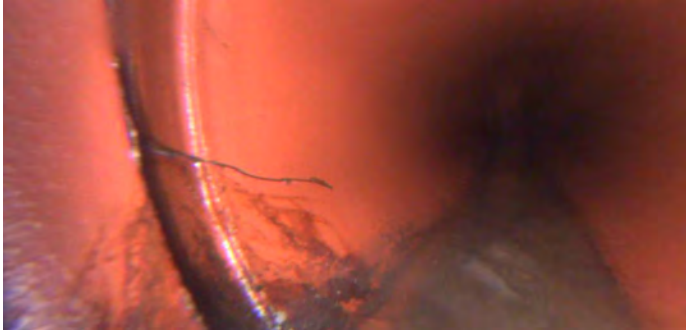
Code: **RFJ**
Description: **Roots Fine Joint**

Distance (ft): **7.4**
Structural Grade: **0**
O&M Grade: **1**
Clock Start/From: **9**
Clock To:
1st Value:
2nd Value:
Value Percent:
Continuous Index:
Within 8" of Joint: **YES**
Remarks:

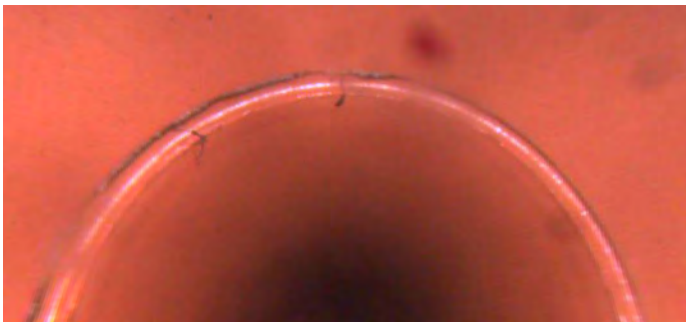
Code: **CM**
Description: **Crack Multiple**

Distance (ft): **12.1**
Structural Grade: **3**
O&M Grade: **0**
Clock Start/From: **11**
Clock To: **12**
1st Value:
2nd Value:
Value Percent:
Continuous Index:
Within 8" of Joint: **YES**
Remarks: **wandering**

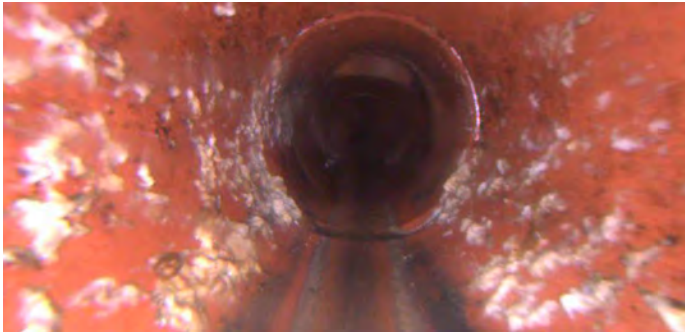
Code: **DAGS**
Description: **Deposits Attached Grease**

Distance (ft): **16.6**
Structural Grade: **0**
O&M Grade: **2**
Clock Start/From: **8**
Clock To: **4**
1st Value:
2nd Value:
Value Percent: **5.000**
Continuous Index:
Within 8" of Joint: **NO**
Remarks:

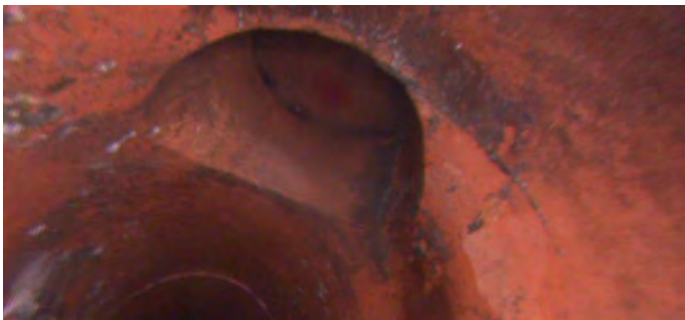
Code: **TF**
Description: **Tap Factory**

Distance (ft): **17.8**
Structural Grade: **0**
O&M Grade: **0**
Clock Start/From: **1**
Clock To:
1st Value: **4.000**
2nd Value:
Value Percent:
Continuous Index:
Within 8" of Joint: **YES**
Remarks:

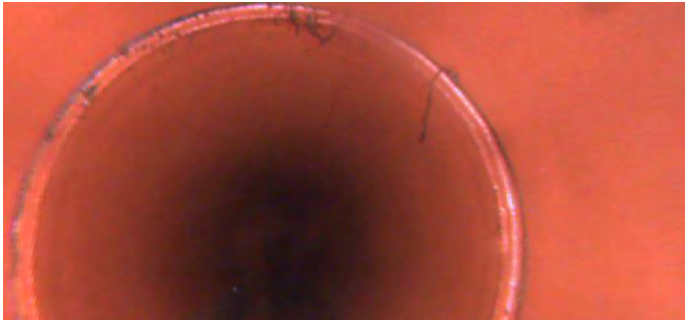
Code: **RFJ**
Description: **Roots Fine Joint**

Distance (ft): **24.1**
Structural Grade: **0**
O&M Grade: **1**
Clock Start/From: **12**
Clock To: **1**
1st Value:
2nd Value:
Value Percent:
Continuous Index: **S01**
Within 8" of Joint: **YES**
Remarks: **wandering**

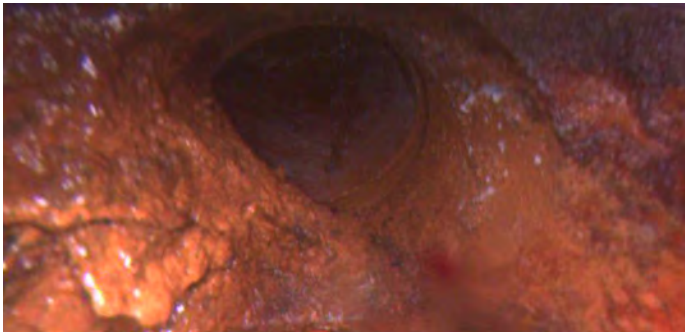
Code: **TFD**
Description: **Tap Factory Defective**

Distance (ft): **30.3**
Structural Grade: **0**
O&M Grade: **2**
Clock Start/From: **12**
Clock To:
1st Value: **4.000**
2nd Value:
Value Percent:
Continuous Index:
Within 8" of Joint:
Remarks: **DAE**

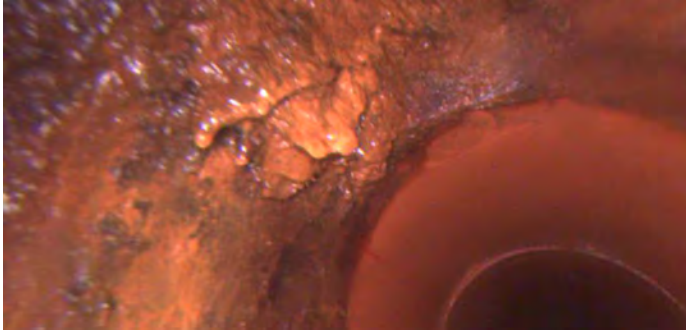
Code: **DAE**
Description: **Deposits Attached Encrustation**

Distance (ft): **30.3**
Structural Grade: **0**
O&M Grade: **2**
Clock Start/From: **8**
Clock To: **12**
1st Value:
2nd Value:
Value Percent: **10.000**
Continuous Index:
Within 8" of Joint: **NO**
Remarks:

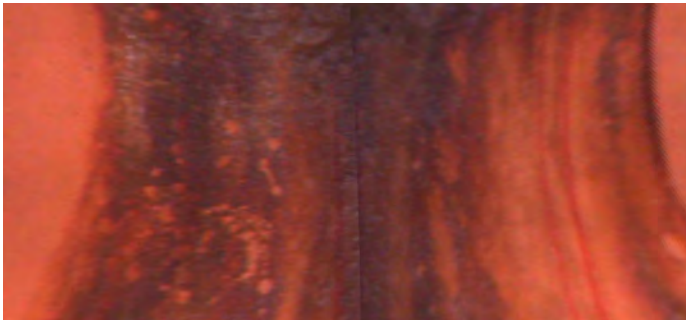
Code: **IS**
Description: **Infil Stain**

Distance (ft): **30.6**
Structural Grade: **0**
O&M Grade: **0**
Clock Start/From: **7**
Clock To: **5**
1st Value:
2nd Value:
Value Percent:
Continuous Index:
Within 8" of Joint: **YES**
Remarks:

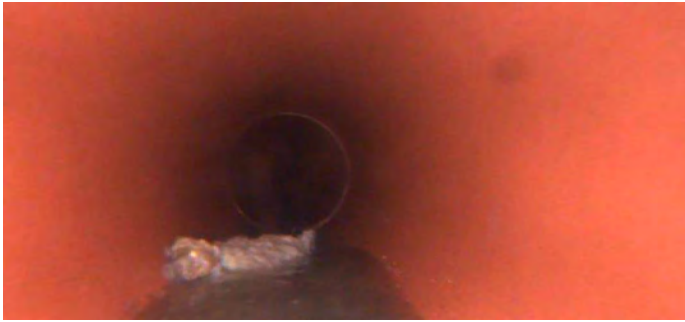
Code: **DSZ**
Description: **Deposits Settled Other**

Distance (ft): **44.6**
Structural Grade: **0**
O&M Grade: **2**
Clock Start/From: **6**
Clock To:
1st Value:
2nd Value:
Value Percent: **5.000**
Continuous Index:
Within 8" of Joint: **NO**
Remarks: **tissue**

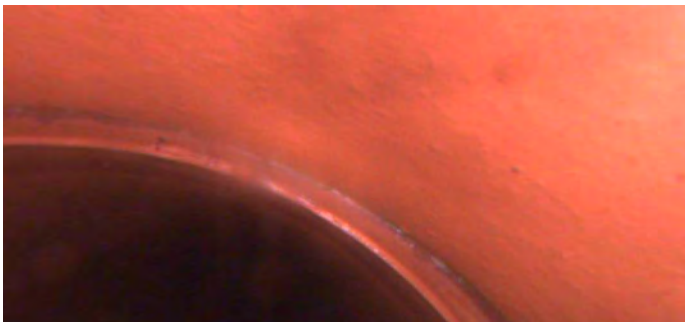
Code: **MSA**
Description: **Abandoned Survey**

Distance (ft): **47.0**
Structural Grade: **0**
O&M Grade: **0**
Clock Start/From:
Clock To:
1st Value:
2nd Value:
Value Percent:
Continuous Index:
Within 8" of Joint: **NO**
Remarks: **stuck on joint/ dsz?**

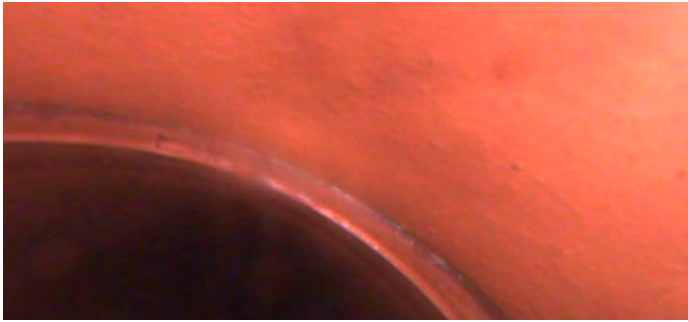
Code:	RFJ
Description:	Roots Fine Joint
Distance (ft):	47.0
Structural Grade:	0
O&M Grade:	1
Clock Start/From:	12
Clock To:	1
1st Value:	
2nd Value:	
Value Percent:	
Continuous Index:	F01
Within 8" of Joint:	YES
Remarks:	wandering
