## Profile/Photo Observation Report

Street:	<b>E 38th Ave</b>	Flow Control:	<b>Not Controlled</b>
City:	<b>Hobart, IN</b>	Year Renewed:	
Location:	<b>Other</b>	Tape/Media #:	
Purpose:	<b>Not Known</b>	Dia/Height:	<b>10"</b>
Use:	<b>Sanitary</b>	Material:	<b>VCP</b>
Drain Area:	<b>NA</b>	Lining:	
Category:	<b>NA</b>		
Comment:

Location Details:		Direction of Survey:	<b>Upstream</b>
US MH:	<b>M-203-041</b>	DS MH:	<b>M-203-042</b>
		Total Length Surveyed (ft):	<b>47.0</b>

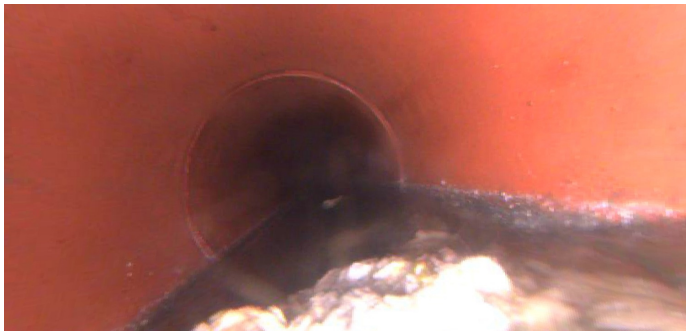
Code: **AMH**  
Description: **Manhole**

Distance (ft): **.0**  
Structural Grade: **0**  
O&M Grade: **0**  
Clock Start/From:  
Clock To:  
1st Value:  
2nd Value:  
Value Percent:  
Continuous Index:  
Within 8" of Joint: **NO**  
Remarks: **M-203-042**

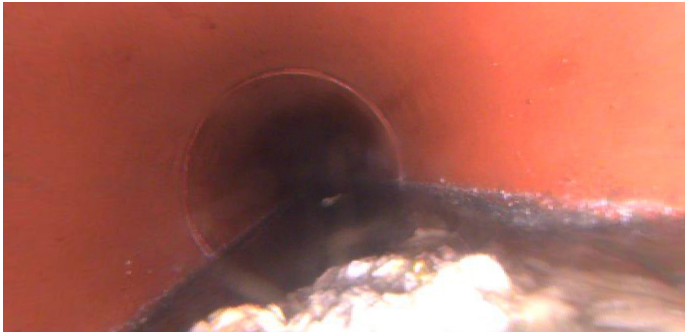
Code:	<b>MWL</b>
Description:	<b>Water Level</b>

Distance (ft):	<b>.0</b>
Structural Grade:	<b>0</b>
O&M Grade:	<b>0</b>
Clock Start/From:	
Clock To:	
1st Value:	
2nd Value:	
Value Percent:	<b>5.000</b>
Continuous Index:	
Within 8" of Joint:	<b>NO</b>
Remarks:

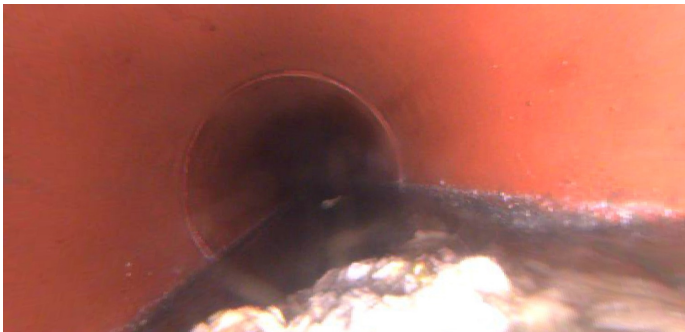
Code:	<b>DSZ</b>
Description:	<b>Deposits Settled Other</b>

Distance (ft):	<b>.0</b>
Structural Grade:	<b>0</b>
O&M Grade:	<b>2</b>
Clock Start/From:	<b>6</b>
Clock To:	
1st Value:	
2nd Value:	
Value Percent:	<b>5.000</b>
Continuous Index:	
Within 8" of Joint:	<b>NO</b>
Remarks:	<b>debris</b>

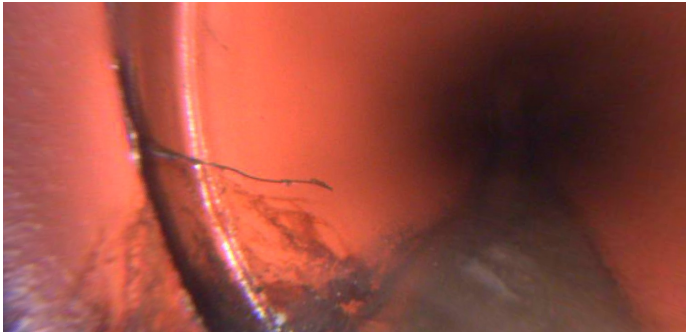
Code: **RFJ**  
Description: **Roots Fine Joint**

Distance (ft): **7.4**  
Structural Grade: **0**  
O&M Grade: **1**  
Clock Start/From: **9**  
Clock To:  
1st Value:  
2nd Value:  
Value Percent:  
Continuous Index:  
Within 8" of Joint: **YES**  
Remarks:

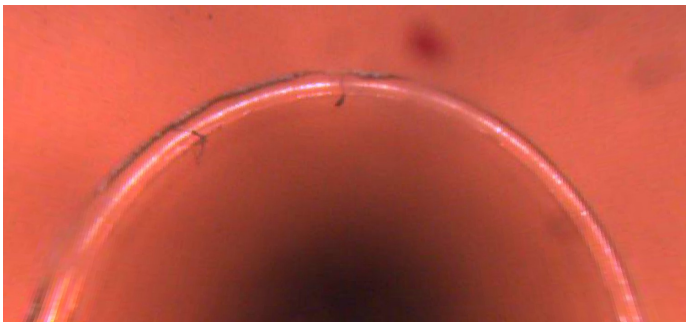
Code: **CM**  
Description: **Crack Multiple**

Distance (ft): **12.1**  
Structural Grade: **3**  
O&M Grade: **0**  
Clock Start/From: **11**  
Clock To: **12**  
1st Value:  
2nd Value:  
Value Percent:  
Continuous Index:  
Within 8" of Joint: **YES**  
Remarks: **wandering**

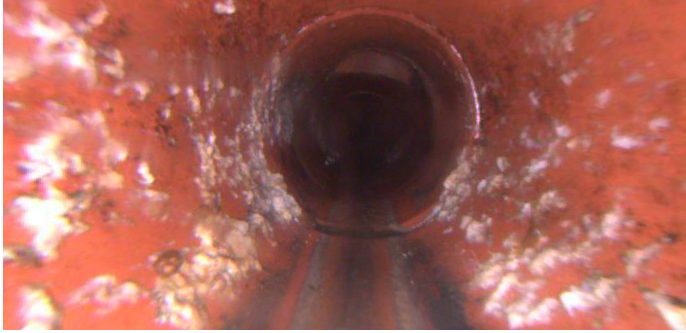
Code: **DAGS**  
Description: **Deposits Attached Grease**

Distance (ft): **16.6**  
Structural Grade: **0**  
O&M Grade: **2**  
Clock Start/From: **8**  
Clock To: **4**  
1st Value:  
2nd Value:  
Value Percent: **5.000**  
Continuous Index:  
Within 8" of Joint: **NO**  
Remarks:

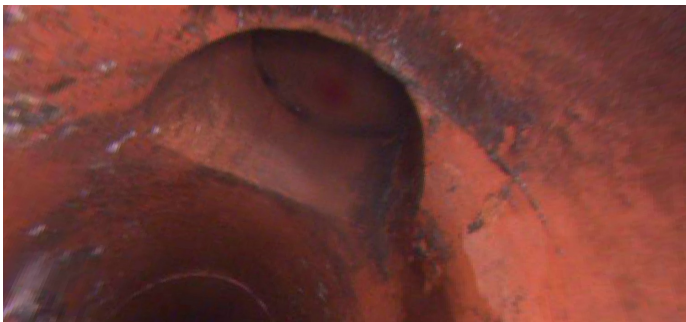
Code: **TF**  
Description: **Tap Factory**

Distance (ft): **17.8**  
Structural Grade: **0**  
O&M Grade: **0**  
Clock Start/From: **1**  
Clock To:  
1st Value: **4.000**  
2nd Value:  
Value Percent:  
Continuous Index:  
Within 8" of Joint: **YES**  
Remarks:

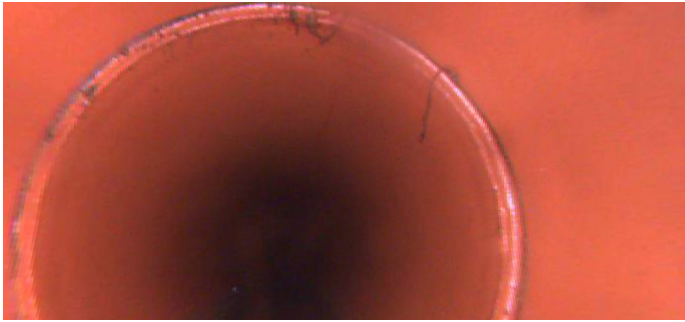
Code: **RFJ**  
Description: **Roots Fine Joint**

Distance (ft): **24.1**  
Structural Grade: **0**  
O&M Grade: **1**  
Clock Start/From: **12**  
Clock To: **1**  
1st Value:  
2nd Value:  
Value Percent:  
Continuous Index: **S01**  
Within 8" of Joint: **YES**  
Remarks: **wandering**

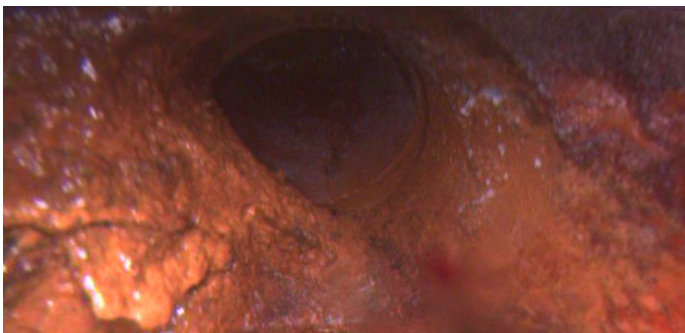
Code: **TFD**  
Description: **Tap Factory Defective**

Distance (ft): **30.3**  
Structural Grade: **0**  
O&M Grade: **2**  
Clock Start/From: **12**  
Clock To:  
1st Value: **4.000**  
2nd Value:  
Value Percent:  
Continuous Index:  
Within 8" of Joint:  
Remarks: **DAE**

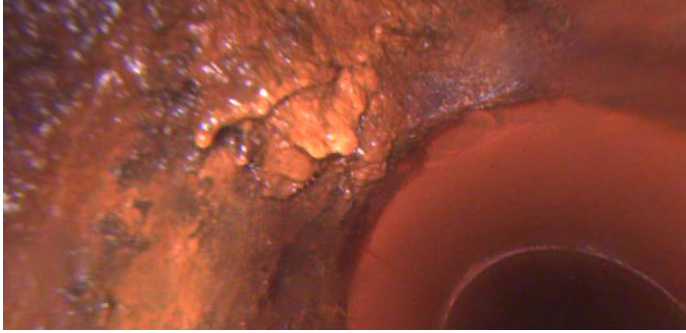
Code: **DAE**  
Description: **Deposits Attached Encrustation**

Distance (ft): **30.3**  
Structural Grade: **0**  
O&M Grade: **2**  
Clock Start/From: **8**  
Clock To: **12**  
1st Value:  
2nd Value:  
Value Percent: **10.000**  
Continuous Index:  
Within 8" of Joint: **NO**  
Remarks:

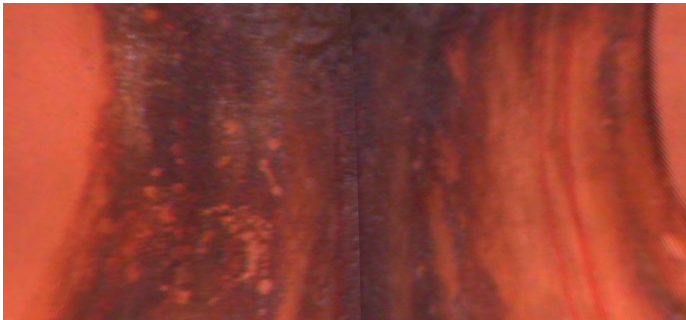
Code: **IS**  
Description: **Infil Stain**

Distance (ft): **30.6**  
Structural Grade: **0**  
O&M Grade: **0**  
Clock Start/From: **7**  
Clock To: **5**  
1st Value:  
2nd Value:  
Value Percent:  
Continuous Index:  
Within 8" of Joint: **YES**  
Remarks:

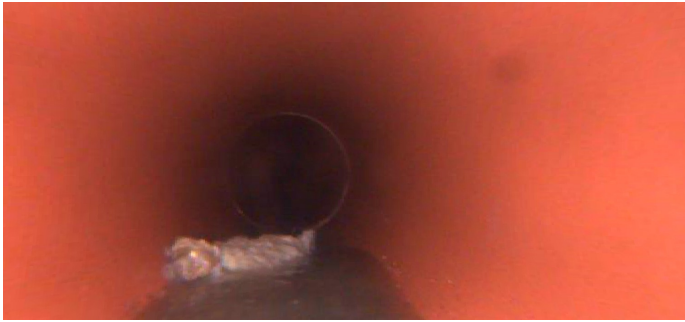
Code: **DSZ**  
Description: **Deposits Settled Other**

Distance (ft): **44.6**  
Structural Grade: **0**  
O&M Grade: **2**  
Clock Start/From: **6**  
Clock To:  
1st Value:  
2nd Value:  
Value Percent: **5.000**  
Continuous Index:  
Within 8" of Joint: **NO**  
Remarks: **tissue**

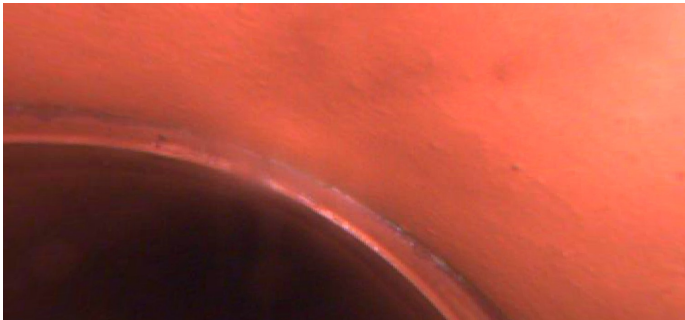
Code: **MSA**  
Description: **Abandoned Survey**

Distance (ft): **47.0**  
Structural Grade: **0**  
O&M Grade: **0**  
Clock Start/From:  
Clock To:  
1st Value:  
2nd Value:  
Value Percent:  
Continuous Index:  
Within 8" of Joint: **NO**  
Remarks: **stuck on joint/ dsz?**

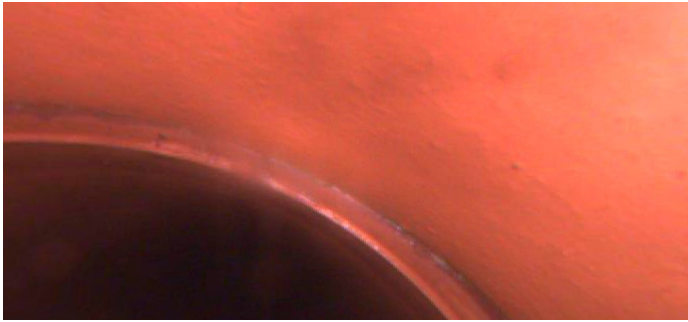
Code:	RFJ
Description:	Roots Fine Joint
Distance (ft):	47.0
Structural Grade:	0
O&M Grade:	1
Clock Start/From:	12
Clock To:	1
1st Value:	
2nd Value:	
Value Percent:	
Continuous Index:	F01
Within 8" of Joint:	YES
Remarks:	wandering
