Profile/Photo Observation Report

| Street: | ALLEY BETWEEN | Flow Control: | Not Controlled |
| City: | Hobart, IN | Year Renewed: | |

| US MH: | M-203-042 | DS MH: | M-203-043 |

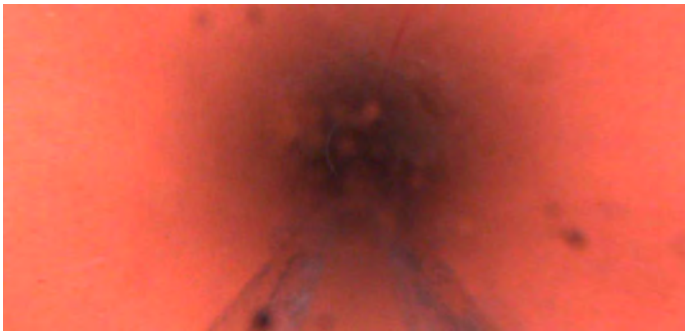
Code: **AMH**
Description: **Manhole**

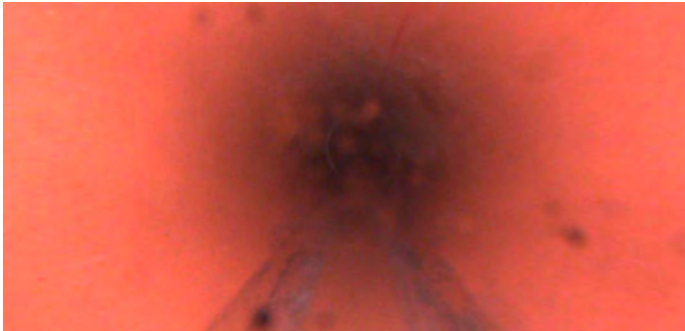
| Code: | MWL |
| Description: | Water Level |

| Distance (ft): | .0 |
| Value Percent: | 5.000 |

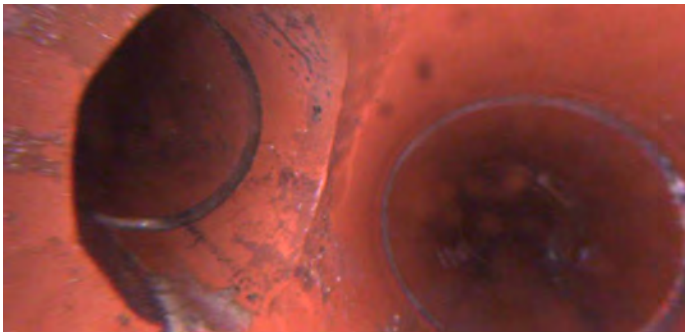
| Code: | TF |
| Description: | Tap Factory |

| Distance (ft): | 30.5 |

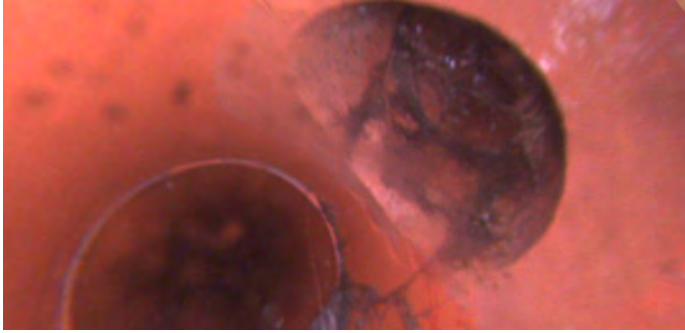
Code: **TF**
Description: **Tap Factory**

Distance (ft): **32.4**
Structural Grade: **0**
O&M Grade: **0**
Clock Start/From: **2**
Clock To:
1st Value: **4.000**
2nd Value:
Value Percent:
Continuous Index:
Within 8" of Joint:
Remarks:

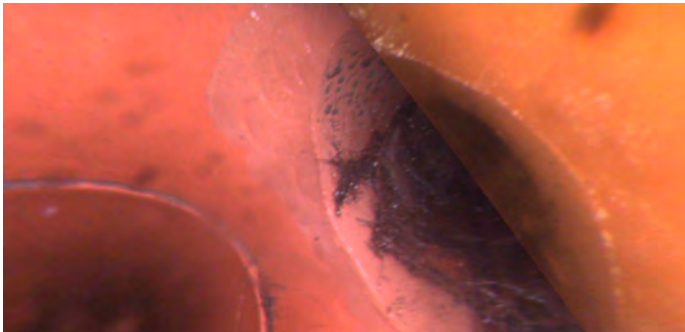
| Position | Code | Observation | Video (sec) | Grade |
|---|---|---|---|---|
| 32.8 | RFL | Roots Fine Lateral | 122 | M 1 |

Code: **RFL**
Description: **Roots Fine Lateral**

Distance (ft): **32.8**
Structural Grade: **0**
O&M Grade: **1**
Clock Start/From: **7**
Clock To: **5**
1st Value:
2nd Value:
Value Percent:
Continuous Index:
Within 8" of Joint: **NO**
Remarks:

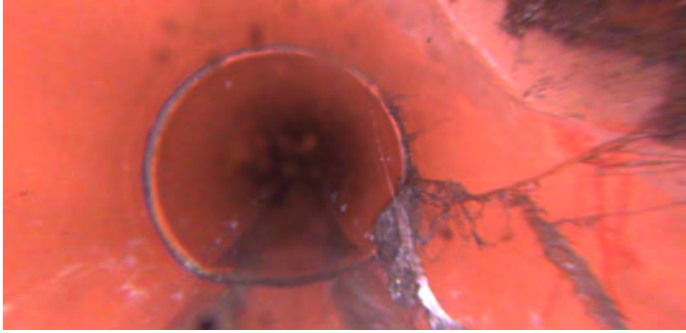
| Position | Code | Observation | Video (sec) | Grade |
|---|---|---|---|---|
| 32.8 | RFJ | Roots Fine Joint | 133 | M 1 |

Code: **RFJ**
Description: **Roots Fine Joint**

Distance (ft): **32.8**
Structural Grade: **0**
O&M Grade: **1**
Clock Start/From: **4**
Clock To: **5**
1st Value:
2nd Value:
Value Percent:
Continuous Index:
Within 8" of Joint: **YES**
Remarks:

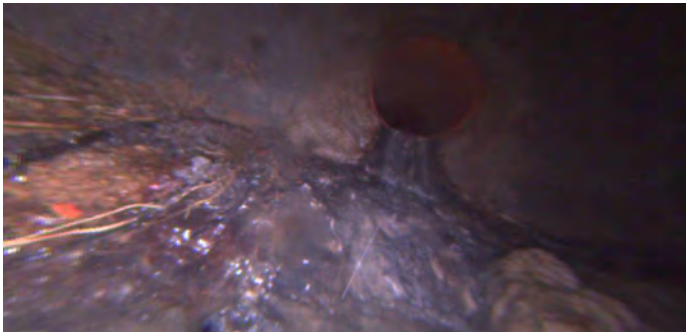
Code: **AMH**
Description: **Manhole**

Distance (ft): **77.6**
Structural Grade: **0**
O&M Grade: **0**
Clock Start/From:
Clock To:
1st Value:
2nd Value:
Value Percent:
Continuous Index:
Within 8" of Joint: **NO**
Remarks: **M-203-043**
