## Profile/Photo Observation Report

Street:	<b>E 38th Ave</b>	Flow Control:	<b>Not Controlled</b>
City:	<b>Hobart, IN</b>	Year Renewed:	
Location:	<b>Other</b>	Tape/Media #:	
Purpose:	<b>Not Known</b>	Dia/Height:	<b>10"</b>
Use:	<b>Sanitary</b>	Material:	<b>VCP</b>
Drain Area:	<b>NA</b>	Lining:	
Category:	<b>NA</b>		
Comment:	<b>pump</b>

Location Details:		Direction of Survey:	<b>Downstream</b>
US MH:	<b>M-203-042</b>	DS MH:	<b>M-203-043</b>
		Total Length Surveyed (ft):	<b>77.6</b>

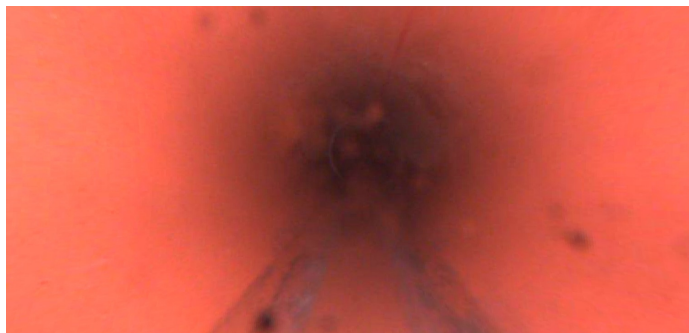
32.8	RFL	Roots Fine Lateral	122	M 1
	32.8	RFJ	Roots Fine Joint	133	M 1
	77.6	AMH	Manhole	234	NA
<div> <div>Code:</div> <div>AMH</div> </div> <div> <div>Description:</div> <div>Manhole</div> </div> <div> <div>Distance (ft):</div> <div>.0</div> </div> <div> <div>Structural Grade:</div> <div>0</div> </div> <div> <div>O&amp;M Grade:</div> <div>0</div> </div> <div> <div>Clock Start/From:</div> <div></div> </div> <div> <div>Clock To:</div> <div></div> </div> <div> <div>1st Value:</div> <div></div> </div> <div> <div>2nd Value:</div> <div></div> </div> <div> <div>Value Percent:</div> <div></div> </div> <div> <div>Continuous Index:</div> <div></div> </div> <div> <div>Within 8" of Joint:</div> <div>NO</div> </div> <div> <div>Remarks:</div> <div>M-203-042</div> </div>

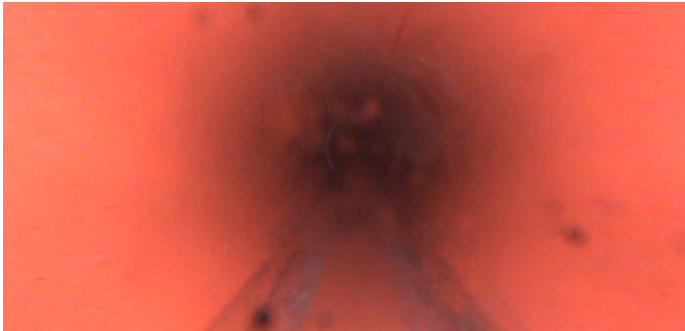
Code:	<b>MWL</b>
Description:	<b>Water Level</b>

Distance (ft):	<b>.0</b>
Structural Grade:	<b>0</b>
O&M Grade:	<b>0</b>
Clock Start/From:	
Clock To:	
1st Value:	
2nd Value:	
Value Percent:	<b>5.000</b>
Continuous Index:	
Within 8" of Joint:	<b>NO</b>
Remarks:

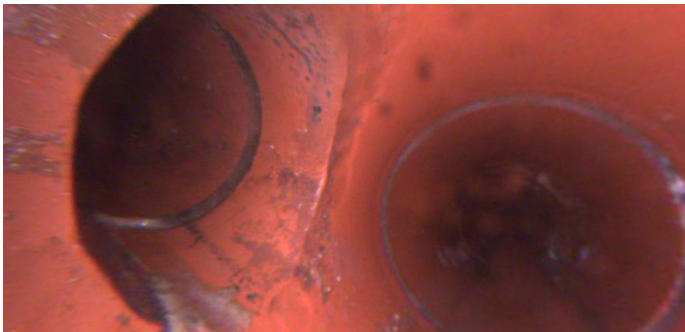
Code:	<b>TF</b>
Description:	<b>Tap Factory</b>

Distance (ft):	<b>30.5</b>
Structural Grade:	<b>0</b>
O&M Grade:	<b>0</b>
Clock Start/From:	<b>9</b>
Clock To:	
1st Value:	<b>4.000</b>
2nd Value:	
Value Percent:	
Continuous Index:	
Within 8" of Joint:	
Remarks:

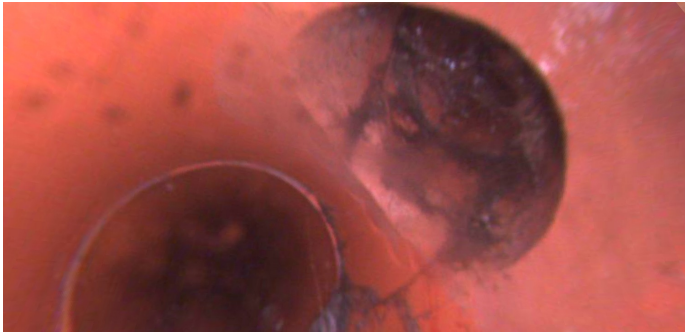
Code: **TF**  
Description: **Tap Factory**

Distance (ft): **32.4**  
Structural Grade: **0**  
O&M Grade: **0**  
Clock Start/From: **2**  
Clock To:  
1st Value: **4.000**  
2nd Value:  
Value Percent:  
Continuous Index:  
Within 8" of Joint:  
Remarks:

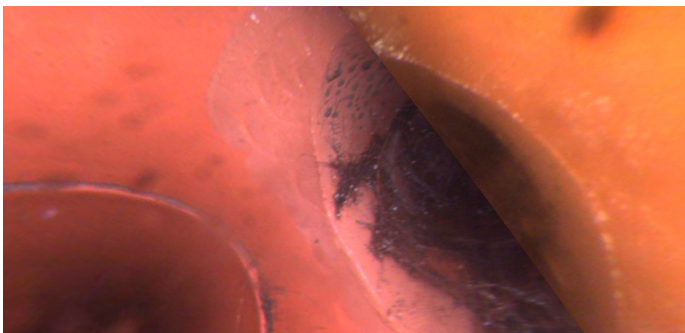
Code: **RFL**  
Description: **Roots Fine Lateral**

Distance (ft): **32.8**  
Structural Grade: **0**  
O&M Grade: **1**  
Clock Start/From: **7**  
Clock To: **5**  
1st Value:  
2nd Value:  
Value Percent:  
Continuous Index:  
Within 8" of Joint: **NO**  
Remarks:

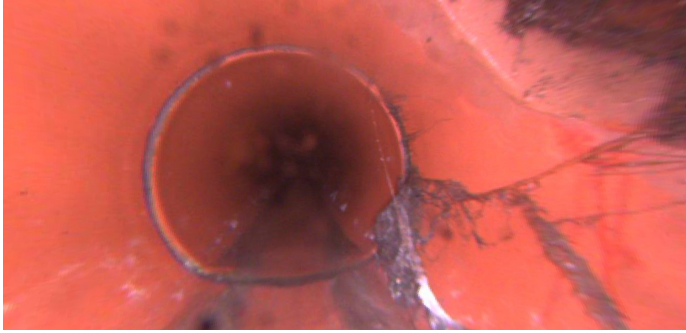
Code: **RFJ**  
Description: **Roots Fine Joint**

Distance (ft): **32.8**  
Structural Grade: **0**  
O&M Grade: **1**  
Clock Start/From: **4**  
Clock To: **5**  
1st Value:  
2nd Value:  
Value Percent:  
Continuous Index:  
Within 8" of Joint: **YES**  
Remarks:

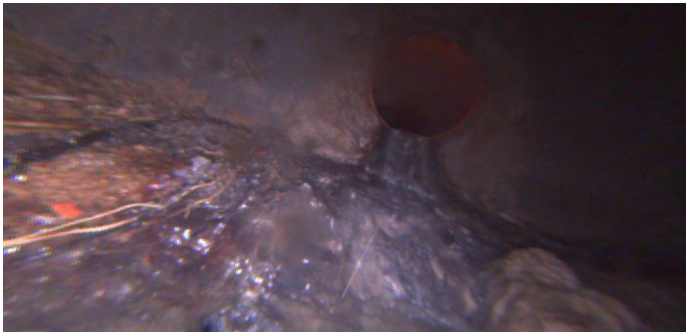
Code: **AMH**  
Description: **Manhole**

Distance (ft): **77.6**  
Structural Grade: **0**  
O&M Grade: **0**  
Clock Start/From:  
Clock To:  
1st Value:  
2nd Value:  
Value Percent:  
Continuous Index:  
Within 8" of Joint: **NO**  
Remarks: **M-203-043**
