Profile/Photo Observation Report

Date:	03/25/2018	Weather:		Coding:	PACP 6.0
Pipe Length (ft):	275.3	Owner:	NA	Pre Clean:	Not Known
P.O.#:		Surveyor:	Byrd Fitzgerald	PSR:	P-203-045-043
Customer:		Clean Date:	01/01/1900	Shape:	C

Street:	ALLEY BETWEEN MAITLAND ST & EV	Flow Control:	Not Controlled
City:	Hobart, IN	Year Renewed:	
Location:	Other	Tape/Media #:	
Purpose:	Not Known	Dia/Height:	10"
Use:	Sanitary	Material:	VCP
Drain Area:	NA	Lining:	
Category:	NA		
Comment:

Location Details:		Direction of Survey:	Downstream
US MH:	M-203-043	DS MH:	M-203-045
		Total Length Surveyed (ft):	258.6

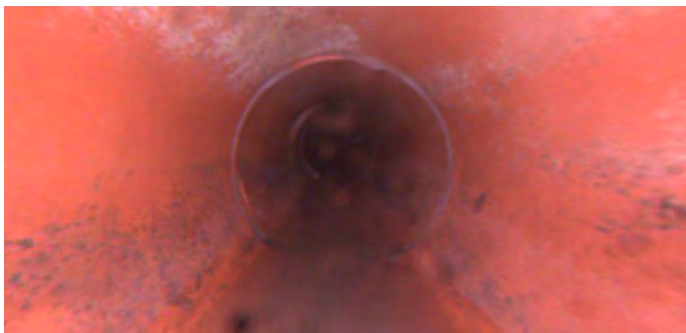
Code: **AMH**
Description: **Manhole**

Distance (ft): **.0**
Structural Grade: **0**
O&M Grade: **0**
Clock Start/From:
Clock To:
1st Value:
2nd Value:
Value Percent:
Continuous Index:
Within 8" of Joint: **NO**
Remarks: **M-203-043**

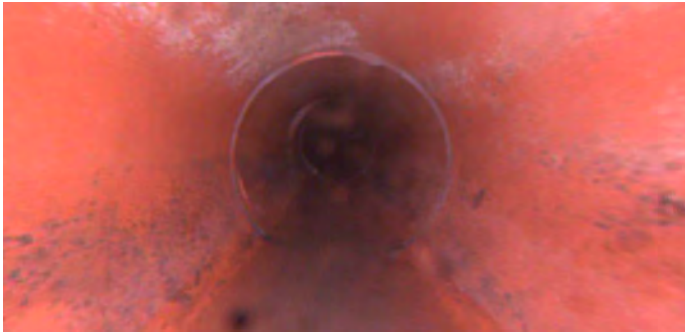
Code:	MWL
Description:	Water Level

Distance (ft):	.0
Structural Grade:	0
O&M Grade:	0
Clock Start/From:	
Clock To:	
1st Value:	
2nd Value:	
Value Percent:	5.000
Continuous Index:	
Within 8" of Joint:	NO
Remarks:

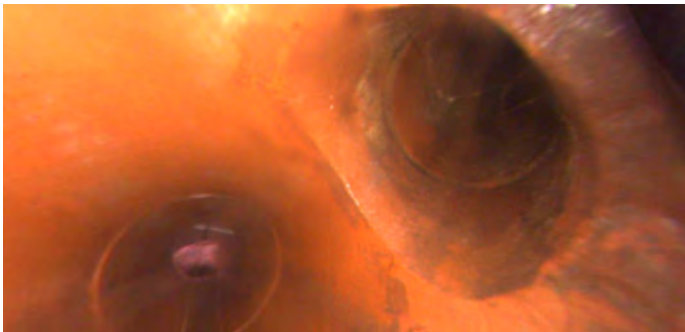
Code:	TF
Description:	Tap Factory

Distance (ft):	3.9
Structural Grade:	0
O&M Grade:	0
Clock Start/From:	10
Clock To:	
1st Value:	4.000
2nd Value:	
Value Percent:	
Continuous Index:	
Within 8" of Joint:	
Remarks:

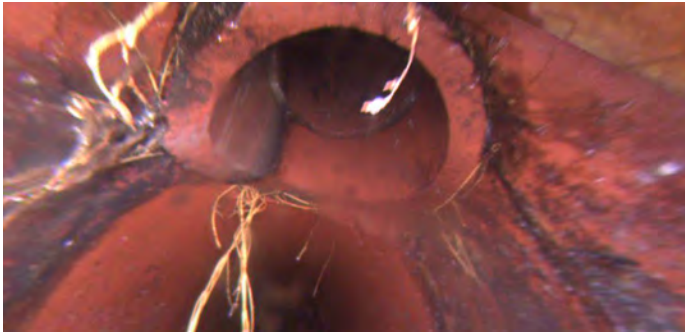
Code: **TBD**
Description: **Tap Break-in Defective**

Distance (ft): **11.5**
Structural Grade: **0**
O&M Grade: **3**
Clock Start/From: **12**
Clock To:
1st Value: **4.000**
2nd Value:
Value Percent:
Continuous Index:
Within 8" of Joint:
Remarks: **roots**

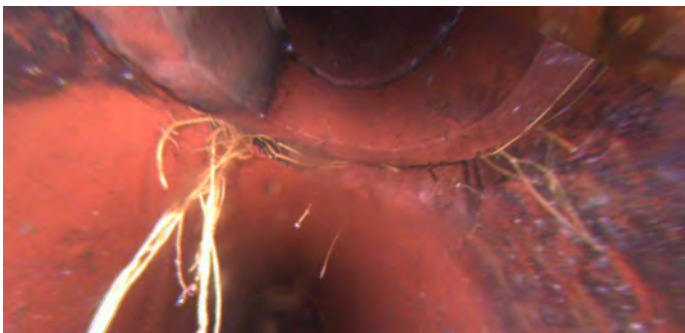
Code: **RFC**
Description: **Roots Fine Connection**

Distance (ft): **11.7**
Structural Grade: **0**
O&M Grade: **1**
Clock Start/From: **7**
Clock To: **5**
1st Value:
2nd Value:
Value Percent:
Continuous Index:
Within 8" of Joint: **NO**
Remarks: **around tap**

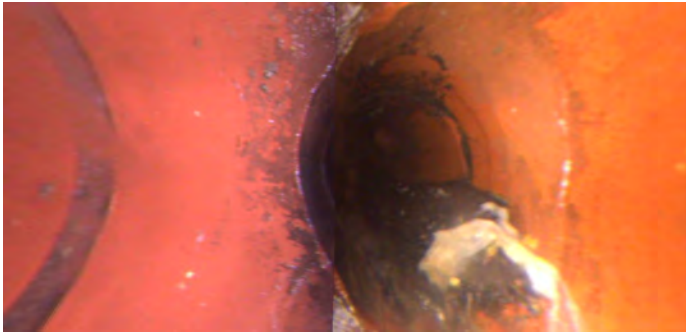
Code: **TFD**
Description: **Tap Factory Defective**

Distance (ft): **15.8**
Structural Grade: **0**
O&M Grade: **2**
Clock Start/From: **2**
Clock To:
1st Value: **4.000**
2nd Value:
Value Percent:
Continuous Index:
Within 8" of Joint:
Remarks: **partially blocked**

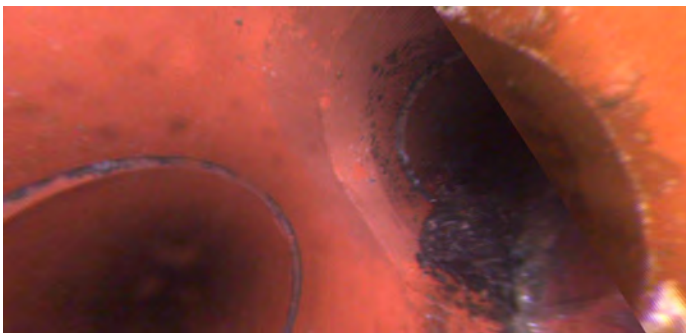
Code: **TFD**
Description: **Tap Factory Defective**

Distance (ft): **57.5**
Structural Grade: **0**
O&M Grade: **2**
Clock Start/From: **2**
Clock To:
1st Value: **4.000**
2nd Value:
Value Percent:
Continuous Index:
Within 8" of Joint: **YES**
Remarks: **partially blocked**

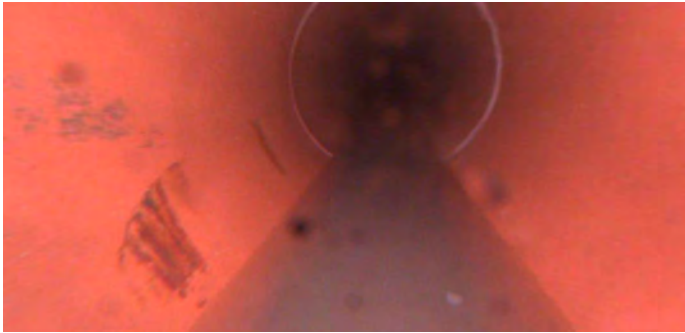
Code: **IW**
Description: **Infil Weeper**

Distance (ft): **62.3**
Structural Grade: **0**
O&M Grade: **2**
Clock Start/From: **8**
Clock To: **9**
1st Value:
2nd Value:
Value Percent:
Continuous Index:
Within 8" of Joint:
Remarks:

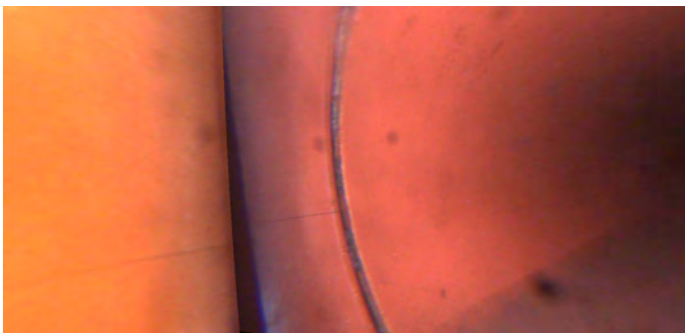
Code: **CL**
Description: **Crack Longitudinal**

Distance (ft): **63.3**
Structural Grade: **2**
O&M Grade: **0**
Clock Start/From: **8**
Clock To:
1st Value:
2nd Value:
Value Percent:
Continuous Index:
Within 8" of Joint: **YES**
Remarks:

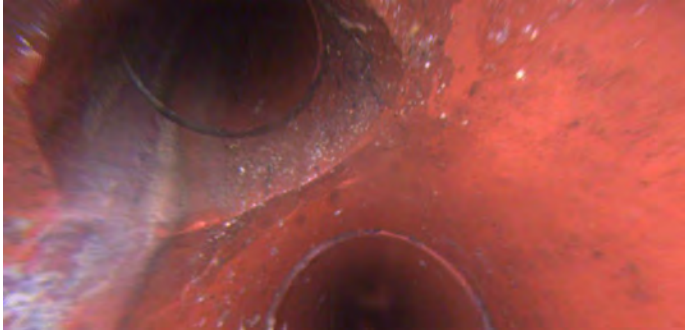
Code: **TF**
Description: **Tap Factory**

Distance (ft): **89.9**
Structural Grade: **0**
O&M Grade: **0**
Clock Start/From: **11**
Clock To:
1st Value: **4.000**
2nd Value:
Value Percent:
Continuous Index:
Within 8" of Joint:
Remarks:

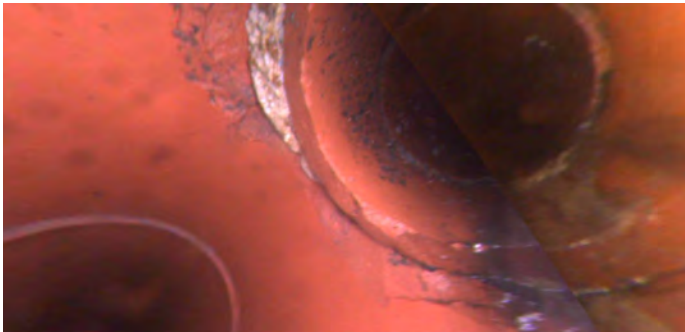
Code: **TBI**
Description: **Tap Break-in Intruding**

Distance (ft): **135.5**
Structural Grade: **0**
O&M Grade: **2**
Clock Start/From: **1**
Clock To:
1st Value: **4.000**
2nd Value: **1.000**
Value Percent:
Continuous Index:
Within 8" of Joint: **YES**
Remarks:

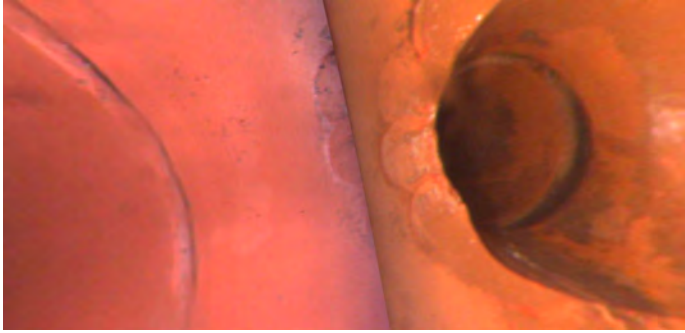
Code: **TF**
Description: **Tap Factory**

Distance (ft): **143.2**
Structural Grade: **0**
O&M Grade: **0**
Clock Start/From: **1**
Clock To:
1st Value: **4.000**
2nd Value:
Value Percent:
Continuous Index:
Within 8" of Joint: **YES**
Remarks:

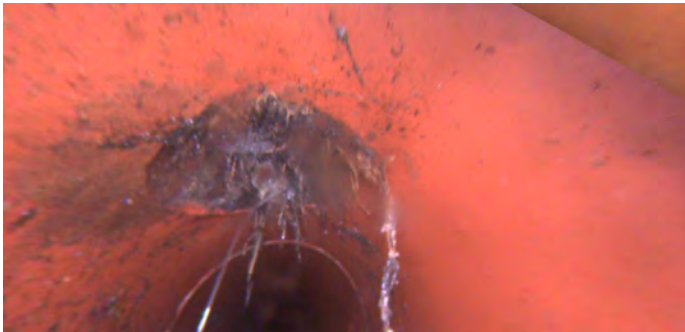
Code: **RFL**
Description: **Roots Fine Lateral**

Distance (ft): **149.5**
Structural Grade: **0**
O&M Grade: **1**
Clock Start/From: **12**
Clock To:
1st Value:
2nd Value:
Value Percent:
Continuous Index:
Within 8" of Joint: **NO**
Remarks:

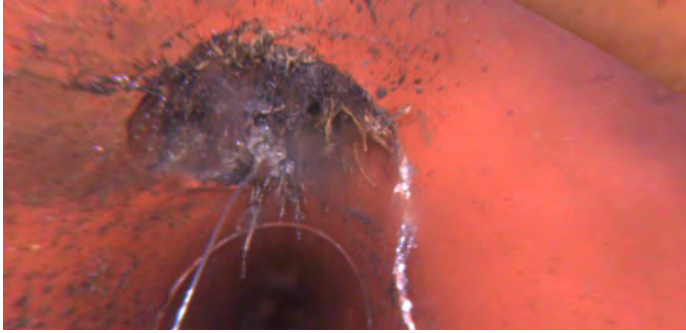
Code: **TFD**
Description: **Tap Factory Defective**

Distance (ft): **149.5**
Structural Grade: **0**
O&M Grade: **2**
Clock Start/From: **12**
Clock To:
1st Value: **4.000**
2nd Value:
Value Percent:
Continuous Index:
Within 8" of Joint:
Remarks: **blocked by roots**

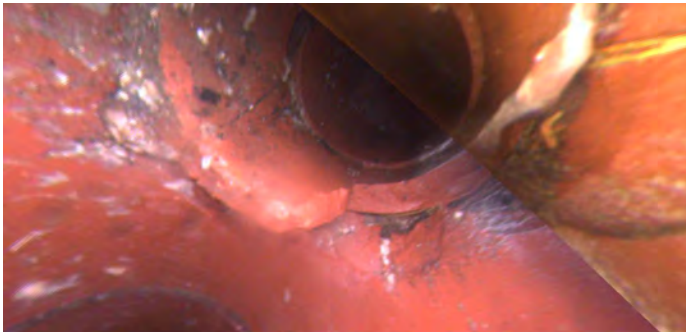
Code: **TB**
Description: **Tap Break-in**

Distance (ft): **170.0**
Structural Grade: **0**
O&M Grade: **0**
Clock Start/From: **1**
Clock To:
1st Value: **4.000**
2nd Value:
Value Percent:
Continuous Index:
Within 8" of Joint:
Remarks:

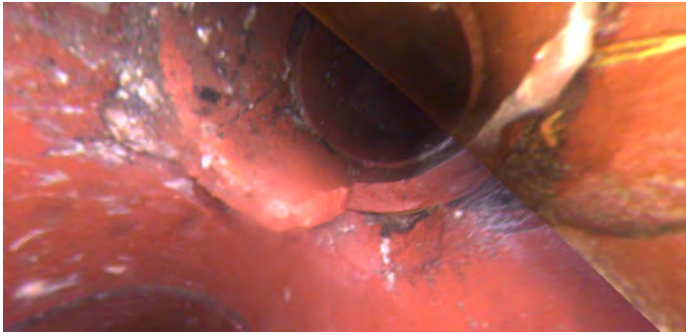
Code: **RFC**
Description: **Roots Fine Connection**

Distance (ft): **170.0**
Structural Grade: **0**
O&M Grade: **1**
Clock Start/From: **7**
Clock To: **5**
1st Value:
2nd Value:
Value Percent:
Continuous Index:
Within 8" of Joint: **NO**
Remarks: **around tap**

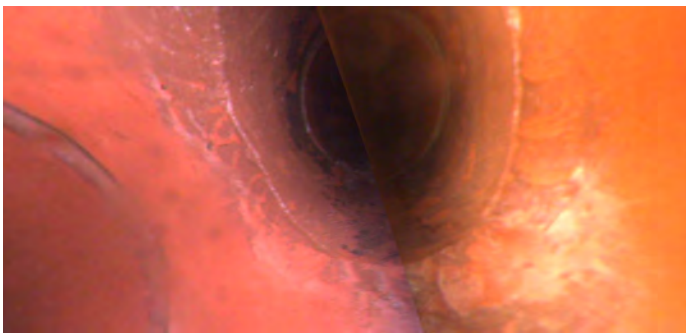
Code: **TF**
Description: **Tap Factory**

Distance (ft): **177.4**
Structural Grade: **0**
O&M Grade: **0**
Clock Start/From: **1**
Clock To:
1st Value: **4.000**
2nd Value:
Value Percent:
Continuous Index:
Within 8" of Joint: **YES**
Remarks:

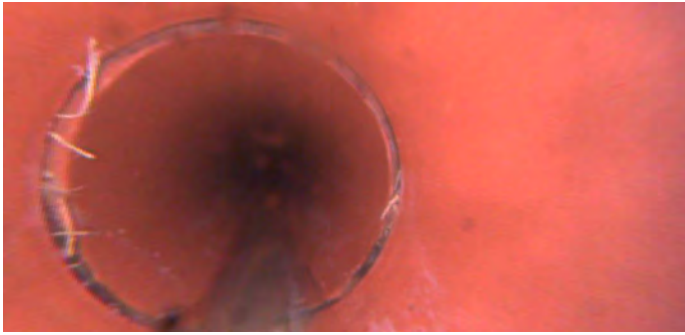
Code: **RFJ**
Description: **Roots Fine Joint**

Distance (ft): **187.5**
Structural Grade: **0**
O&M Grade: **1**
Clock Start/From: **8**
Clock To: **10**
1st Value:
2nd Value:
Value Percent:
Continuous Index: **S01**
Within 8" of Joint: **YES**
Remarks: **wandering**

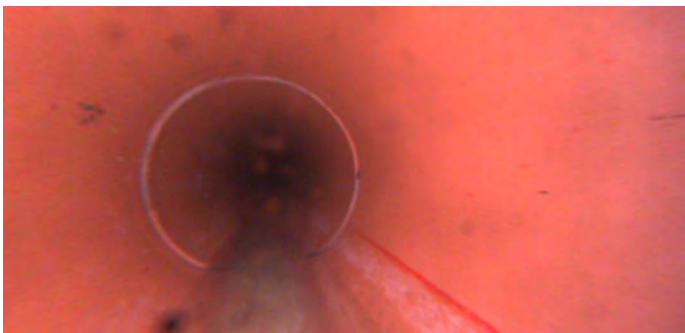
Code: **RFJ**
Description: **Roots Fine Joint**

Distance (ft): **207.3**
Structural Grade: **0**
O&M Grade: **1**
Clock Start/From: **8**
Clock To: **10**
1st Value:
2nd Value:
Value Percent:
Continuous Index: **F01**
Within 8" of Joint: **YES**
Remarks: **wandering**

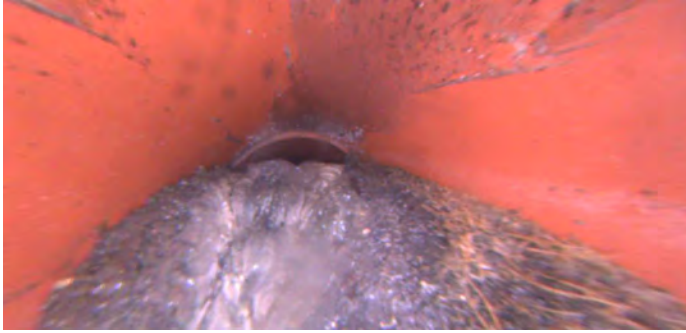
Code: **OBZ**
Description: **Obstacle Other**

Distance (ft): **257.5**
Structural Grade: **0**
O&M Grade: **5**
Clock Start/From: **12**
Clock To: **12**
1st Value:
2nd Value:
Value Percent: **75.000**
Continuous Index:
Within 8" of Joint: **NO**
Remarks: **sediments,roots,tissue?**

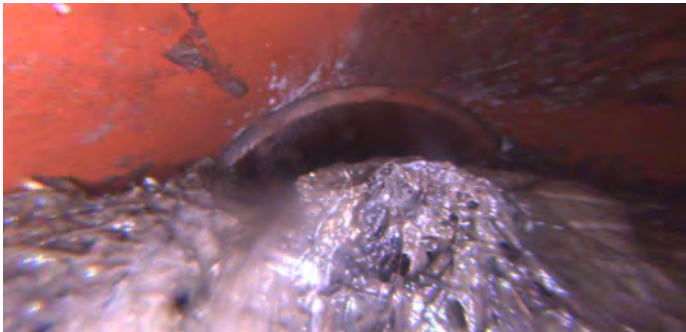
Code: **MSA**
Description: **Abandoned Survey**

Distance (ft): **258.6**
Structural Grade: **0**
O&M Grade: **0**
Clock Start/From:
Clock To:
1st Value:
2nd Value:
Value Percent:
Continuous Index:
Within 8" of Joint: **NO**
Remarks: **blockage**
