Profile/Photo Observation Report

Date:	03/25/2018	Weather:		Coding:	PACP 6.0
Pipe Length (ft):	275.3	Owner:	NA	Pre Clean:	Not Known
P.O.#:		Surveyor:	Byrd Fitzgerald	PSR:	P-203-045-043
Customer:		Clean Date:	01/01/1900	Shape:	C

Street:	E 38th Ave	Flow Control:	Not Controlled
City:	Hobart, IN	Year Renewed:	
Location:	Other	Tape/Media #:	
Purpose:	Not Known	Dia/Height:	10"
Use:	Sanitary	Material:	VCP
Drain Area:	NA	Lining:	
Category:	NA		
Comment:

Location Details:		Direction of Survey:	Downstream
US MH:	M-203-043	DS MH:	M-203-045
		Total Length Surveyed (ft):	258.6

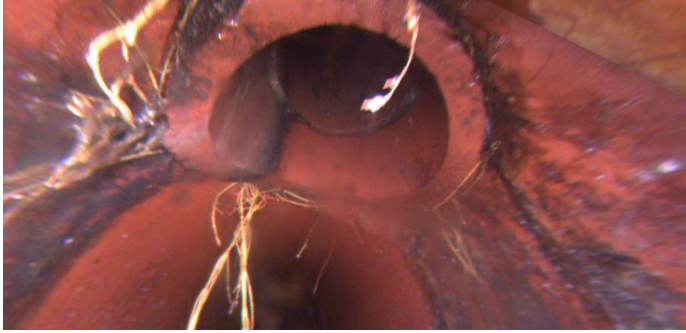
Code: **TBD**
Description: **Tap Break-in Defective**

Distance (ft): **11.5**
Structural Grade: **0**
O&M Grade: **3**
Clock Start/From: **12**
Clock To:
1st Value: **4.000**
2nd Value:
Value Percent:
Continuous Index:
Within 8" of Joint:
Remarks: **roots**

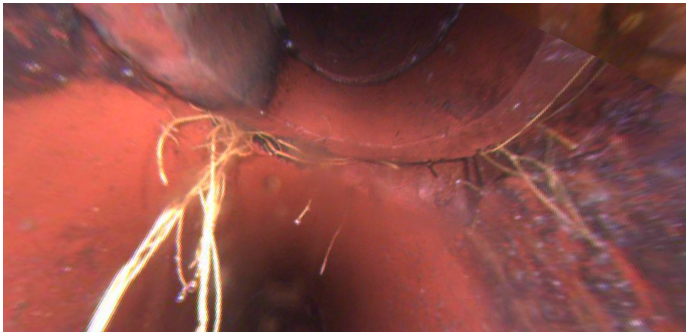
Code: **RFC**
Description: **Roots Fine Connection**

Distance (ft): **11.7**
Structural Grade: **0**
O&M Grade: **1**
Clock Start/From: **7**
Clock To: **5**
1st Value:
2nd Value:
Value Percent:
Continuous Index:
Within 8" of Joint: **NO**
Remarks: **around tap**

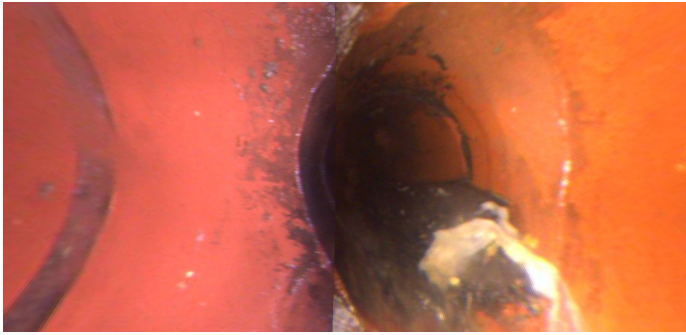
Code: **TFD**
Description: **Tap Factory Defective**

Distance (ft): **15.8**
Structural Grade: **0**
O&M Grade: **2**
Clock Start/From: **2**
Clock To:
1st Value: **4.000**
2nd Value:
Value Percent:
Continuous Index:
Within 8" of Joint:
Remarks: **partially blocked**

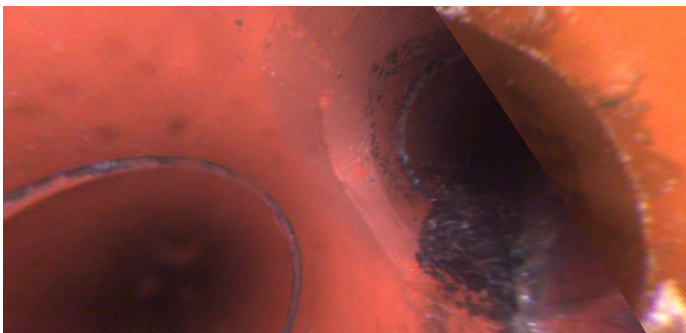
Code: **TFD**
Description: **Tap Factory Defective**

Distance (ft): **57.5**
Structural Grade: **0**
O&M Grade: **2**
Clock Start/From: **2**
Clock To:
1st Value: **4.000**
2nd Value:
Value Percent:
Continuous Index:
Within 8" of Joint: **YES**
Remarks: **partially blocked**

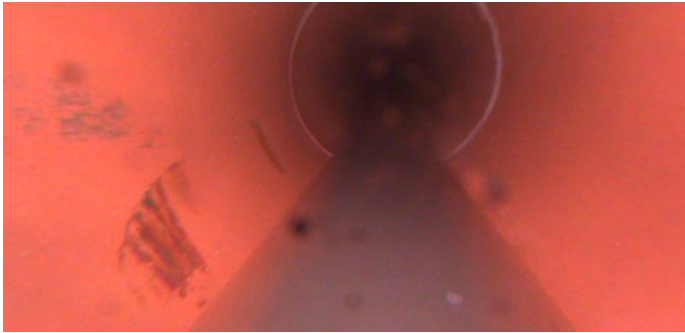
Code: **IW**
Description: **Infil Weeper**

Distance (ft): **62.3**
Structural Grade: **0**
O&M Grade: **2**
Clock Start/From: **8**
Clock To: **9**
1st Value:
2nd Value:
Value Percent:
Continuous Index:
Within 8" of Joint:
Remarks:

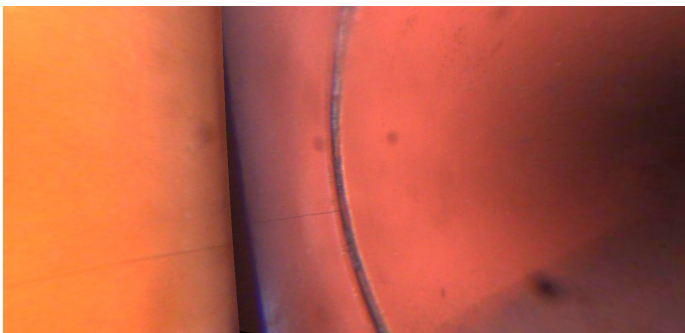
Code: **CL**
Description: **Crack Longitudinal**

Distance (ft): **63.3**
Structural Grade: **2**
O&M Grade: **0**
Clock Start/From: **8**
Clock To:
1st Value:
2nd Value:
Value Percent:
Continuous Index:
Within 8" of Joint: **YES**
Remarks:

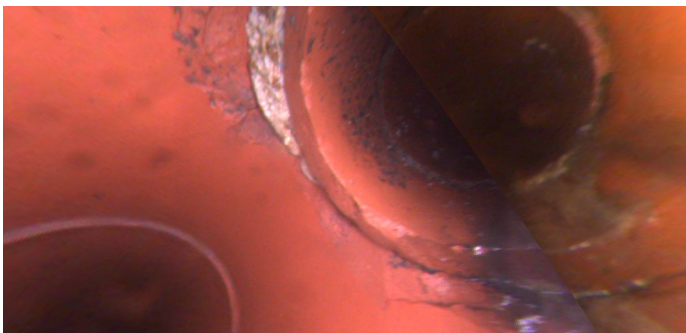
Code: **TBI**
Description: **Tap Break-in Intruding**

Distance (ft): **135.5**
Structural Grade: **0**
O&M Grade: **2**
Clock Start/From: **1**
Clock To:
1st Value: **4.000**
2nd Value: **1.000**
Value Percent:
Continuous Index:
Within 8" of Joint: **YES**
Remarks:

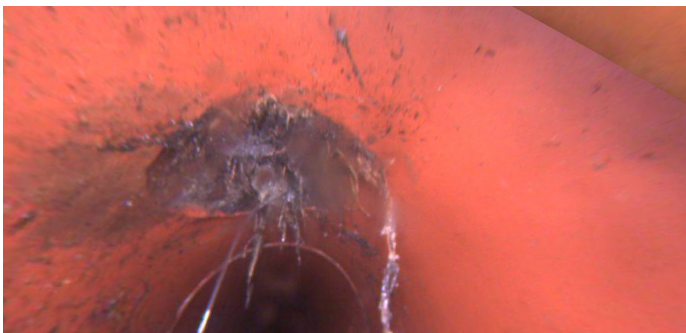
Code: **RFL**
Description: **Roots Fine Lateral**

Distance (ft): **149.5**
Structural Grade: **0**
O&M Grade: **1**
Clock Start/From: **12**
Clock To:
1st Value:
2nd Value:
Value Percent:
Continuous Index:
Within 8" of Joint: **NO**
Remarks:

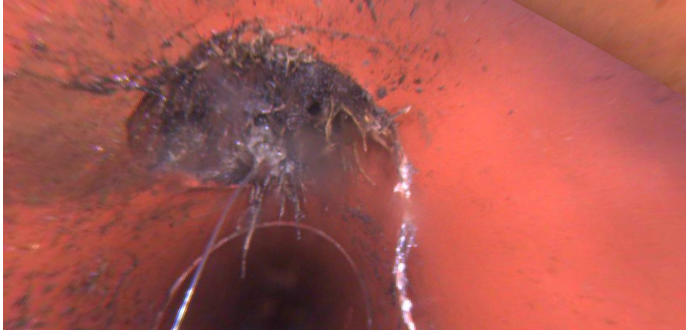
Code: **TFD**
Description: **Tap Factory Defective**

Distance (ft): **149.5**
Structural Grade: **0**
O&M Grade: **2**
Clock Start/From: **12**
Clock To:
1st Value: **4.000**
2nd Value:
Value Percent:
Continuous Index:
Within 8" of Joint:
Remarks: **blocked by roots**

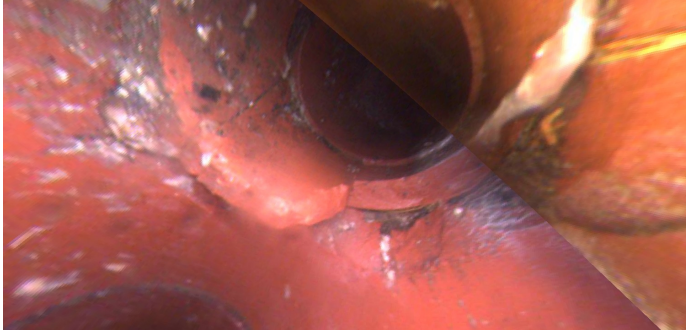
Code: **RFC**
Description: **Roots Fine Connection**

Distance (ft): **170.0**
Structural Grade: **0**
O&M Grade: **1**
Clock Start/From: **7**
Clock To: **5**
1st Value:
2nd Value:
Value Percent:
Continuous Index:
Within 8" of Joint: **NO**
Remarks: **around tap**

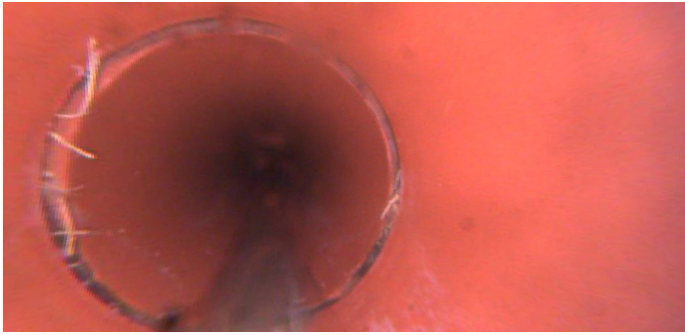
Code: **RFJ**
Description: **Roots Fine Joint**

Distance (ft): **187.5**
Structural Grade: **0**
O&M Grade: **1**
Clock Start/From: **8**
Clock To: **10**
1st Value:
2nd Value:
Value Percent:
Continuous Index: **S01**
Within 8" of Joint: **YES**
Remarks: **wandering**

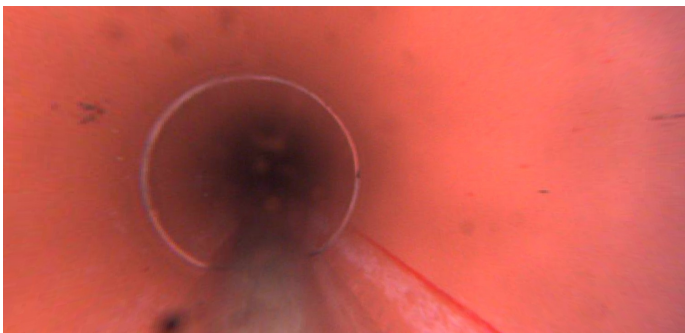
Code: **RFJ**
Description: **Roots Fine Joint**

Distance (ft): **207.3**
Structural Grade: **0**
O&M Grade: **1**
Clock Start/From: **8**
Clock To: **10**
1st Value:
2nd Value:
Value Percent:
Continuous Index: **F01**
Within 8" of Joint: **YES**
Remarks: **wandering**

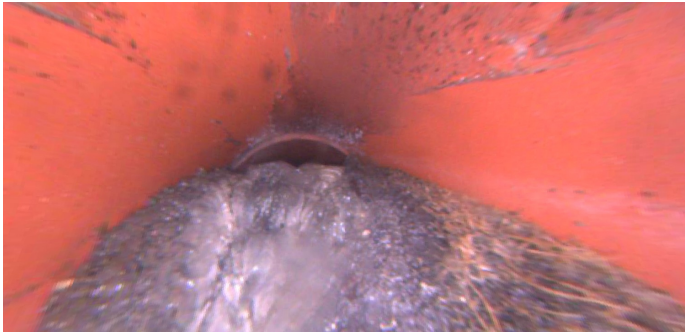
Code: **OBZ**
Description: **Obstacle Other**

Distance (ft): **257.5**
Structural Grade: **0**
O&M Grade: **5**
Clock Start/From: **12**
Clock To: **12**
1st Value:
2nd Value:
Value Percent: **75.000**
Continuous Index:
Within 8" of Joint: **NO**
Remarks: **sediments,roots,tissue?**

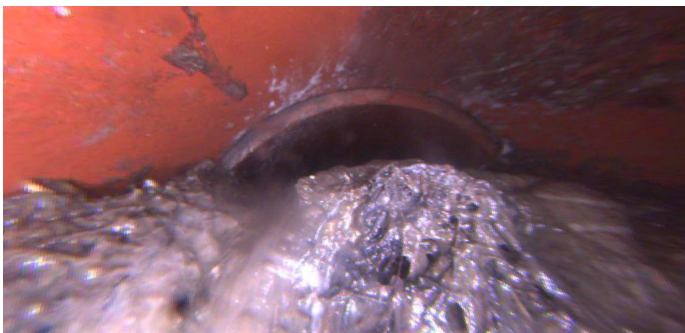
Code: **MSA**
Description: **Abandoned Survey**

Distance (ft): **258.6**
Structural Grade: **0**
O&M Grade: **0**
Clock Start/From:
Clock To:
1st Value:
2nd Value:
Value Percent:
Continuous Index:
Within 8" of Joint: **NO**
Remarks: **blockage**
