## Profile/Photo Observation Report

Street:	<b>E 38th Ave</b>	Flow Control:	<b>Not Controlled</b>
City:	<b>Hobart, IN</b>	Year Renewed:	
Location:	<b>Other</b>	Tape/Media #:	
Purpose:	<b>Not Known</b>	Dia/Height:	<b>8"</b>
Use:	<b>Sanitary</b>	Material:	<b>VCP</b>
Drain Area:	<b>NA</b>	Lining:	
Category:	<b>NA</b>		
Comment:

Location Details:		Direction of Survey:	<b>Downstream</b>
US MH:	<b>M-203-045</b>	DS MH:	<b>M-203-044</b>
		Total Length Surveyed (ft):	<b>25.2</b>

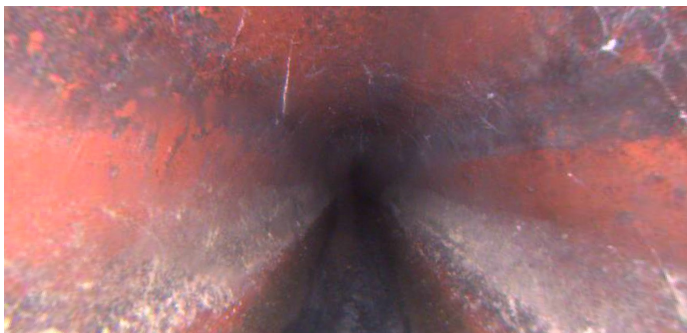
Code: **DAZ**  
Description: **Deposits Attached Other**

Distance (ft): **.0**  
Structural Grade: **0**  
O&M Grade: **2**  
Clock Start/From: **7**  
Clock To: **5**  
1st Value:  
2nd Value:  
Value Percent: **5.000**  
Continuous Index: **S01**  
Within 8" of Joint: **NO**  
Remarks:

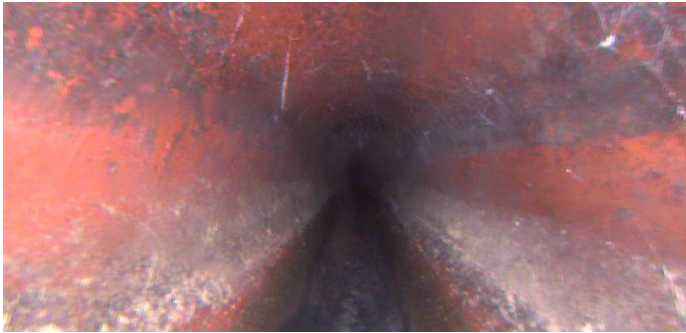
Code:	<b>AMH</b>
Description:	<b>Manhole</b>

Distance (ft):	<b>.0</b>
Structural Grade:	<b>0</b>
O&M Grade:	<b>0</b>
Clock Start/From:	
Clock To:	
1st Value:	
2nd Value:	
Value Percent:	
Continuous Index:	
Within 8" of Joint:	<b>NO</b>
Remarks:	<b>M-203-045</b>

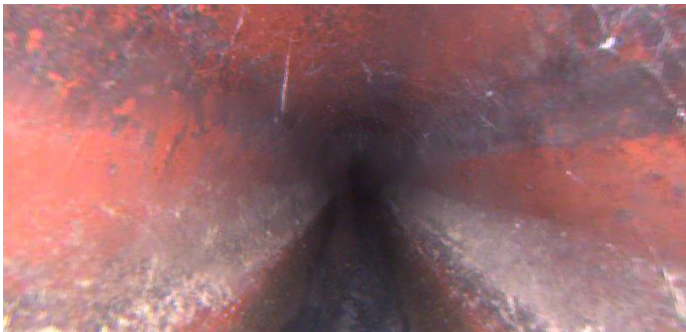
Code:	<b>MWL</b>
Description:	<b>Water Level</b>

Distance (ft):	<b>.0</b>
Structural Grade:	<b>0</b>
O&M Grade:	<b>0</b>
Clock Start/From:	
Clock To:	
1st Value:	
2nd Value:	
Value Percent:	<b>5.000</b>
Continuous Index:	
Within 8" of Joint:	<b>NO</b>
Remarks:

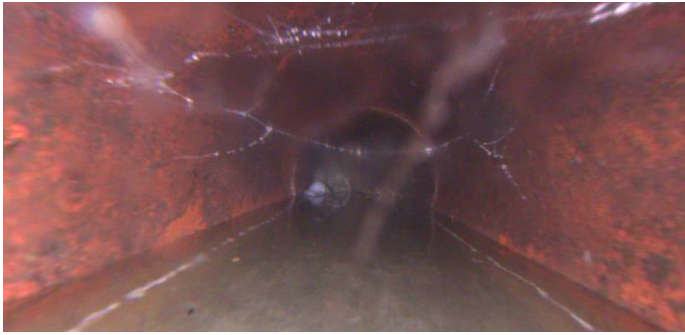
Code: **DAZ**  
Description: **Deposits Attached Other**

Distance (ft): **23.1**  
Structural Grade: **0**  
O&M Grade: **2**  
Clock Start/From: **7**  
Clock To: **5**  
1st Value:  
2nd Value:  
Value Percent: **5.000**  
Continuous Index: **F01**  
Within 8" of Joint: **NO**  
Remarks:

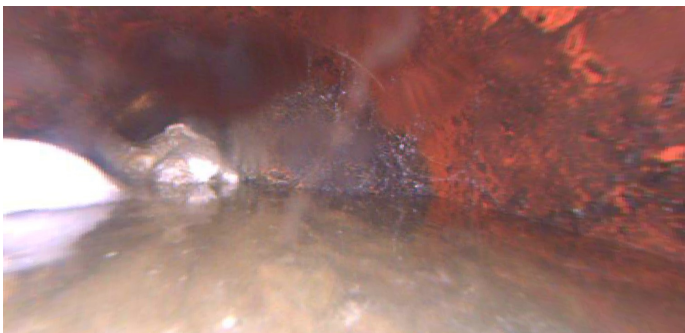
Code: **RBB**  
Description: **Roots Ball Barrel**

Distance (ft): **24.4**  
Structural Grade: **0**  
O&M Grade: **5**  
Clock Start/From: **1**  
Clock To: **6**  
1st Value:  
2nd Value:  
Value Percent: **55.000**  
Continuous Index:  
Within 8" of Joint: **NO**  
Remarks:

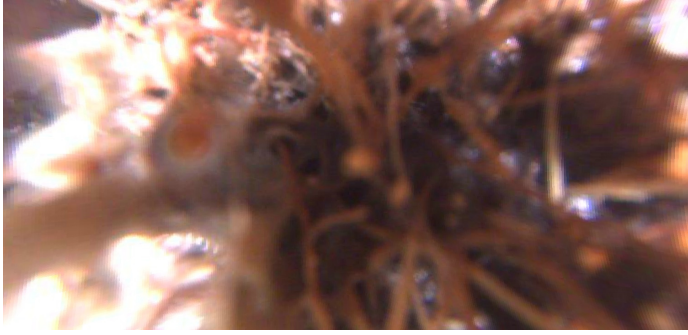
Code:	<b>MSA</b>
Description:	<b>Abandoned Survey</b>
Distance (ft):	<b>25.2</b>
Structural Grade:	<b>0</b>
O&M Grade:	<b>0</b>
Clock Start/From:	
Clock To:	
1st Value:	
2nd Value:	
Value Percent:	
Continuous Index:	
Within 8" of Joint:	<b>NO</b>
Remarks:	<b>rbb</b>
