## Profile/Photo Observation Report

Street:	<b>E 38th Ave</b>	Flow Control:	<b>Not Controlled</b>
City:	<b>Hobart, IN</b>	Year Renewed:	
Location:	<b>Other</b>	Tape/Media #:	
Purpose:	<b>Not Known</b>	Dia/Height:	<b>8"</b>
Use:	<b>Sanitary</b>	Material:	<b>VCP</b>
Drain Area:	<b>NA</b>	Lining:	
Category:	<b>NA</b>		
Comment:

Location Details:		Direction of Survey:	<b>Downstream</b>
US MH:	<b>M-203-045</b>	DS MH:	<b>M-203-046</b>
		Total Length Surveyed (ft):	<b>6.6</b>

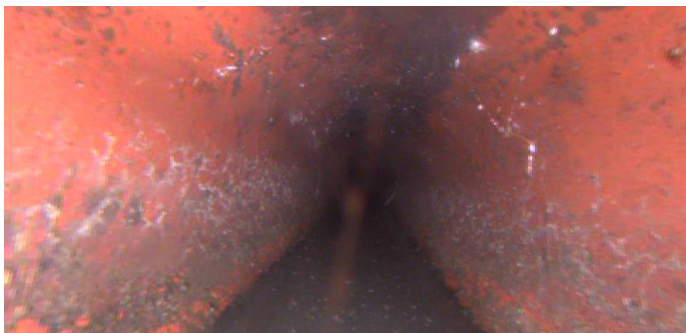
Code: **AMH**  
Description: **Manhole**

Distance (ft): **.0**  
Structural Grade: **0**  
O&M Grade: **0**  
Clock Start/From:  
Clock To:  
1st Value:  
2nd Value:  
Value Percent:  
Continuous Index:  
Within 8" of Joint: **NO**  
Remarks: **M-203-045**

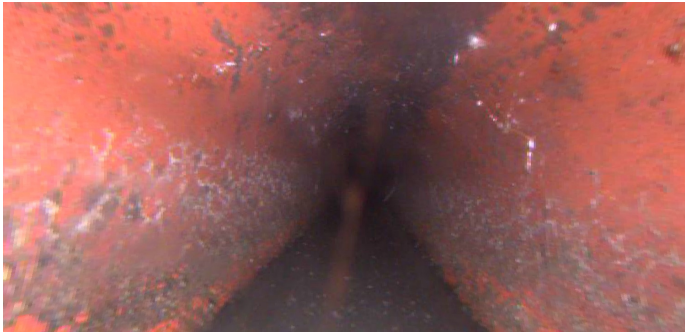
Code:	<b>MWL</b>
Description:	<b>Water Level</b>

Distance (ft):	<b>.0</b>
Structural Grade:	<b>0</b>
O&M Grade:	<b>0</b>
Clock Start/From:	
Clock To:	
1st Value:	
2nd Value:	
Value Percent:	<b>5.000</b>
Continuous Index:	
Within 8" of Joint:	<b>NO</b>
Remarks:
