Profile/Photo Observation Report

Date:	04/13/2018	Weather:		Coding:	PACP 6.0
Pipe Length (ft):		Owner:	City of Hobart	Pre Clean:	No Pre-Cleaning
P.O.#:	44-1	Surveyor:	M. Pielacha	PSR:	M-203-049-M-203-050
Customer:	City of Hobart	Clean Date:		Shape:	C

Street:	Off 37th Street	Flow Control:	Not Controlled
City:	Hobart, IN	Year Renewed:	
Location:	Light Highway	Tape/Media #:	DEP 44
Purpose:	Routine Assessment	Dia/Height:	8"
Use:	Sanitary	Material:	VCP
Drain Area:		Lining:

US MH: **M-203-049** DS MH: **M-203-050** Total Length Surveyed (ft): **13.5**

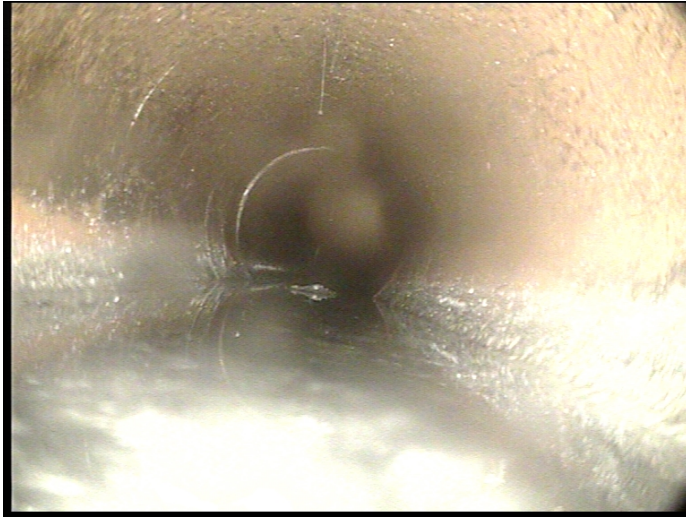
Code:	AMH
Description:	Manhole
Distance (ft):	.0
Structural Grade:	0
O&M Grade:	0
Clock Start/From:	
Clock To:	
1st Value:	
2nd Value:	
Value Percent:	
Continuous Index:	
Within 8" of Joint:	NO
Remarks:	M-203-049

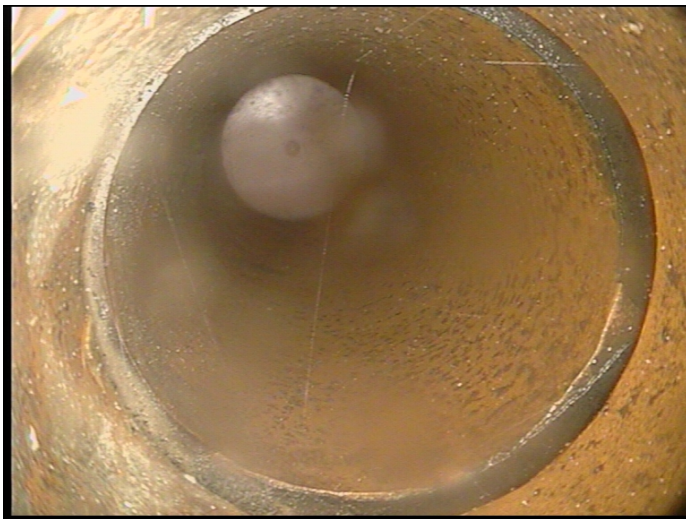
Code: **MWL**
Description: **Water Level**

Distance (ft): **.0**
Structural Grade: **0**
O&M Grade: **0**
Clock Start/From:
Clock To:
1st Value:
2nd Value:
Value Percent: **10.000**
Continuous Index:
Within 8" of Joint: **NO**
Remarks:

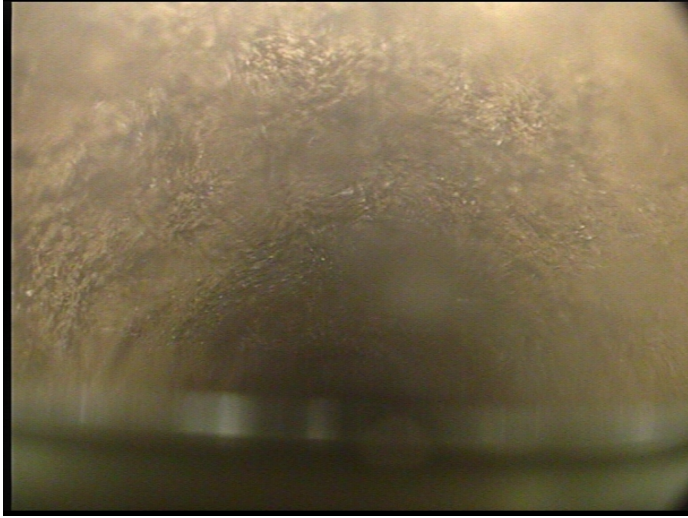
Code: **TFC**
Description: **Tap Factory Capped**

Distance (ft): **10.6**
Structural Grade: **0**
O&M Grade: **0**
Clock Start/From: **9**
Clock To:
1st Value: **6.000**
2nd Value:
Value Percent:
Continuous Index:
Within 8" of Joint: **NO**
Remarks:
