## Profile/Photo Observation Report

Date:	<b>04/13/2018</b>	Weather:		Coding:	<b>PACP 6.0</b>
Pipe Length (ft):		Owner:	<b>City of Hobart</b>	Pre Clean:	<b>No Pre-Cleaning</b>
P.O.#:	<b>44-1</b>	Surveyor:	<b>M. Pielacha</b>	PSR:	<b>M-203-049-M-203-050</b>
Customer:	<b>City of Hobart</b>	Clean Date:		Shape:	<b>C</b>

Street:	<b>Off 37th Street</b>	Flow Control:	<b>Not Controlled</b>
City:	<b>Hobart, IN</b>	Year Renewed:	
Location:	<b>Light Highway</b>	Tape/Media #:	<b>DEP 44</b>
Purpose:	<b>Routine Assessment</b>	Dia/Height:	<b>8"</b>
Use:	<b>Sanitary</b>	Material:	<b>VCP</b>
Drain Area:		Lining:

US MH: **M-203-049** DS MH: **M-203-050** Total Length Surveyed (ft): **13.5**

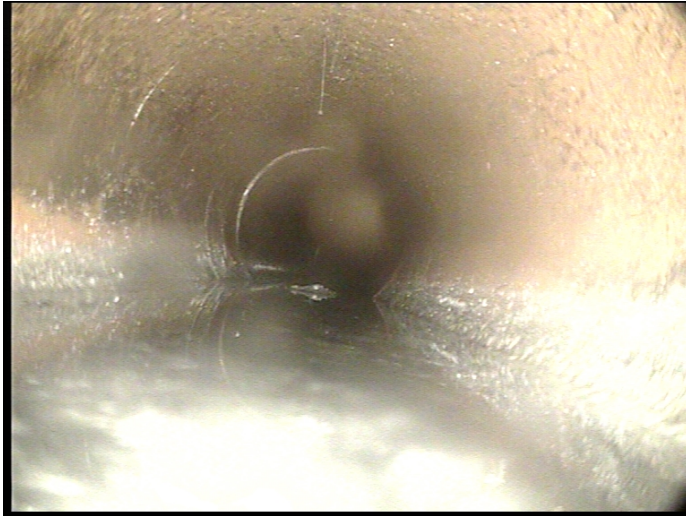
Code:	AMH
Description:	Manhole
Distance (ft):	.0
Structural Grade:	0
O&M Grade:	0
Clock Start/From:	
Clock To:	
1st Value:	
2nd Value:	
Value Percent:	
Continuous Index:	
Within 8" of Joint:	NO
Remarks:	M-203-049

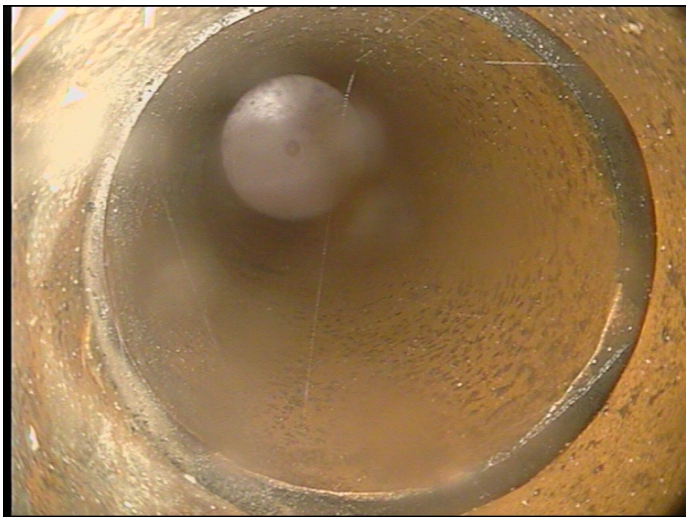
Code: **MWL**  
Description: **Water Level**

Distance (ft): **.0**  
Structural Grade: **0**  
O&M Grade: **0**  
Clock Start/From:  
Clock To:  
1st Value:  
2nd Value:  
Value Percent: **10.000**  
Continuous Index:  
Within 8" of Joint: **NO**  
Remarks:

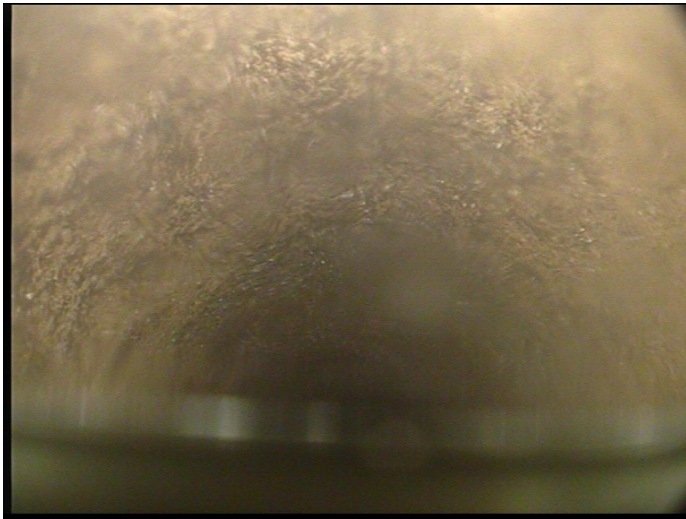
Code: **TFC**  
Description: **Tap Factory Capped**

Distance (ft): **10.6**  
Structural Grade: **0**  
O&M Grade: **0**  
Clock Start/From: **9**  
Clock To:  
1st Value: **6.000**  
2nd Value:  
Value Percent:  
Continuous Index:  
Within 8" of Joint: **NO**  
Remarks:
