Profile/Photo Observation Report

Street:	W 38TH AVE	Flow Control:	Not Controlled
City:	Hobart, IN	Year Renewed:	
Location:	Other	Tape/Media #:	
Purpose:	Not Known	Dia/Height:	12"
Use:	Sanitary	Material:	PVC
Drain Area:	NA	Lining:	
Category:	NA		
Comment:

Location Details:		Direction of Survey:	Downstream
US MH:	M-203-051	DS MH:	M-203-041
		Total Length Surveyed (ft):	7.4

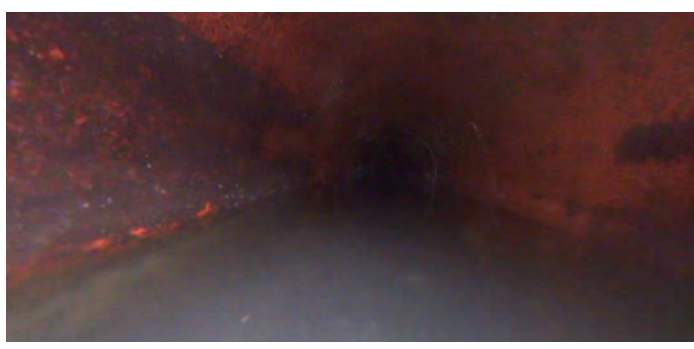
Code: **AMH**
Description: **Manhole**

Distance (ft): **.0**
Structural Grade: **0**
O&M Grade: **0**
Clock Start/From:
Clock To:
1st Value:
2nd Value:
Value Percent:
Continuous Index:
Within 8" of Joint: **NO**
Remarks: **M-203-051**

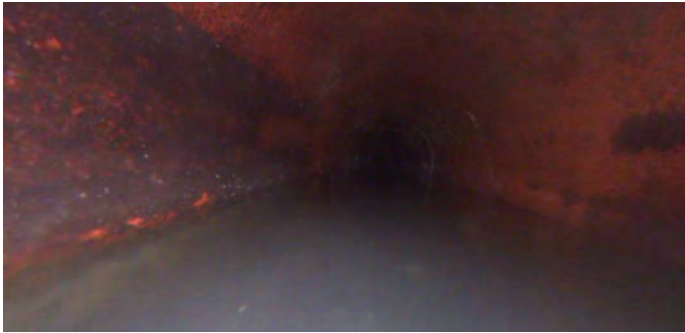
Code:	MWL
Description:	Water Level

Distance (ft):	.0
Structural Grade:	0
O&M Grade:	0
Clock Start/From:	
Clock To:	
1st Value:	
2nd Value:	
Value Percent:	40.000
Continuous Index:	
Within 8" of Joint:	NO
Remarks:

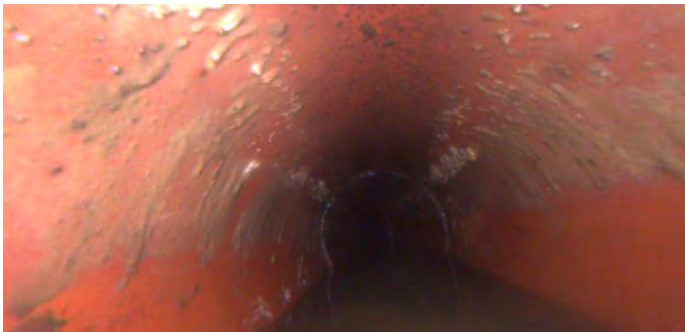
Code:	MSA
Description:	Abandoned Survey

Distance (ft):	7.4
Structural Grade:	0
O&M Grade:	0
Clock Start/From:	
Clock To:	
1st Value:	
2nd Value:	
Value Percent:	
Continuous Index:	
Within 8" of Joint:	NO
Remarks:	debris under water
