Profile/Photo Observation Report

Street:	E 38th Ave	Flow Control:	Not Controlled
City:	Hobart, IN	Year Renewed:	
Location:	Other	Tape/Media #:	
Purpose:	Not Known	Dia/Height:	12"
Use:	Sanitary	Material:	PVC
Drain Area:	NA	Lining:	
Category:	NA		
Comment:

Location Details:		Direction of Survey:	Downstream
US MH:	M-203-051	DS MH:	M-203-041
		Total Length Surveyed (ft):	7.4

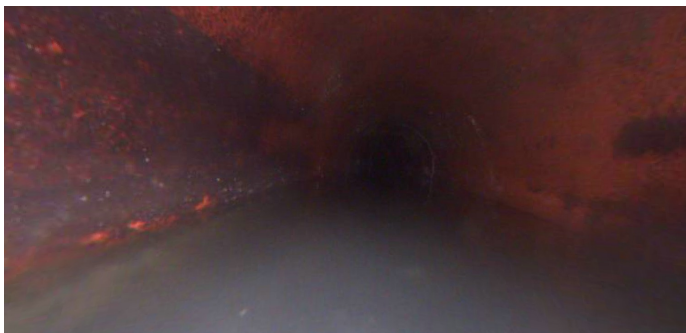
Code: **AMH**
Description: **Manhole**

Distance (ft): **.0**
Structural Grade: **0**
O&M Grade: **0**
Clock Start/From:
Clock To:
1st Value:
2nd Value:
Value Percent:
Continuous Index:
Within 8" of Joint: **NO**
Remarks: **M-203-051**

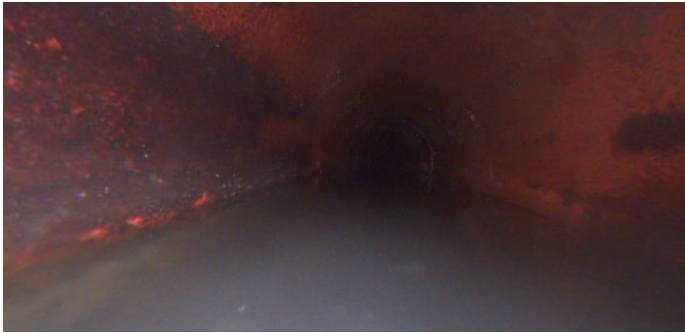
Code:	MWL
Description:	Water Level

Distance (ft):	.0
Structural Grade:	0
O&M Grade:	0
Clock Start/From:	
Clock To:	
1st Value:	
2nd Value:	
Value Percent:	40.000
Continuous Index:	
Within 8" of Joint:	NO
Remarks:

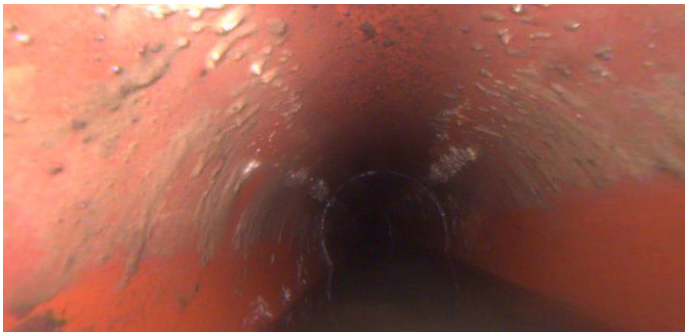
Code:	MSA
Description:	Abandoned Survey

Distance (ft):	7.4
Structural Grade:	0
O&M Grade:	0
Clock Start/From:	
Clock To:	
1st Value:	
2nd Value:	
Value Percent:	
Continuous Index:	
Within 8" of Joint:	NO
Remarks:	debris under water
